The following is an excerpt from the book [Post-disaster shelter: 10 Designs, IFRC, 2013](#). Inclusion of this design is for information purposes and does not necessarily imply best practice. Designs are site specific.

B.5 Haiti – 2010 – ‘T-Shelter’

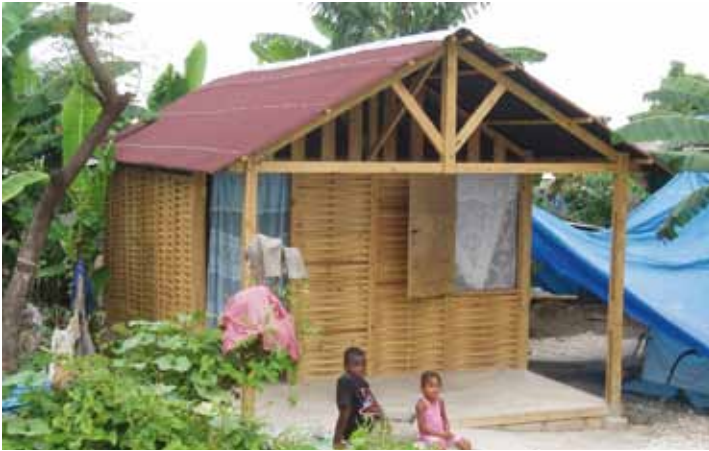
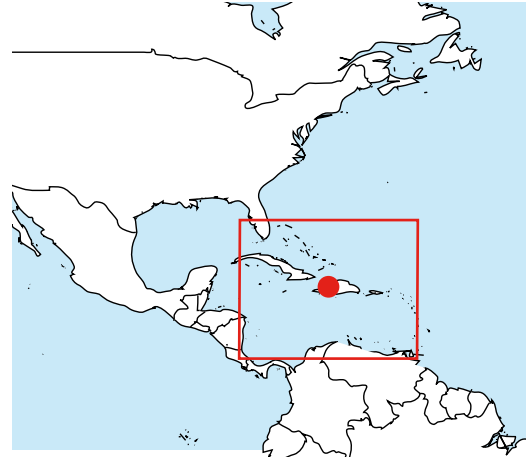
This shelter is a rectangular timber framed structure with a gable roof and a covered floor area of approximately 5.4m x 3.7m with a covered porch measuring approximately 1.8m x 3.7m. The roof has wood and corrugated bituminous roofing supported on timber purlins and trusses. The exterior walls are wood framed, and the wall infill is constructed using a traditional technique called clissage, which consists of thin slats of wood woven between the wall framing. The foundation consists of wood posts embedded in concrete piers, and the floor is an elevated concrete slab supported by a short masonry wall between the wood posts. As designed, the shelter has one door and two windows. The shelters were designed to be accessible by persons with reduced mobility and individual modifications were made according to personal needs.

The masonry foundation wall raises the floor, providing resistance to flood damage. Using preservative treated wood and/or protective coatings would help prevent deterioration of the frame, increasing the shelter lifetime.

There is a lack of data on the performance characteristics of the clissage walls under lateral loading, it is not possible to determine the performance of the shelter under wind and earthquake with any accuracy. Proper site analysis is necessary prior to construction to determine appropriate finished floor heights to provide any mitigation of flood hazards.

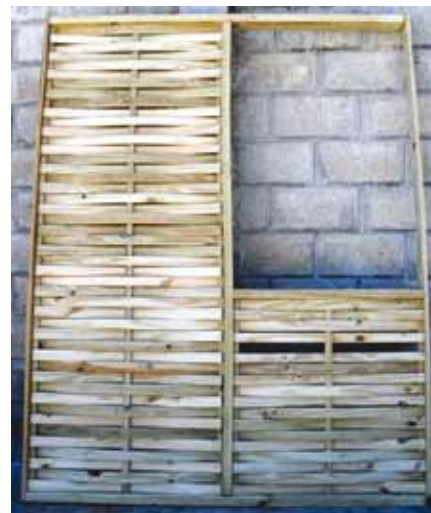
Details of a clissage panel

Left drawing of a pre-manufactured clissage window panel and right photograph to show how the wooden slats were woven together. Panels were pre-fabricated and then nailed together on site.
