## Note on the assessment:

The following is an excerpt from the book [Post-disaster shelter: 10 Designs, IFRC, 2013](#). Inclusion of this design is for information purposes and does not necessarily imply best practice. Designs are site specific.

## B.1 Afghanistan – 2009 – ‘Winterised Shelter’

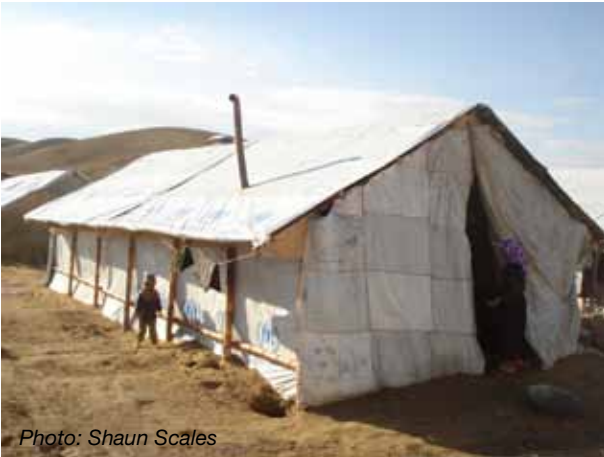
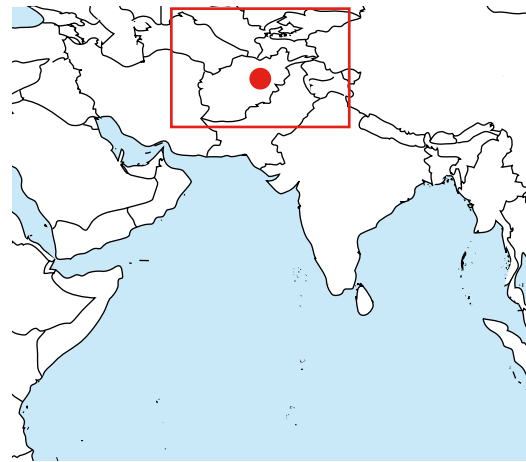
This style of construction uses materials which create a lightweight shelter which can be quickly deployed in remote locations. The simple framing systems are well suited to mass fabrication using a mix of skilled and unskilled labour, and the light weight of the building framing does not require the use of heavy equipment for construction. Bamboo is a durable construction material, and is stronger than most wood species, but the plastic sheeting used for the walls and roof should only be considered temporary. The shelter frames should be able to resist the expected wind loads without failing the bamboo, but will most likely deflect significantly during strong storms. Given the relatively large span of the frames, snow loads can be problematic and occupants should be encouraged to reduce snow accumulation on the roof to prevent collapse.

The plastic sheet roof and walls are simple to install, but will not withstand many seasons before they deteriorate due to UV exposure. It should be expected high winds and/or windblown debris will rip or tear the sheathing. Plastic sheets can be expected to last less than two years.

The performance of the shelter is good for seismic loads, and should be able to withstand most wind storms without collapse. Snow should not be allowed to accumulate more than 300mm on the roof at any time. Proper site analysis is necessary prior to construction to provide any mitigation of flood hazards.

- ↘ The bamboo poles are assumed to be 8cm in diameter and have a 5mm wall thickness.
- ↘ Plastic sheeting is sufficiently attached to the bamboo framing to transfer wind loads to the frames. The capacity of the plastic or its connections to resist wind and snow loads was not analysed, given the temporary nature of this type of construction
- ↘ Lateral foundation loads are resisted by lateral soil bearing, and uplift loads are resisted by the shelter weight alone.
- ↘ Structural analysis does not include roof live loads.
- ↘ There is no building code for Afghanistan, so this shelter was only analysed using the [International Building Code \(IBC\) 2012](#).
