# SHELTER PROJECTS

## SITE PLANNING 16 Case Studies

*CASE STUDIES OF HUMANITARIAN SHELTER AND SETTLEMENT RESPONSES WITH SITE PLANNING COMPONENT*

## Shelter Projects - Site Planning: 16 Case Studies

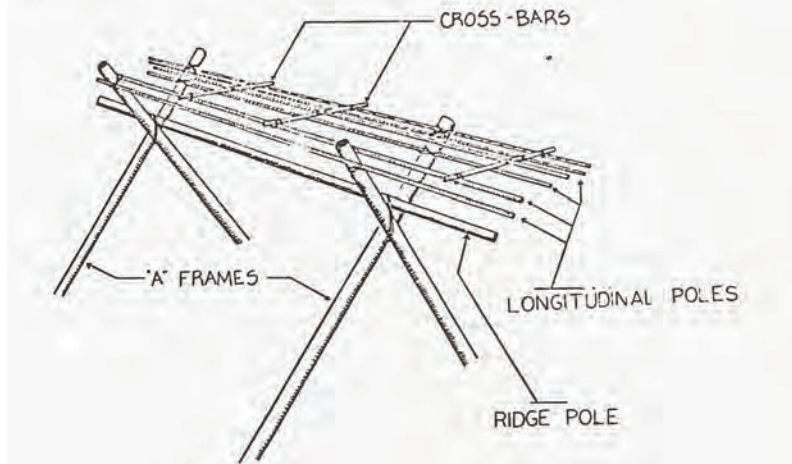
Shelter design details

At the top of the shelter, longitudinal poles should be attached as shown.

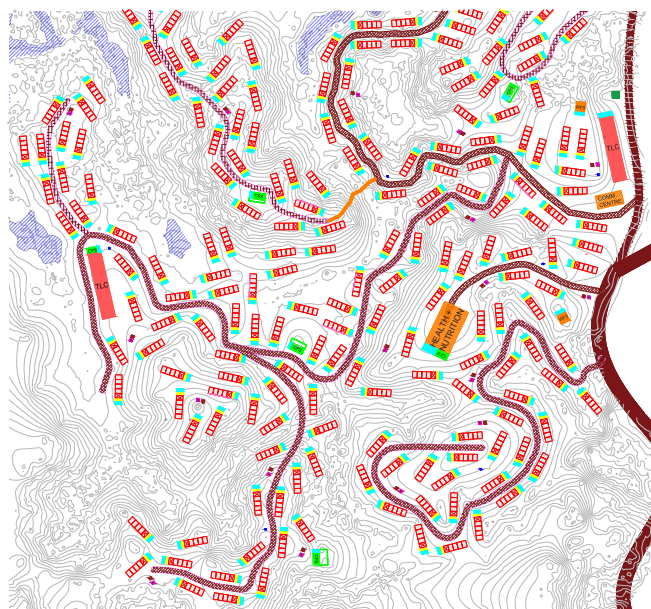
Site planners started to draw the first plans following minimum agreed standards in October 2017, and some of the expansion zones were prepared in advance of refugees settling (Plan: Phoebe Goodwin / UNHCR).

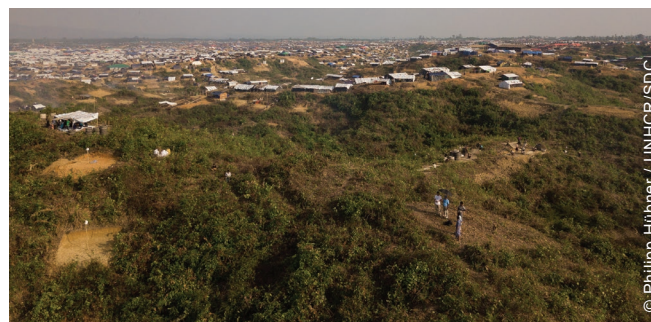
In the initial phase of site planning in the field, drones were used to identify prime land for communal facilities, that was demarcated by teams on the ground.

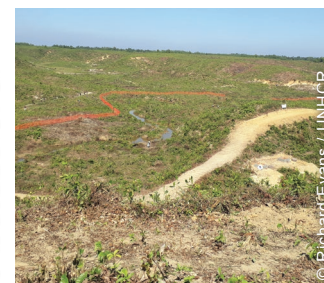
Access to the site was challenging and agencies fenced the west side of the zone to prevent uncontrolled expansion towards the natural reserve area.

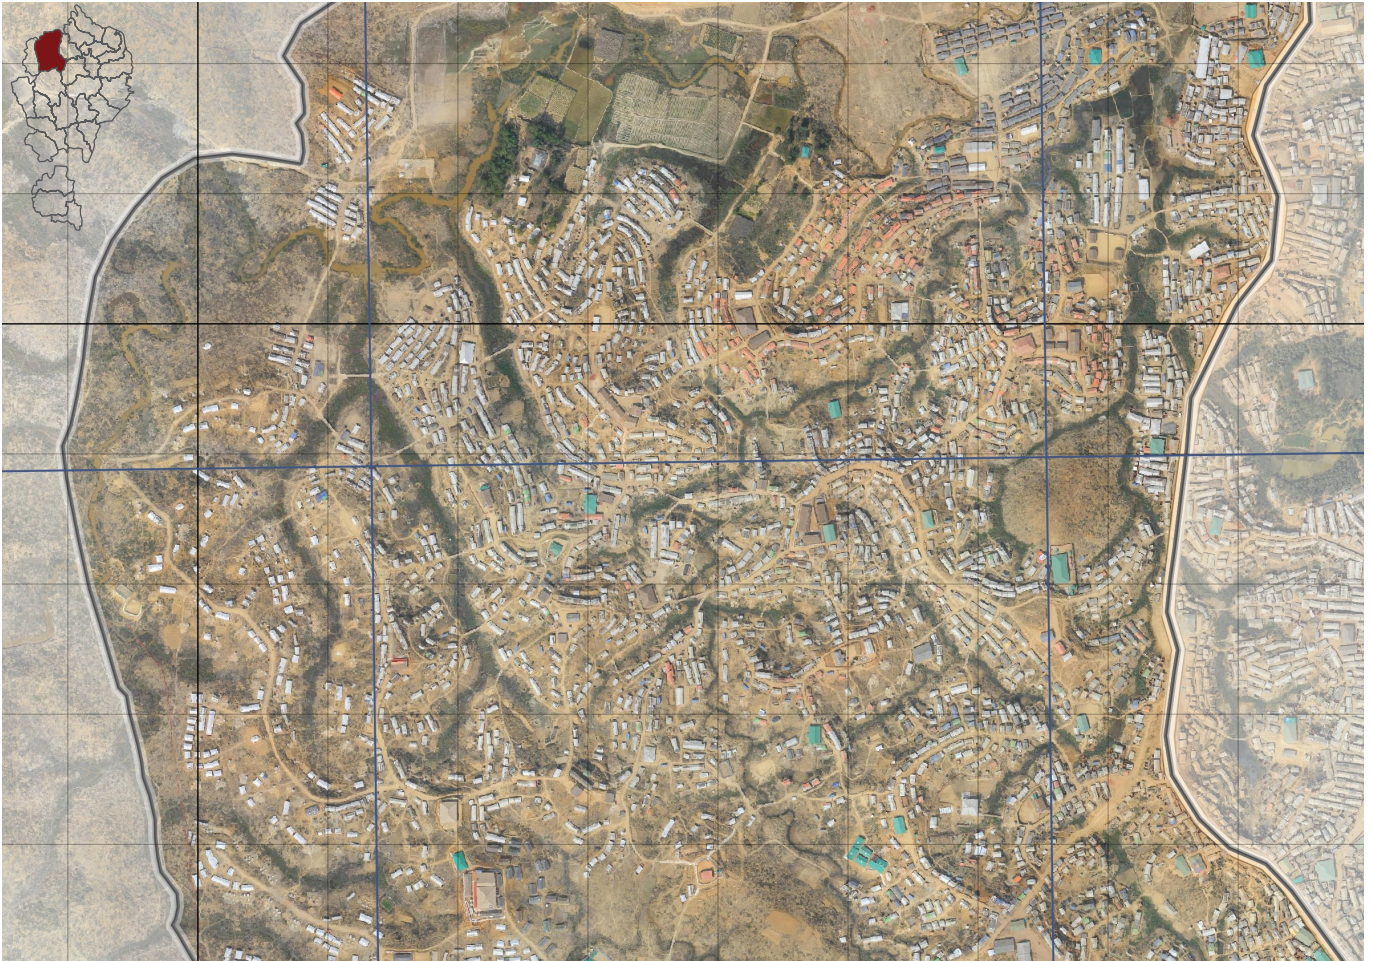
Drone image of zone OO after refugees settled, in February 2018. Densities were lower here than in other parts of the site, and services were relatively well distributed. However, this also meant that assistance was not evenly spread throughout the site, as other areas remained very dense and lacked services (Source: NPM, 14 Feb 2018).

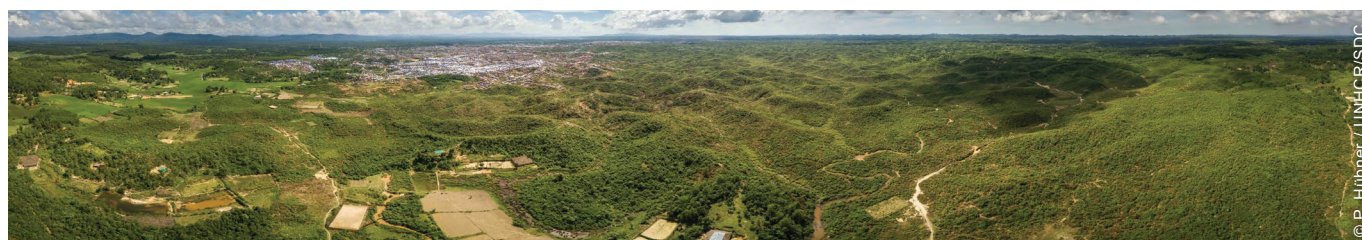
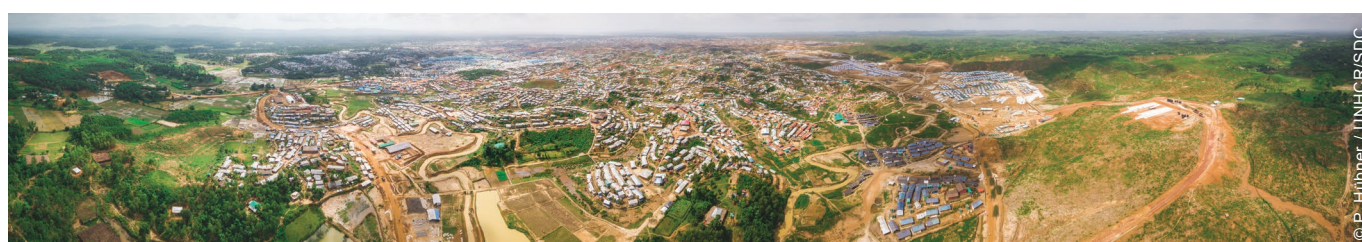
*The additional 1,000 acres were quickly occupied in the span of a few months. Given the scale of the site, a macro-settlement approach was needed to identify the strategic location of facilities and plan for the future growth, infrastructure and likely scenarios.*

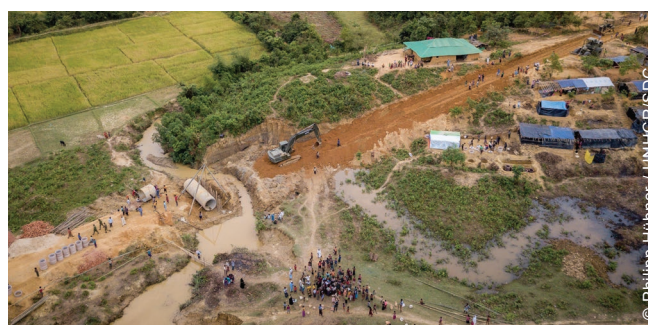
Major infrastructure (such as the Army road and culverts) was needed to convert a forest land into a liveable settlement.

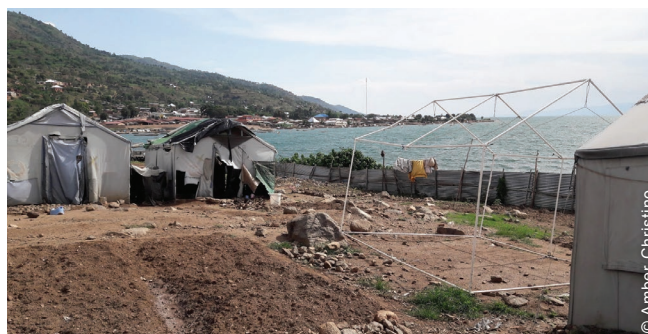
The tents provided in the camps were intended to last about six months, but families lived there for two years, in battered tents like these at Cashi camp.

The shelter kits initially provided were intended to last approximately six months, though families lived there for more than two years. Living conditions rapidly deteriorated; tents were in dire need of repair; rain poured in from holes in the roofs, creating a muddy sleeping area and leading to increased incidence of pneumonia and other illnesses. In January 2018, the camps of Mushasha I and II were partially destroyed by floods. Many inhabitants expressed their desire to leave and requested assistance for a more durable shelter solution.

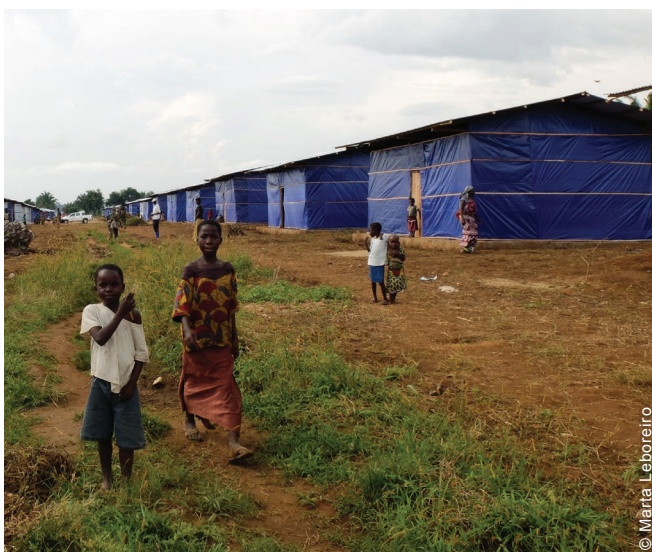
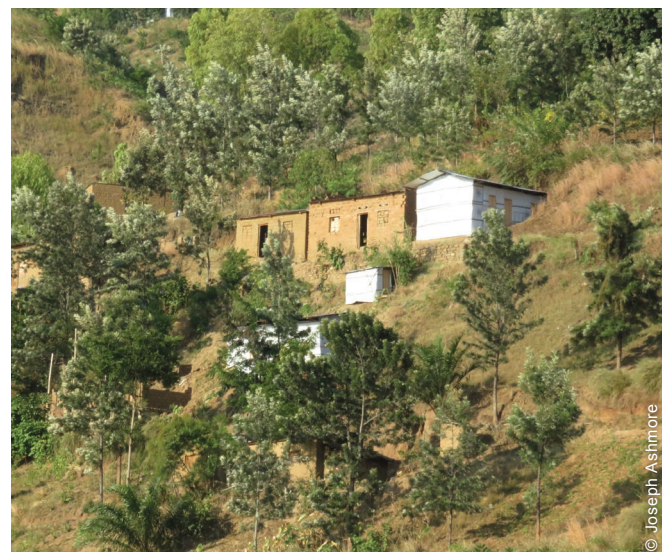
The project supported return by providing shelters on a resettlement site on government-issued land in Kigwena (above left). When land tenure and safety allowed it, shelters were built in the area of origin of the IDPs (above right, in the hills of Rumonge).

159 semi-permanent shelters were built in the areas of origin of the population living in Cashi and Gitaza camps, across seven different hilly locations. Due to timing and the complexity of transport to the isolated hills, some of which are located three hours away from a major road, the stone foundation was removed and households received cash to transport the materials (the equivalent of USD 2.50 per trip from the camp to the new land). Each household built its own latrine with materials provided and a cash grant for digging.

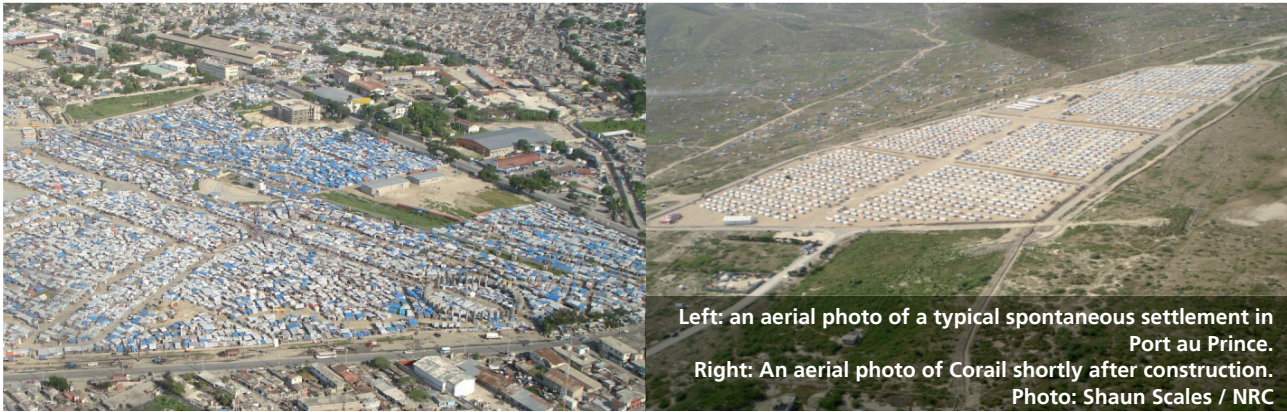
Left: an aerial photo of a typical spontaneous settlement in Port au Prince.  
Right: An aerial photo of Corail shortly after construction.  
Photo: Shaun Scales / NRC

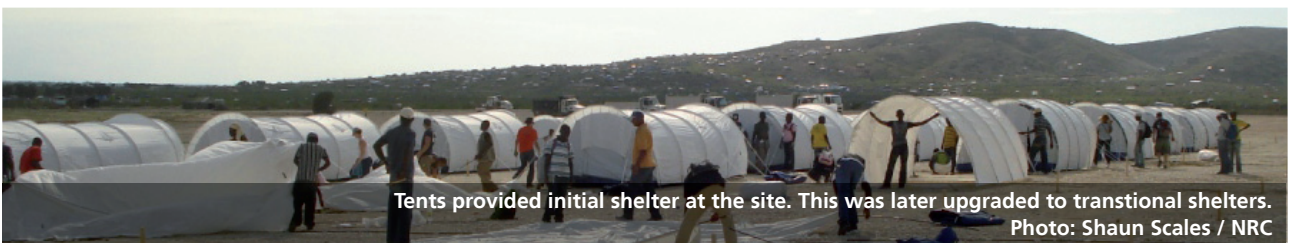
Tents provided initial shelter at the site. This was later upgraded to transitional shelters. Photo: Shaun Scales / NRC

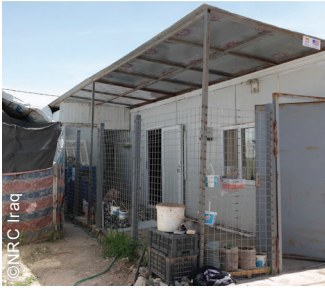
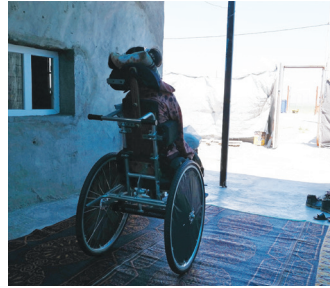
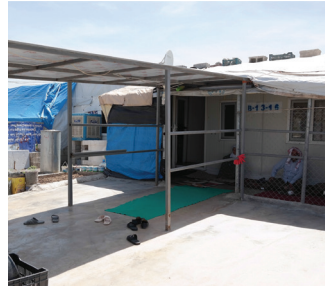
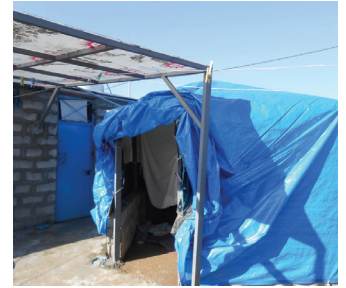
The project worked on a variety of upgrades focused on improving the accessibility and Quality of Life of individuals with disabilities. From left to right: Shaded area and fencing around prefab shelter. Concrete slab improving wheelchair access. Fold out support railing. Shaded entrance and support posts for better access.

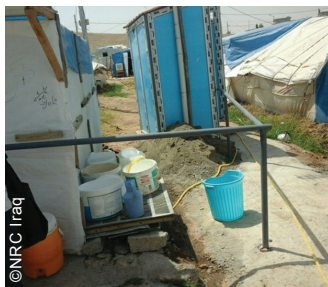
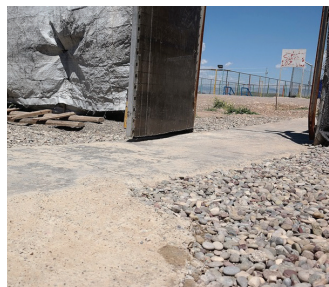
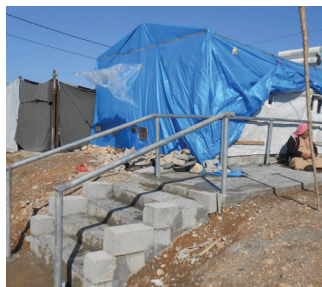
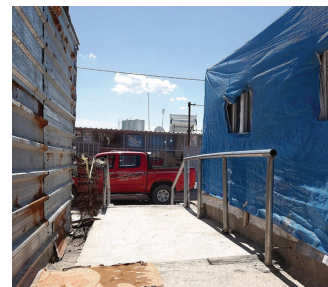
Works also included mobility upgrades within plots or across the camps. From left to right: Concrete pathway and railing leading from shelter to shared/communal latrine. Concrete slab improving wheelchair access. Handrails, concrete stairway and pathway around or between shelter plots.

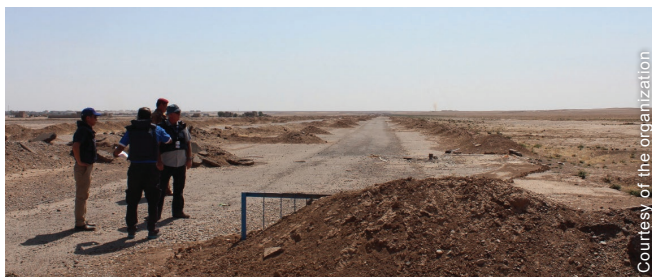
Before mine clearance was completed, sites were only accessible from the perimeter. Planning was done remotely, by observation and thanks to satellite images.

+ **Remote site planning.** In the initial planning stage, the site could not be accessed and so topographic analysis and measurement of site boundaries were done by a mix of observation from the perimeter and analysis of satellite imagery. Plans were then adjusted during the implementation phase. Such remote planning worked well thanks to the high-resolution satellite images acquired from authorized agencies.

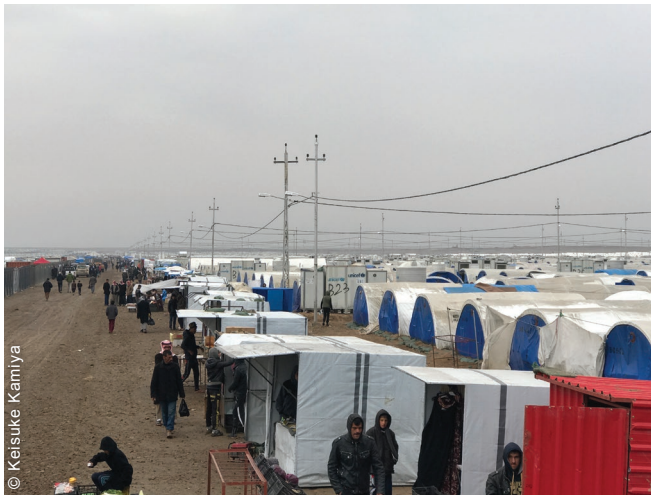
In less than six months, capacity for 17,500 households was established in two sites. The main roads were used for small shops and storage of materials.

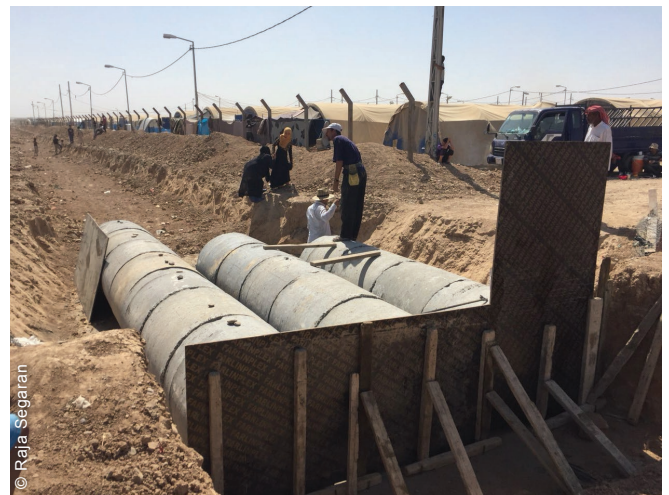
One site was vulnerable to heavy rains and suffered minor flooding during winter. In 2018, storm-water drainage channels and culverts were upgraded.

Storm-water drainage was later expanded in early 2018, after five new sites were built around the main Qayyarah Airstrip site. This consisted in wide earthen channels with protective berms and large concrete culverts.

In late 2018, minor flooding occurred due to the blocking of culverts by informal settlements outside the site.

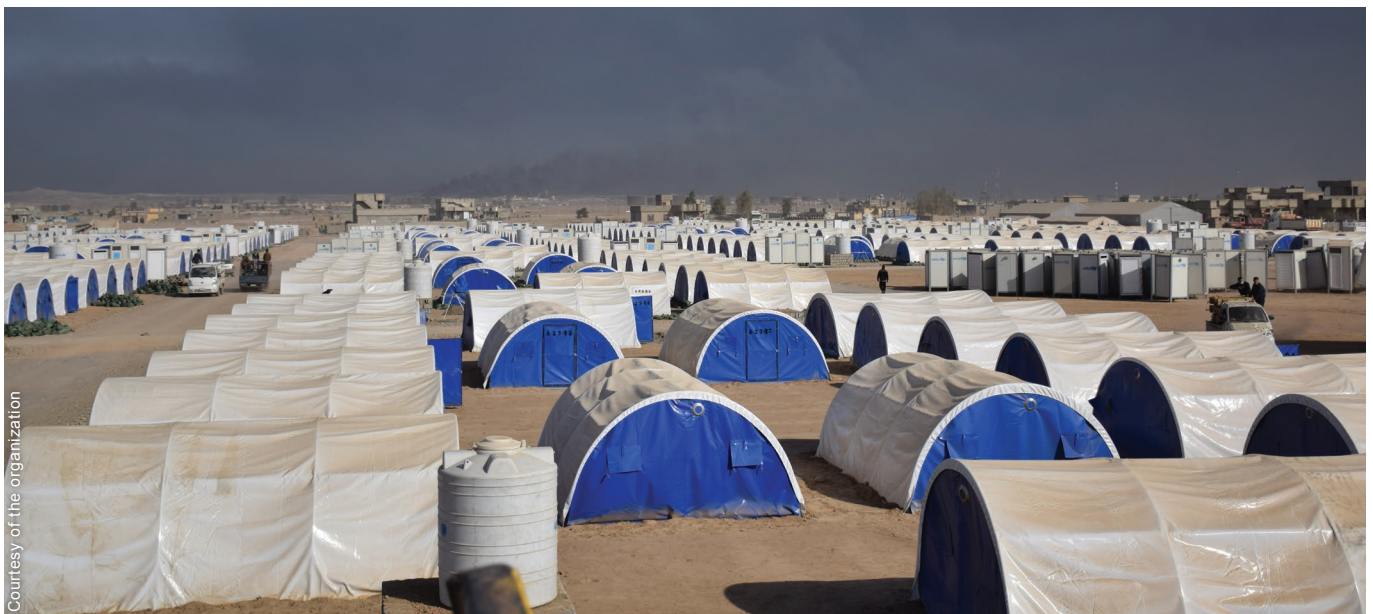
Government standard tents of 6x4m were installed in clustered blocks of 20 each. Space for extensions was minimal but, after families had moved in, upgrades were conducted to the floor and electricity was installed. Partners could then build service facilities in specific blocks pre-allocated in the site plan.

Tents were partly supplied by the government and partly procured by the organization within the country. These followed the government standard specifications and had an estimated lifespan of 6–12 months. About two years after the sites were set up, most tents were damaged due to the extreme weather conditions and the flooding events. In early 2019, the organization was planning to replace the mobile components of over 23,000 such tents, while maintaining the steel structure.

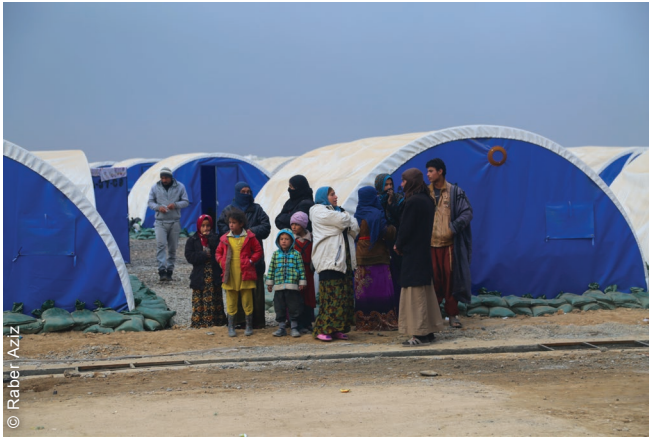
Using a rapid settlement approach, families were accommodated before all facilities and infrastructure were installed. Gravel was added in the shelter areas and roads excavated 20cm lower than the blocks, to prevent flooding.

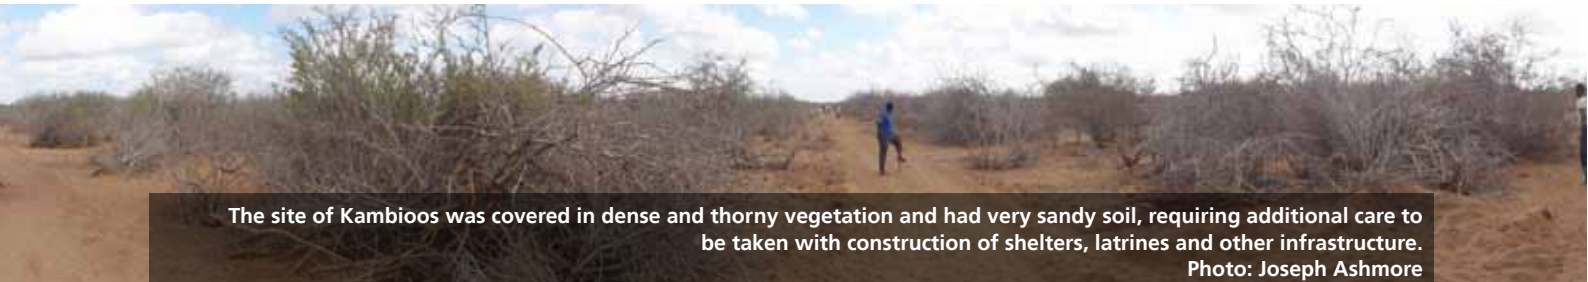
The site of Kambioos was covered in dense and thorny vegetation and had very sandy soil, requiring additional care to be taken with construction of shelters, latrines and other infrastructure.  
Photo: Joseph Ashmore

The site of Kambioos had fewer flooding issues, but there were initially concerns about the water scarcity, and the additional challenges caused by the sandy soil and a bedrock. This created issues in pitching tents and digging latrines, while access roads, both to and within the site were a challenge.

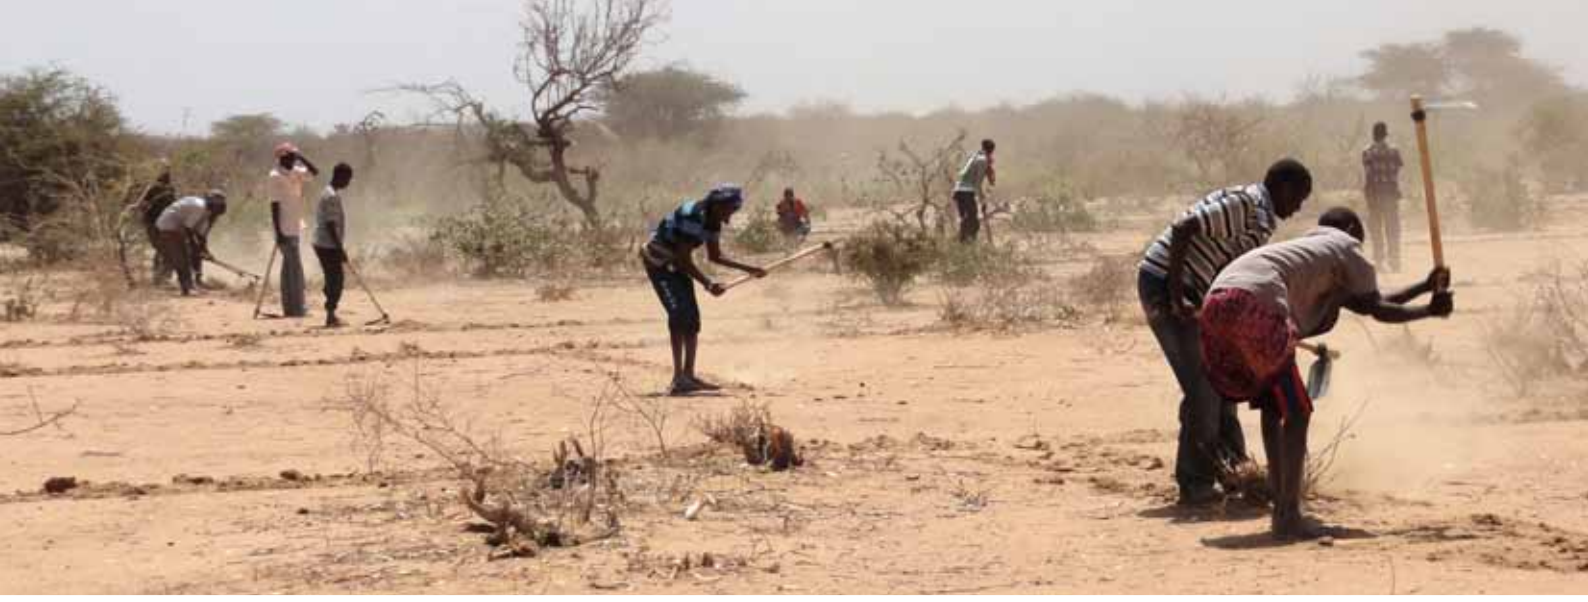
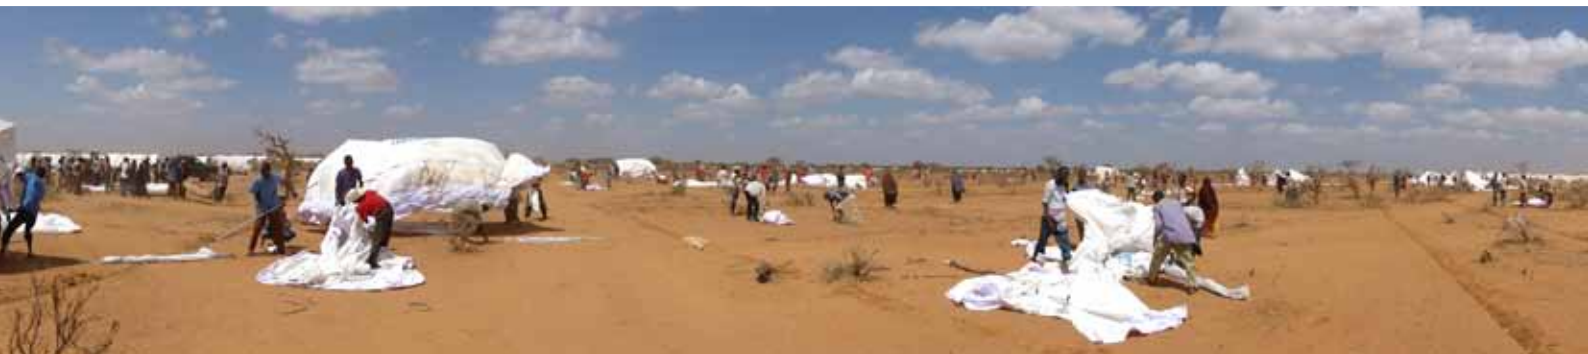
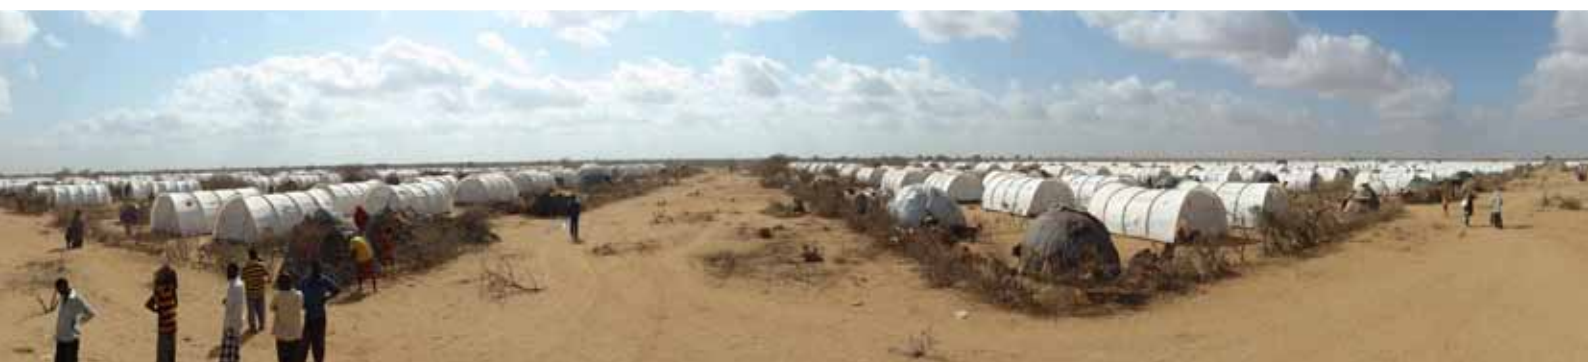
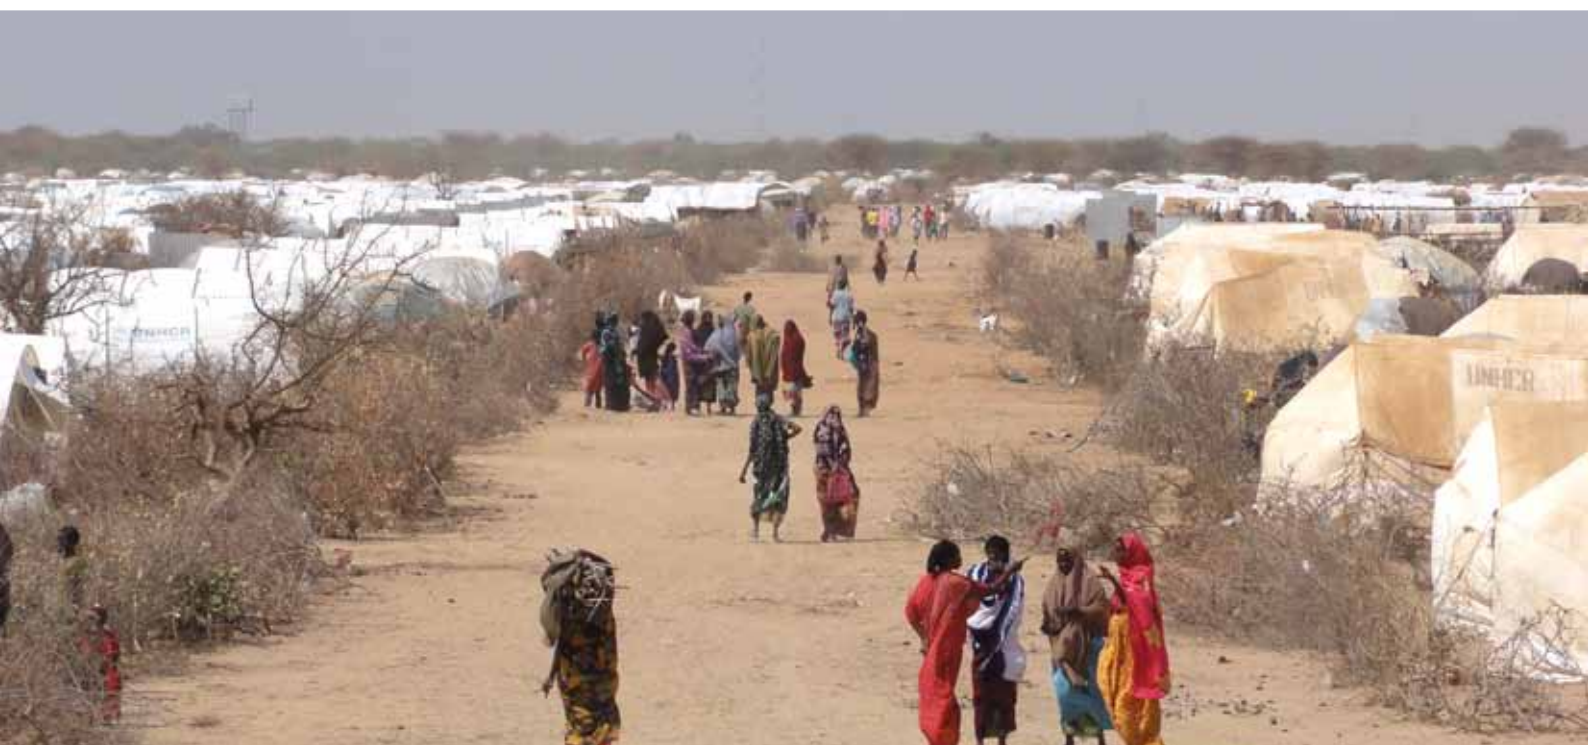
Top to bottom: Site marking; Tent erection on a windy day; Newly established blocks at IFO camp extension. Camps were organised into a) plots, b) communites, c) blocks, and d) sections. Photo: Joseph Ashmore

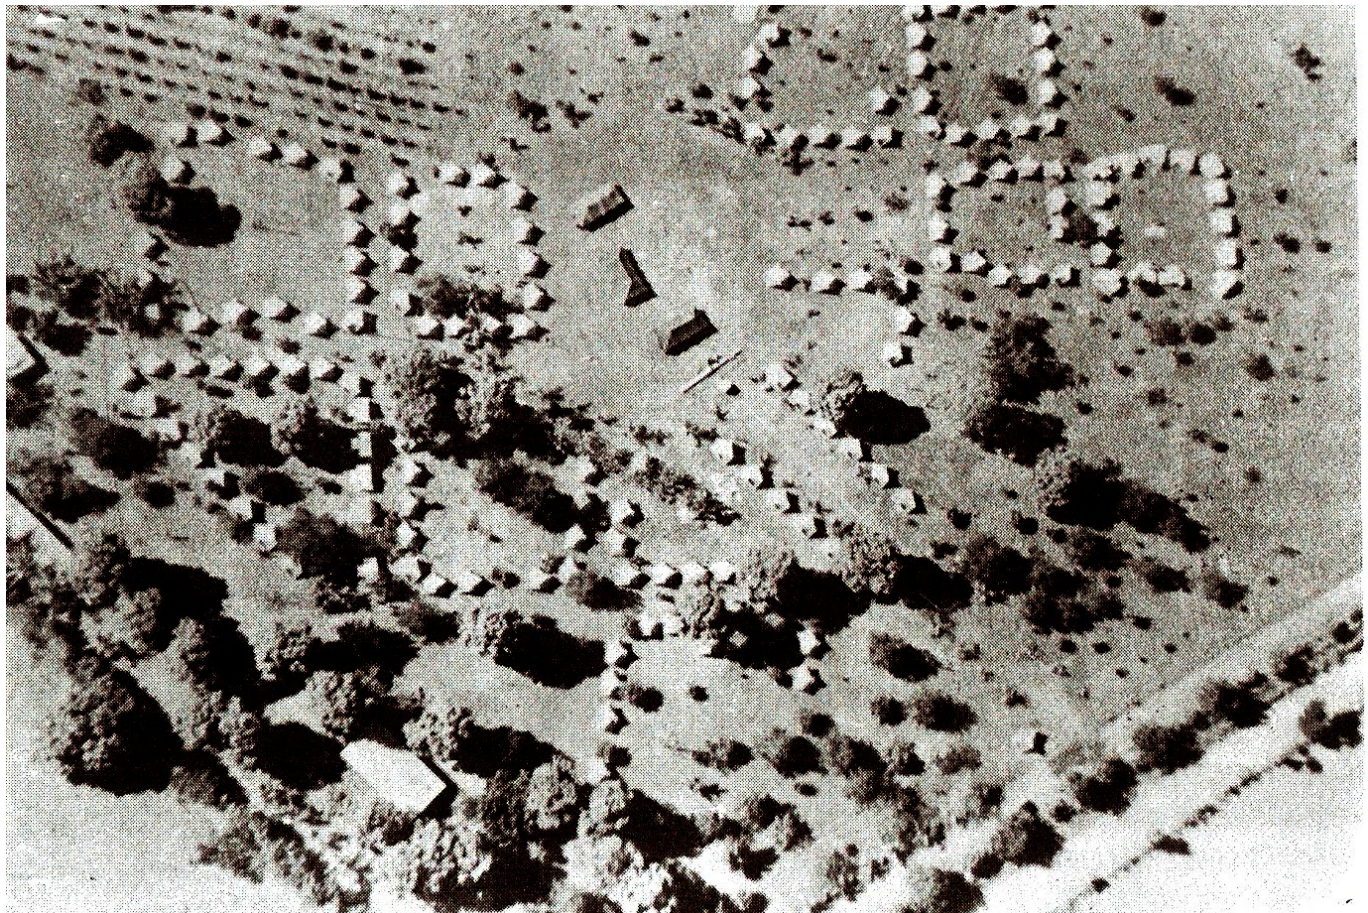
*Aerial photo of Coyotepe camp, Nicaragua, 1973. Photo credits: Fred Cuny Center*

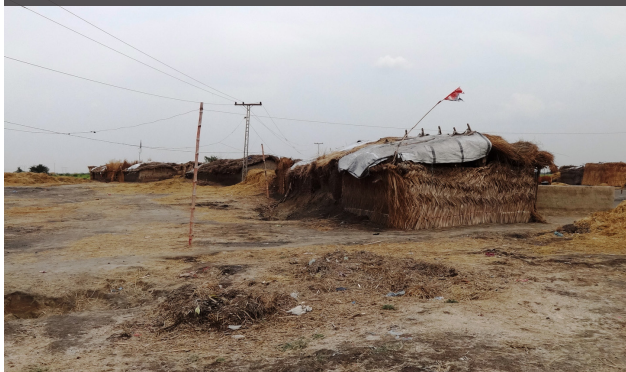
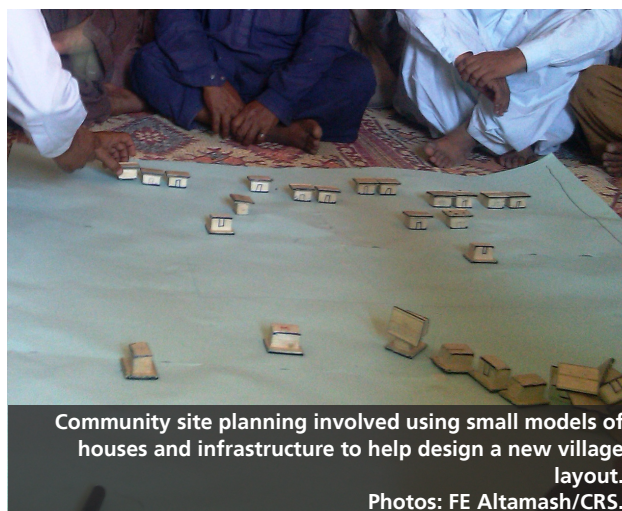
Saeedabad village, Jacobabad before the site had been re-planned. The new plan would result in moving shelters away from electrical wires and poor drainage areas and creating better footpath access around the site.  
Photos: PO Tasleem/CRS

Community site planning involved using small models of houses and infrastructure to help design a new village layout.  
Photos: FE Altamash/CRS.

Following initial community sensitisation about the project, each village was mapped, with key hazards and communal facilities identified. As many participants were illiterate, small models of handpumps, shelters and houses were used in the mapping process.

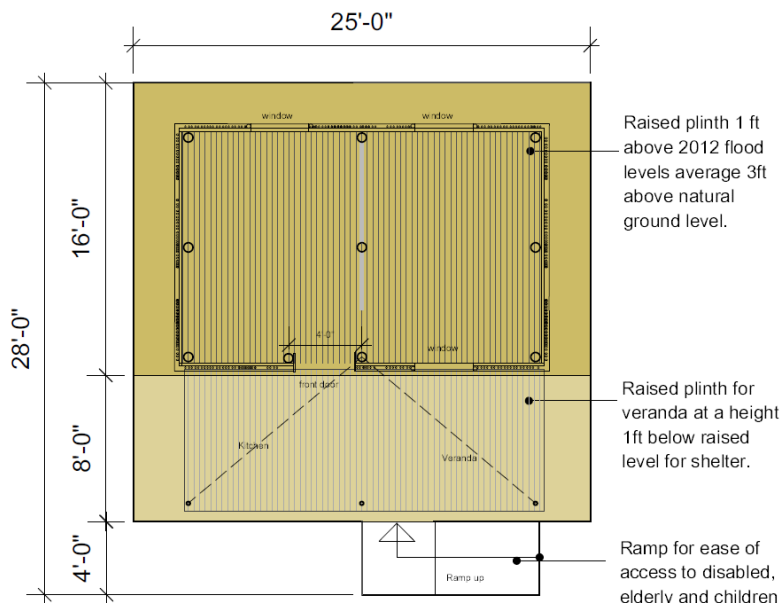
Part of the technical shelter design document specifying details for the plinth. Graphic: CRS

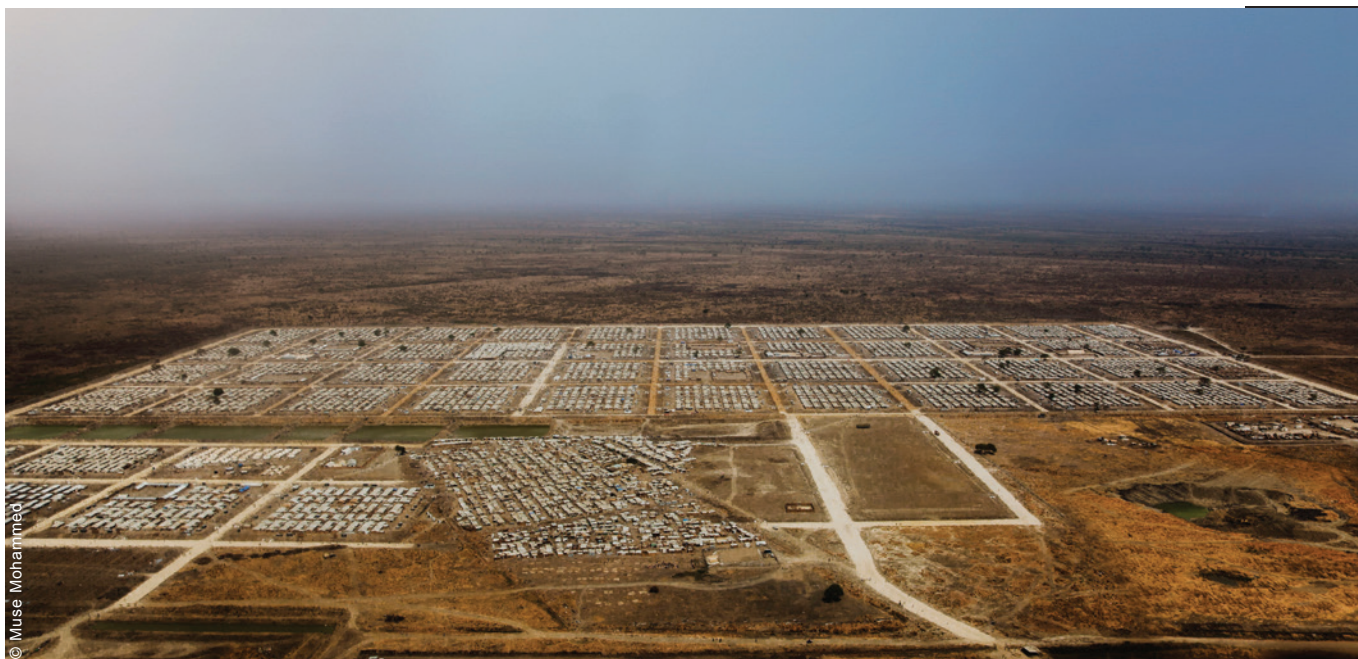
The expansion plan included land that was already spontaneously occupied by camp residents. Careful phasing of major upgrading works was required, as the whole site needed to be upgraded.

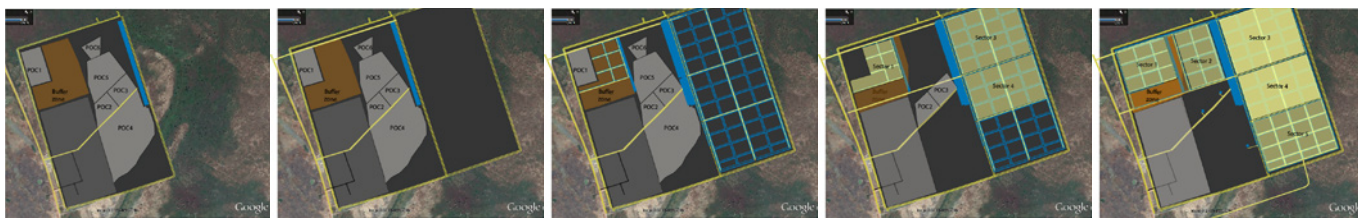
Phase 0: survey and de-mining. Phase 1: Access to site works and perimeter. Phase 2: Internal access and drainage. Phase 3: block development and relocations. Phase 4: block development, relocation and completion.

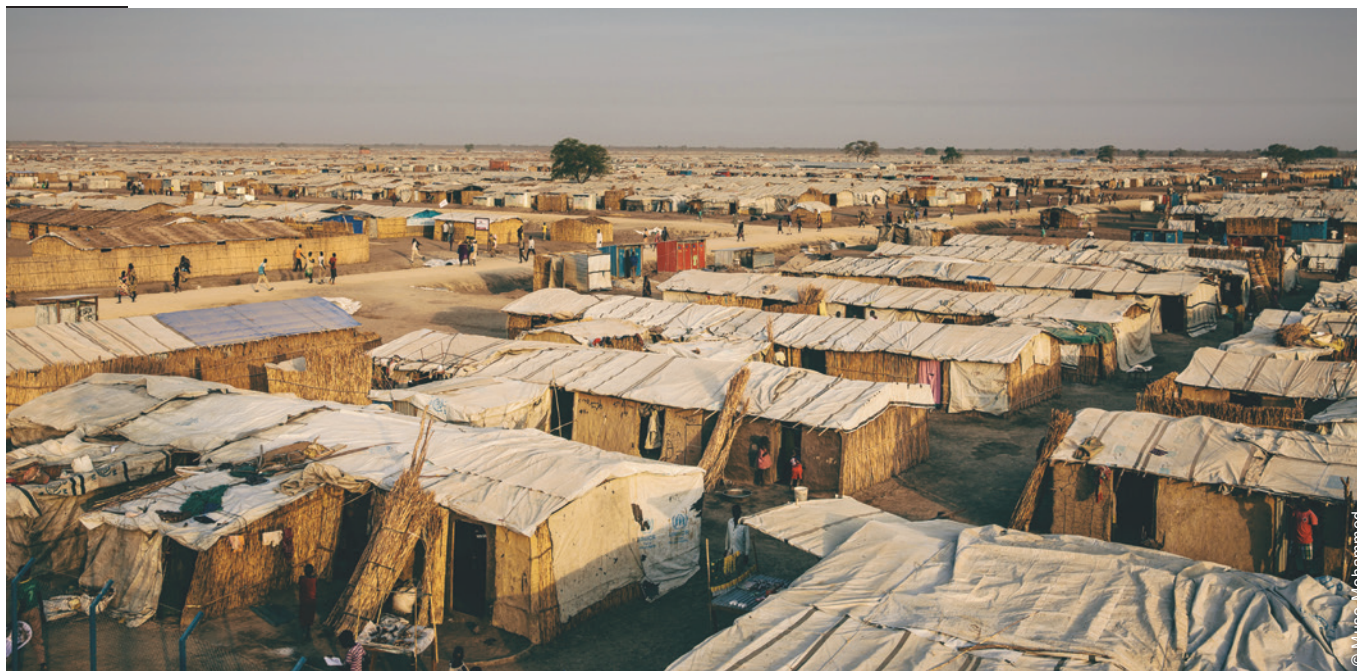
The shelter project built communal shelters due to lack of land and nationally limited resources. These shelters allowed to maximize the use of limited space and impacted shelter strategies throughout the country.

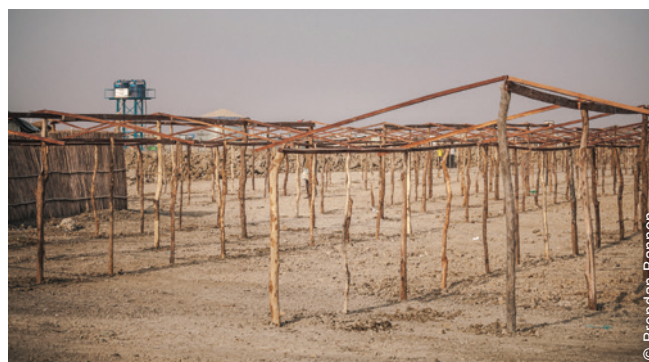
Shelter frames were built by contractors.

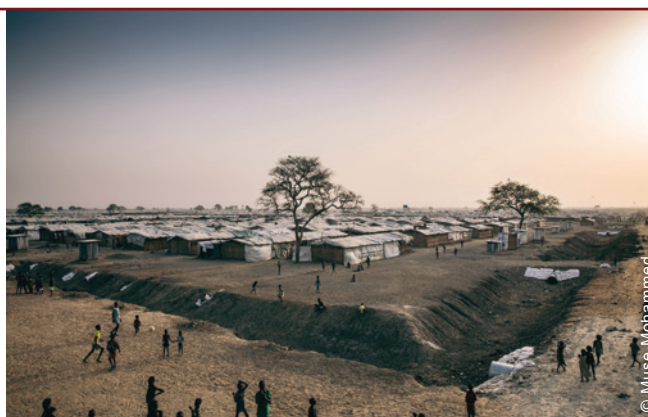
The site works were based on a Dutch “polder” system. They included 28m<sup>2</sup> section drainage ditches, berms, water retention basins, and large volume pumps to evacuate water.

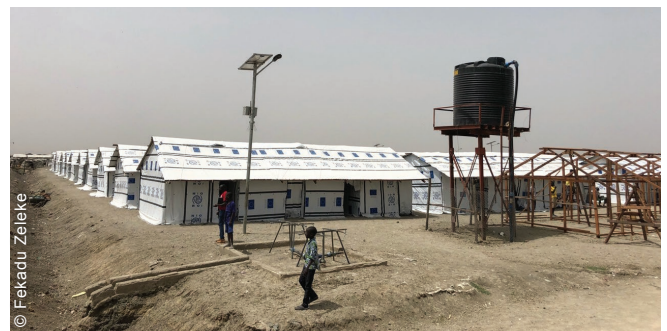
The project rehabilitated a sector of the Malakal PoC through a phased approach.

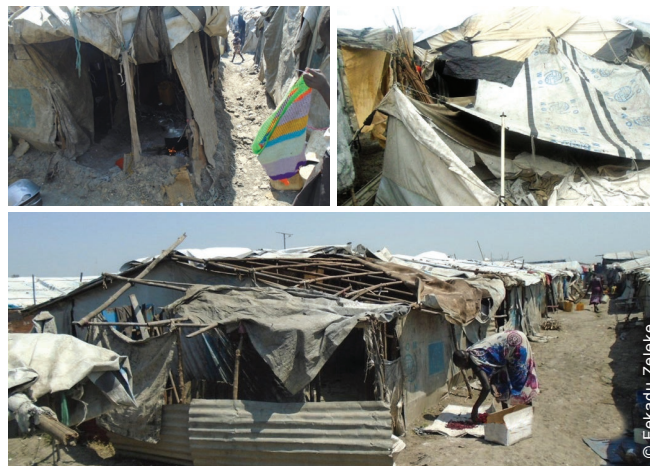
Before rehabilitation, the site offered very poor shelter conditions and was overcrowded, with related fire and safety risks for its residents.

The main issues in the PoC included congestion and overcrowding, encroachment of roads, lack of privacy for families sharing communal shelters, as well as the overall deterioration of shelters. Recurrent flooding affected the site, due to collapse of drainage and lack of tertiary drainage. The environment also contributed to increasing risks to safety and security, including gender-based violence.

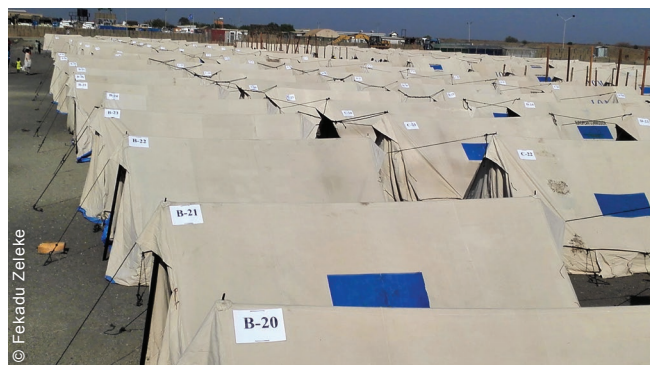
A transit site was established next to sector 4 and used to gradually move people and clear areas of the old site. Due to its small size, the speed of the relocation and rehabilitation process was slow.

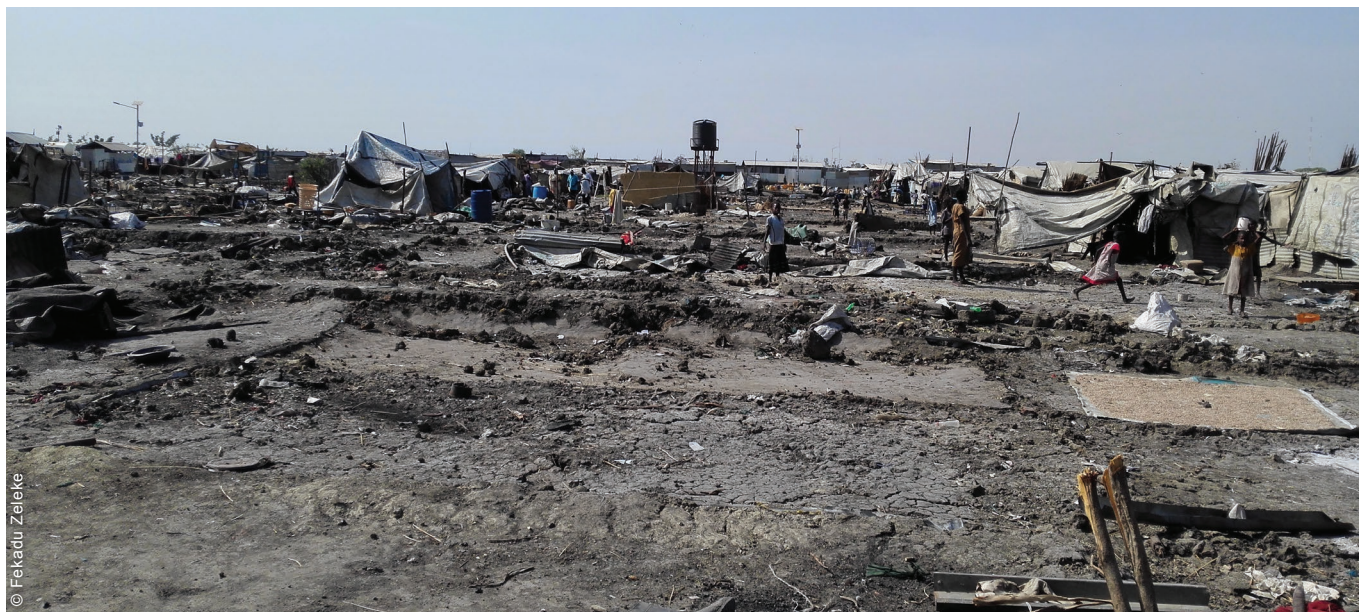
After residents of a block had moved to the transit site, old shelters were dismantled and the area cleared.

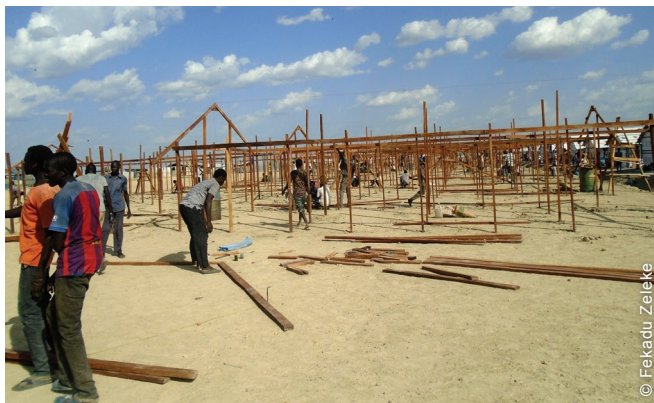
*New shelters were built by local community members after ground levelling.*

The shelters were made of timber and plastic sheeting for walling and roofing. Almost all materials were sourced outside Malakal, due to the unavailability in the local market and to protect the already dilapidated physical environment from further deterioration.

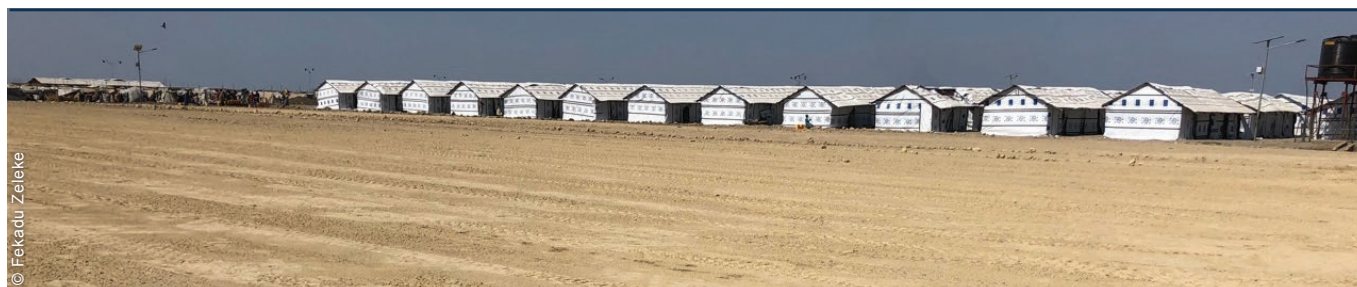
Priority activities in the rehabilitation included backfilling, ground levelling, reconstruction of drainage and rehabilitation of secondary roads, as well as reorganization of the space to improve access to services.

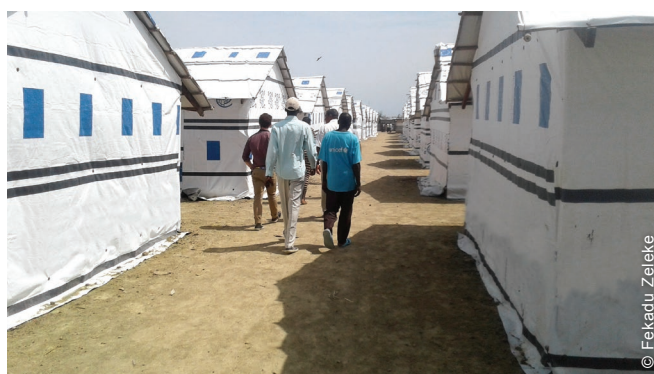
The new shelters were taller and larger to provide better ventilation and privacy.

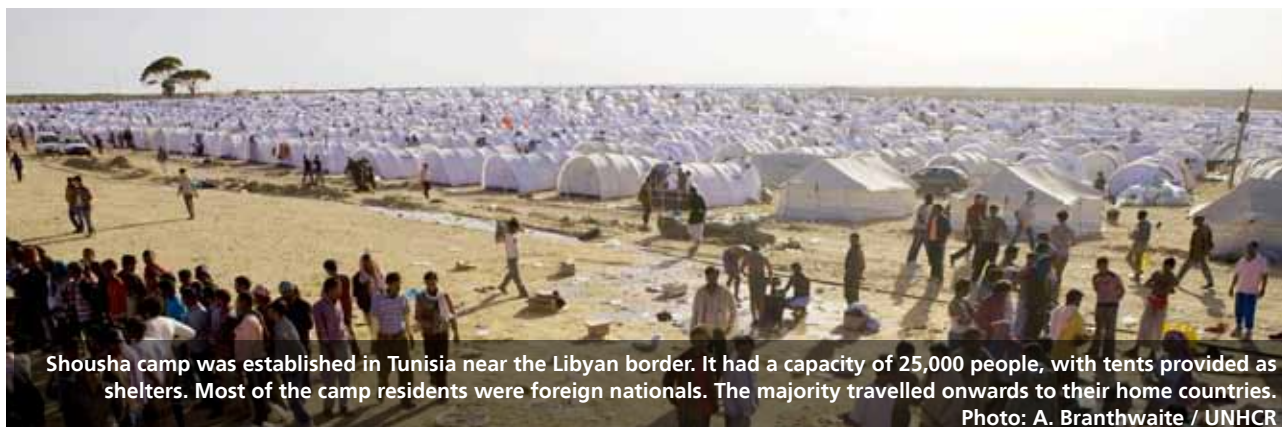
Shousha camp was established in Tunisia near the Libyan border. It had a capacity of 25,000 people, with tents provided as shelters. Most of the camp residents were foreign nationals. The majority travelled onwards to their home countries.

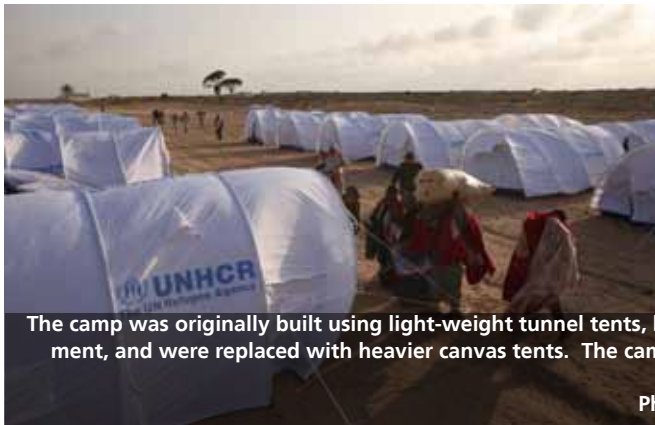
The camp was originally built using light-weight tunnel tents, but these had a limited lifespan in the hot and windy environment, and were replaced with heavier canvas tents. The camp later burned down and was replanned to take into account the population's different nationalities.

The tents were also very fragile, breaking very easily. They did not have any exterior shading and were blown away by the wind. After a few weeks, the white tunnel tents were replaced by heavier green canvas tents. These tents were easier to build and a little more robust. However, the roof pole (horizontal beam) was weak and regularly broke.
