# SHELTER PROJECTS

## SITE PLANNING 16 Case Studies

*CASE STUDIES OF HUMANITARIAN SHELTER AND SETTLEMENT RESPONSES WITH SITE PLANNING COMPONENT*

## Shelter Projects - Site Planning: 16 Case Studies

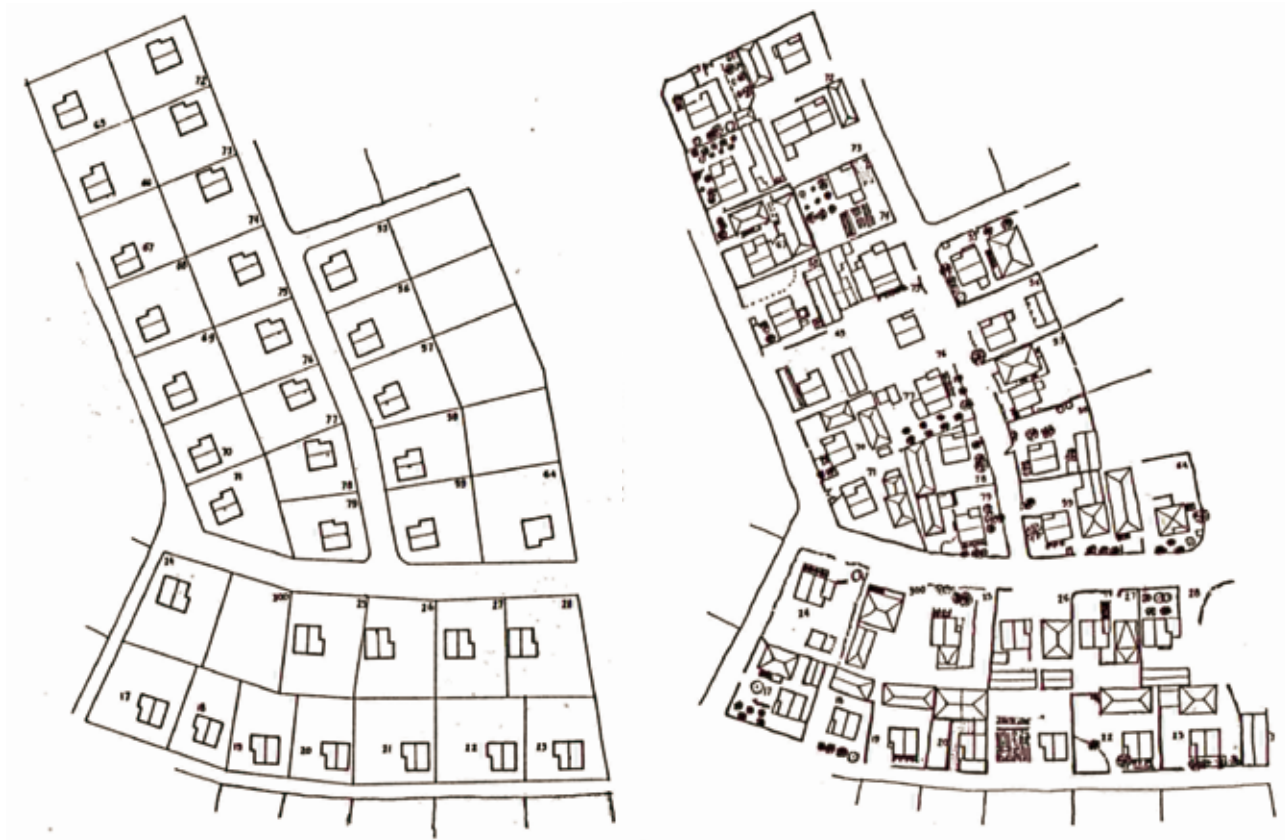
Maps of a neighbourhood of the resettlement village of new Muhipler drawn 13 years apart. Left 1971, Right 1984  
 Illustration: Housing and Culture after Earthquakes / Yasemin Aysan / Paul Oliver / Ian Davis

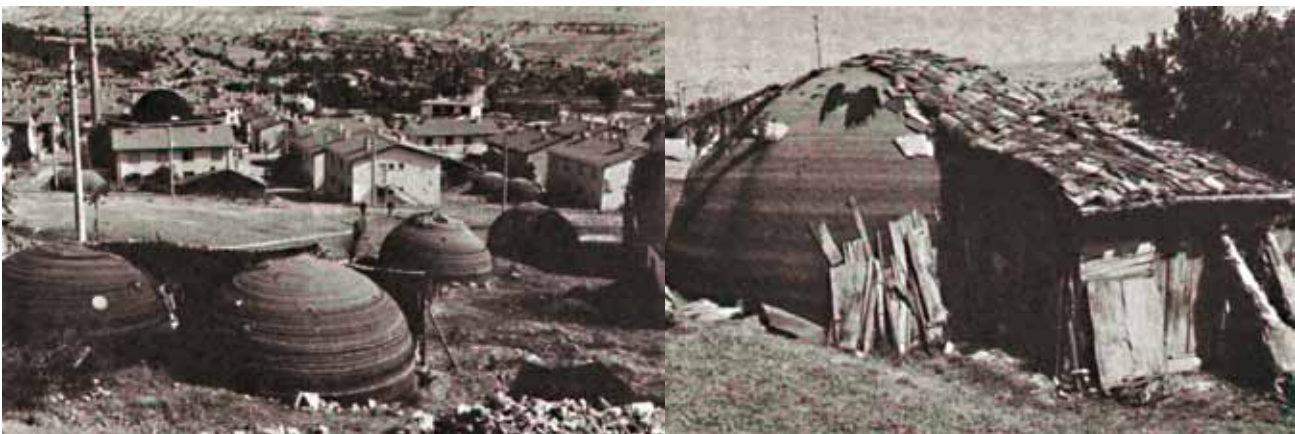
Polyurethane 'igloos' were deployed. An experiment that was discontinued after the 1975 Lice earthquake  
 Photos: Housing and Culture after Earthquakes / Yasemin Aysan / Paul Oliver
