SHELTER PROJECTS

SHELTER IN THE MIDDLE EAST:

16 Case Studies

CASE STUDIES OF HUMANITARIAN SHELTER AND SETTLEMENT RESPONSES IN THE MIDDLE EAST

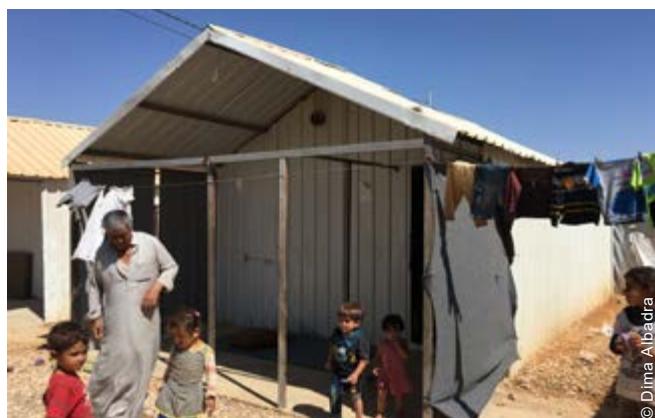
Modular shelters built in camps in Jordan are often adapted by refugees.

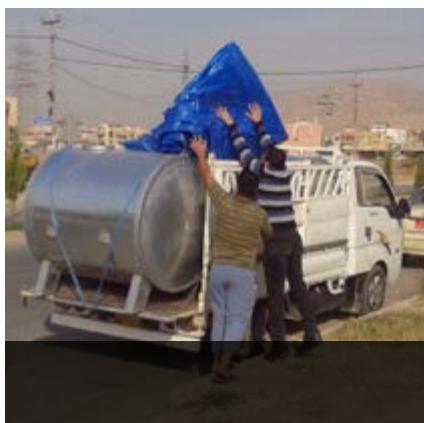
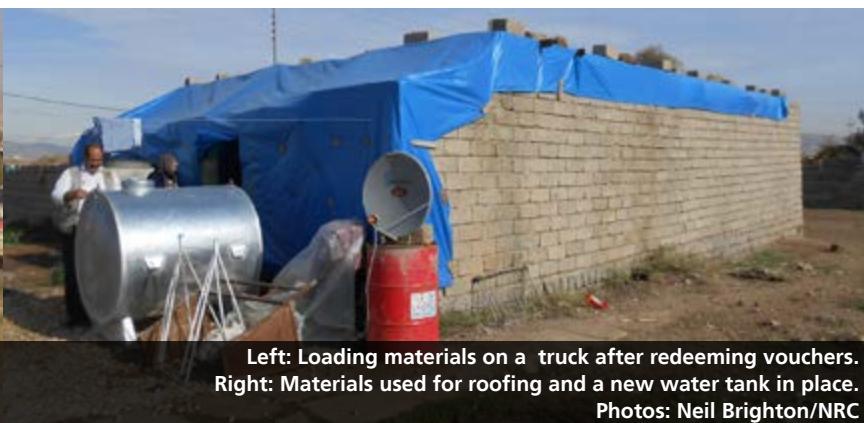
Left: Loading materials on a truck after redeeming vouchers.
Right: Materials used for roofing and a new water tank in place.
Photos: Neil Brighton/NRC

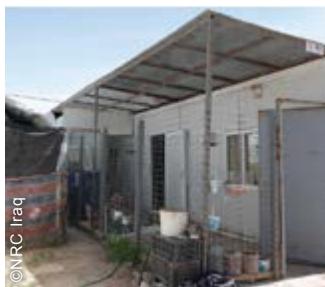
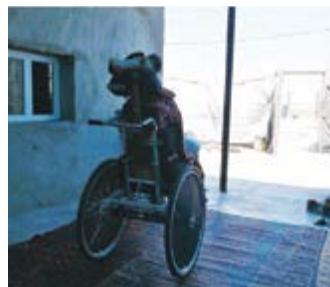
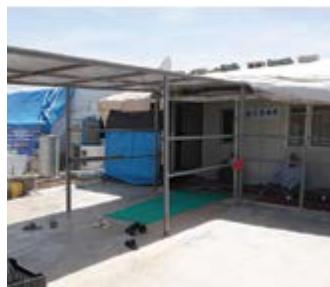
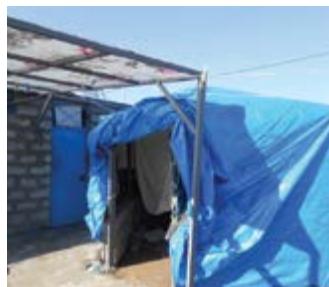
The project worked on a variety of upgrades focused on improving the accessibility and Quality of Life of individuals with disabilities. From left to right: Shaded area and fencing around prefab shelter. Concrete slab improving wheelchair access. Fold out support railing. Shaded entrance and support posts for better access.

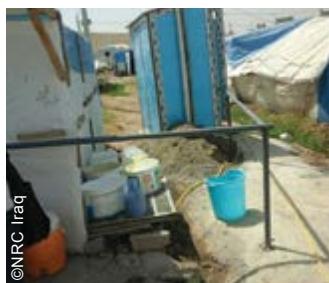
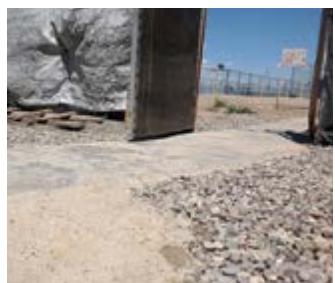
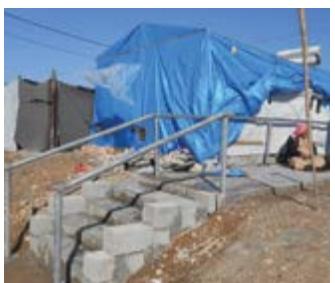
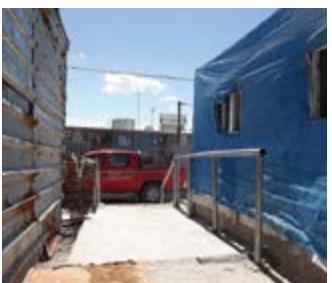
Works also included mobility upgrades within plots or across the camps. From left to right: Concrete pathway and railing leading from shelter to shared/communal latrine. Concrete slab improving wheelchair access. Handrails, concrete stairway and pathway around or between shelter plots.

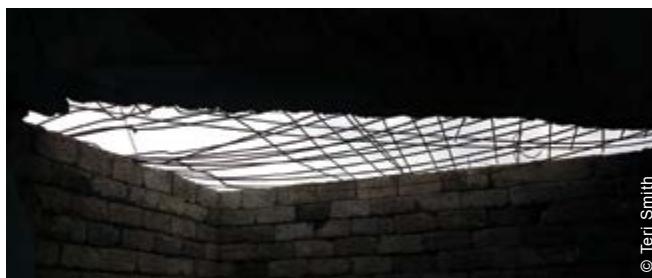
The project rehabilitated houses through a voucher scheme. Repairs included roofs and walls.

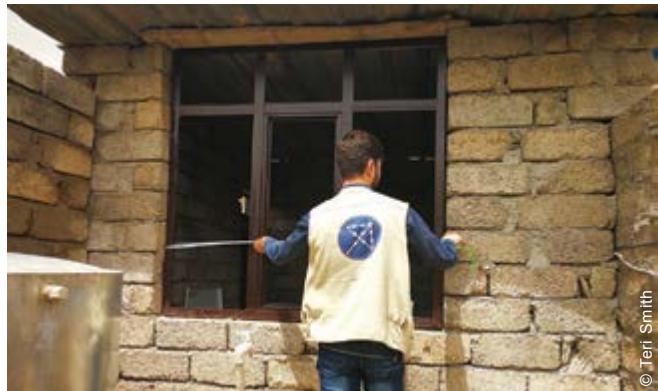
Engineers conducted structural assessments and developed individual BoQs.

Project engineers conducted structural assessments of houses to ensure people were not inhabiting unsafe structures and to create individualized Bills of Quantities (BoQs), taking into consideration households’ unique needs and the different types and levels of damage.

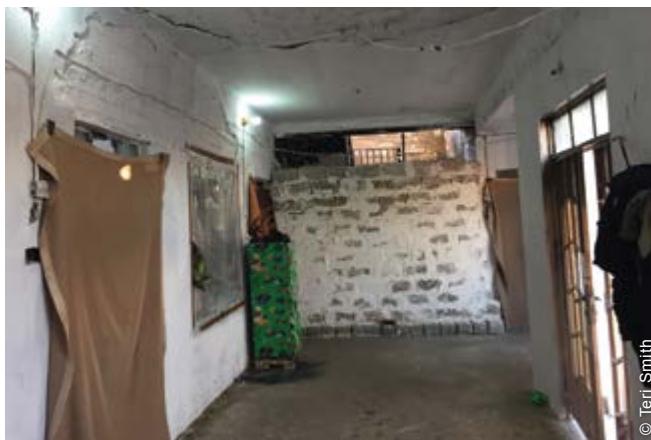
Families in conflict-affected areas also conducted repairs themselves. The image shows a self-built rehabilitation in another location.

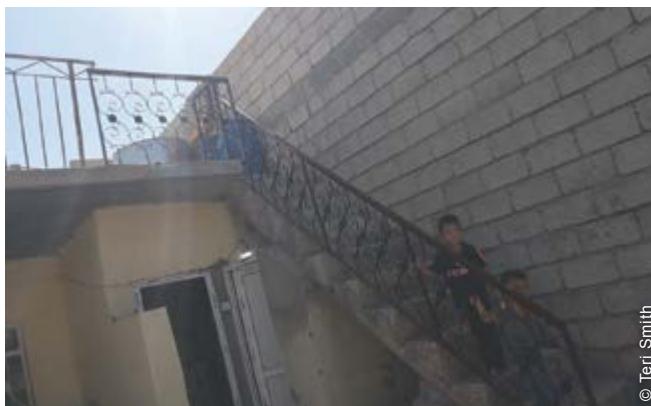
The project repaired walls and stairs, and added handrails for safety.

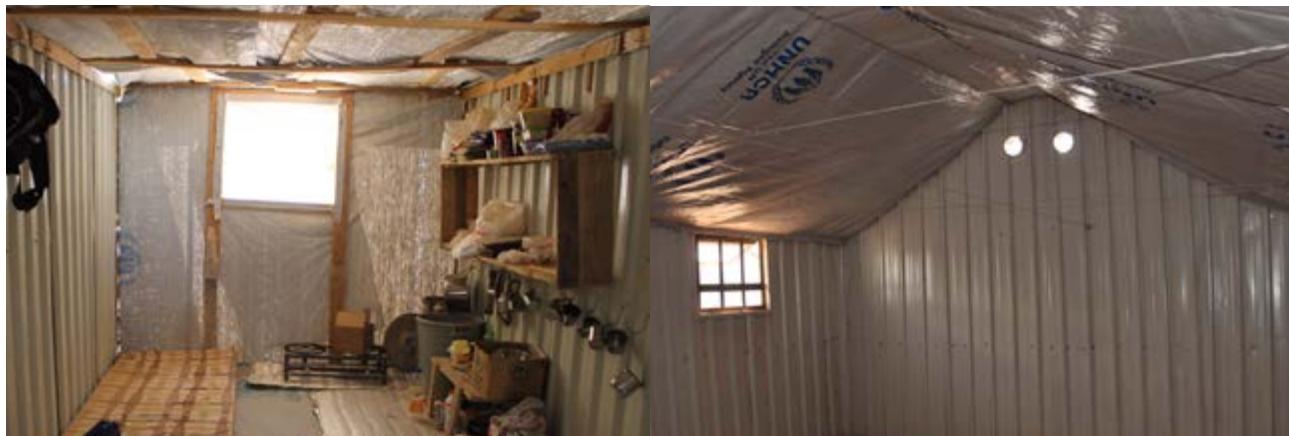
Left: A family converted the outside wall of their shelter into a kitchen. Space between shelters is often covered with plastic to provide a shaded sitting area, a laundry area or for storage.

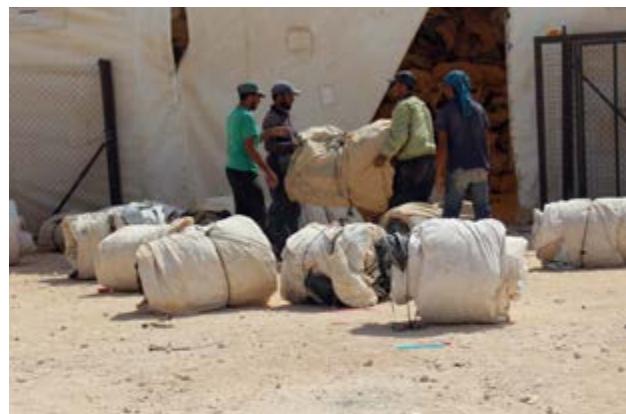
Project staff carrying tents to the rub halls to begin the recycling process.

- Useful category – tent canvases were moved to a separate Rub-hall where they have been repackaged with all other needed items (poles, pegs, ropes etc.), before being redistributed to new arrivals.
- Damaged category – tent materials were used for spare parts. Some parts, such as damaged canvas, were used as additional roofing protection for container shelters, or as patches for tents needing repair. Other damaged spare parts were recycled for use as non-shelter items.
- Repairable category – these tents were in reasonable condition but required patches or the repair of holes. Repairs were made with sewing equipment or glue, using salvaged canvas for patches.

Re-usable and repaired tents were sent back to the camp set-up area for distribution to new arrivals.

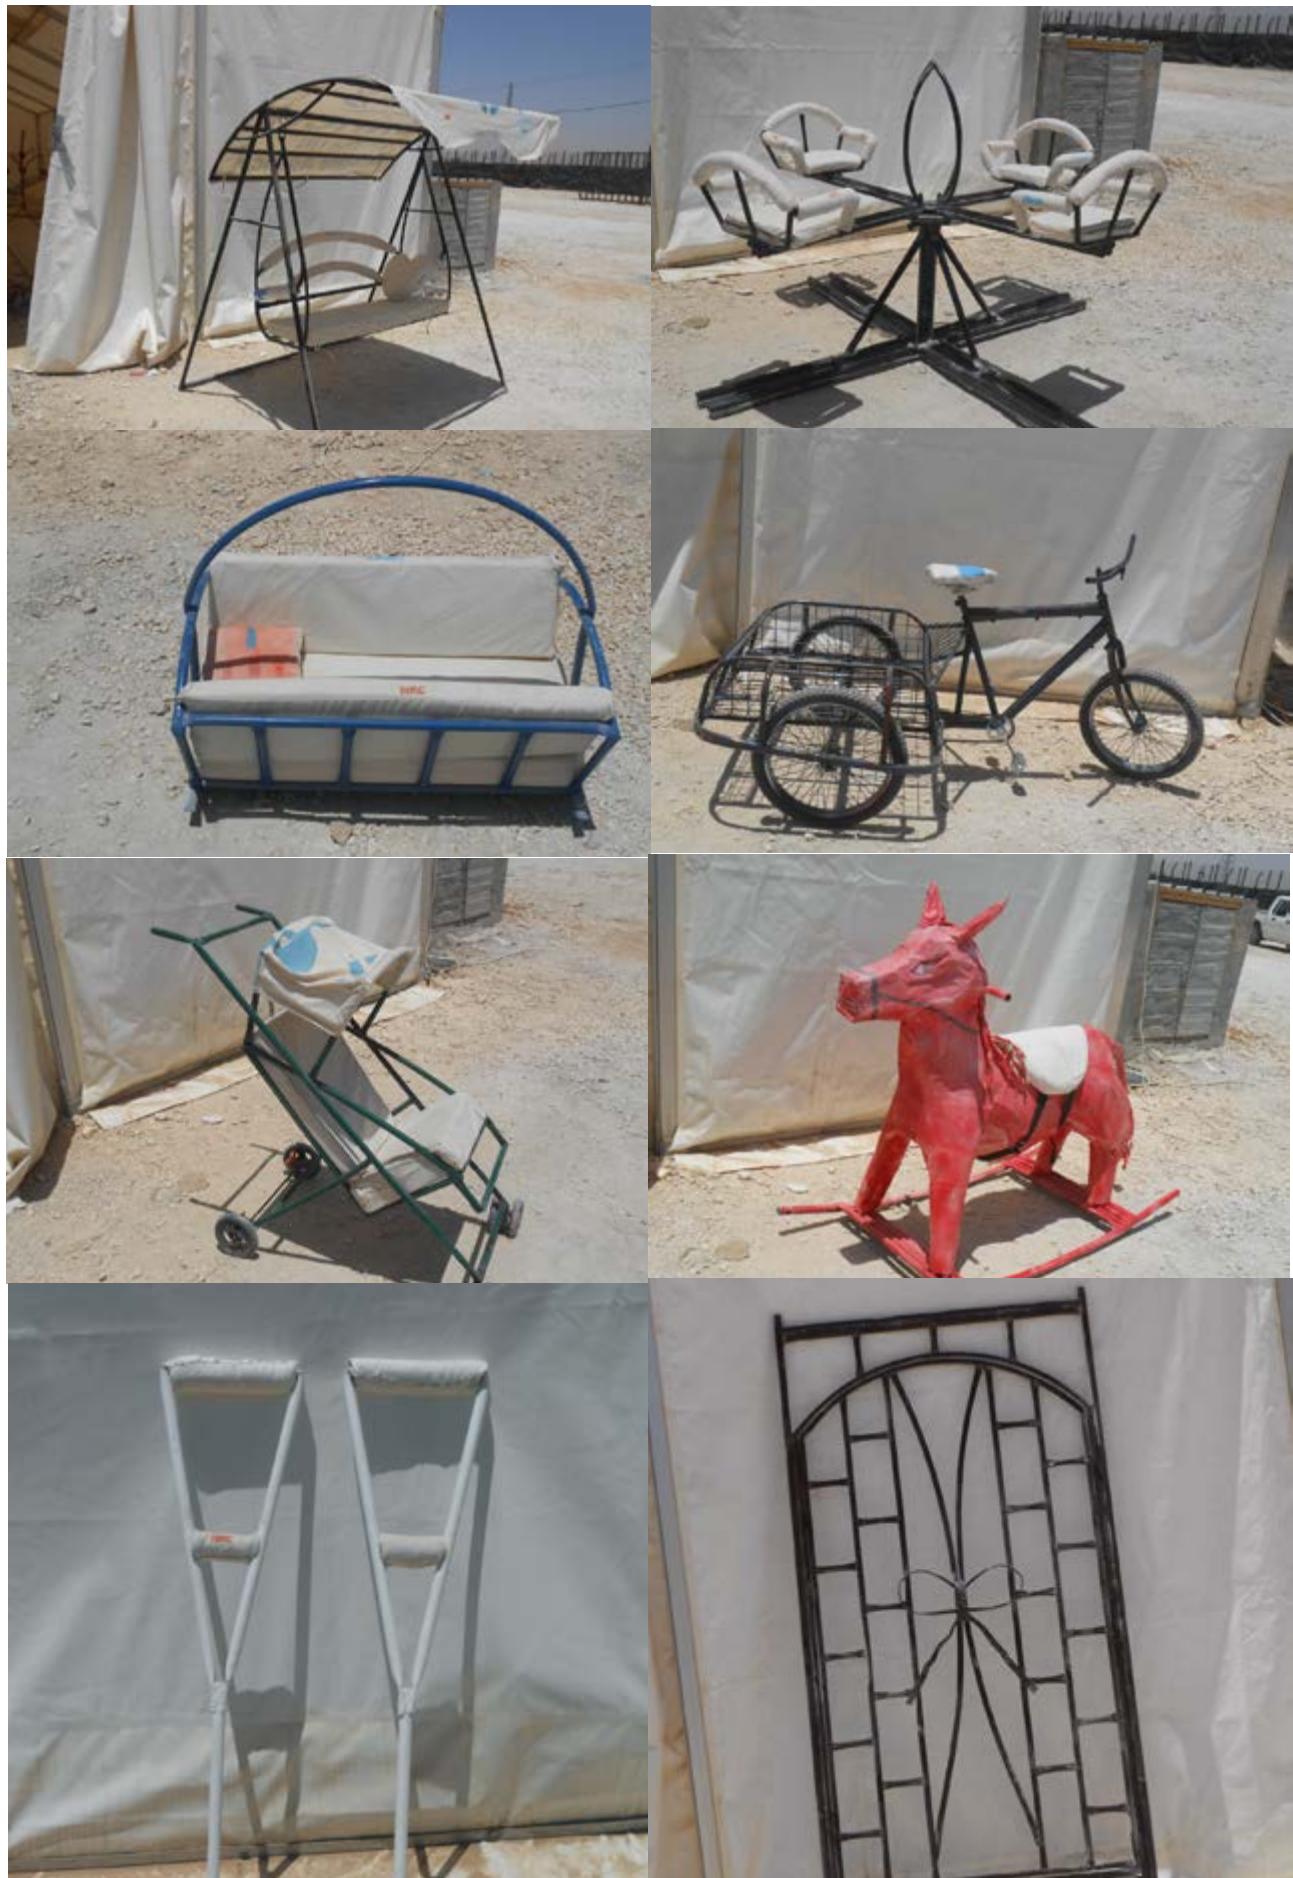
Examples of furniture, play equipment, and disability aids made out of left-over materials from the tent recycling project.
Photo: Fadi Al Masarweh/NRC

The children's play equipment that has been made from left-over tent parts are used in the children's play areas in the camp.

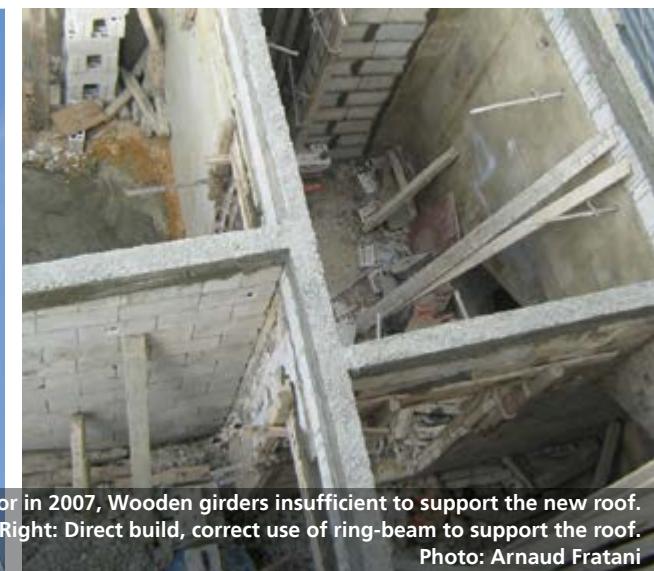
Left: Example of poor construction by a contractor in 2007, Wooden girders insufficient to support the new roof.

Right: Direct build, correct use of ring-beam to support the roof.

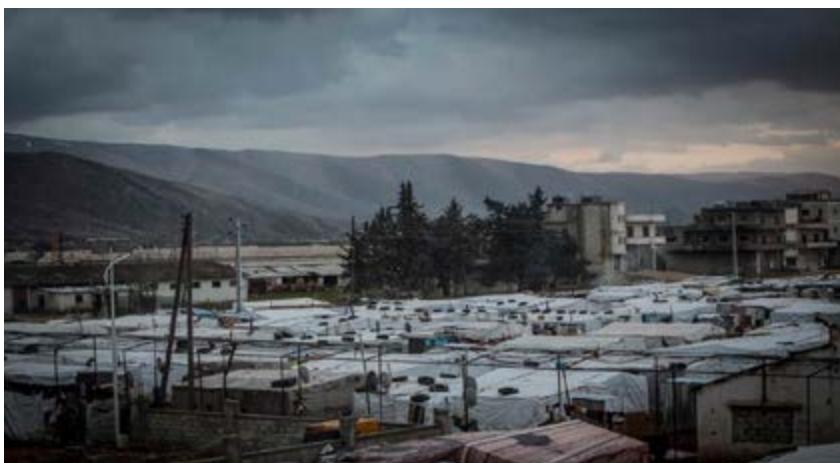
An informal settlement in the Bekaa Valley after a distribution of weatherproofing kits. The weatherproofing kits are designed to improve physical protection from cold and wet weather and increase security, privacy and dignity.
Photo: David Saccà

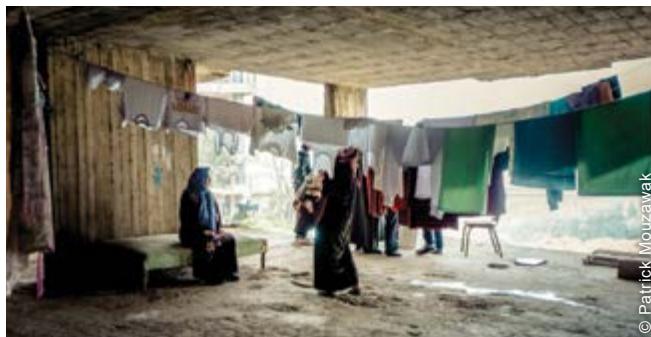
Many refugees in Lebanon settled in unfinished buildings, often in urban areas.

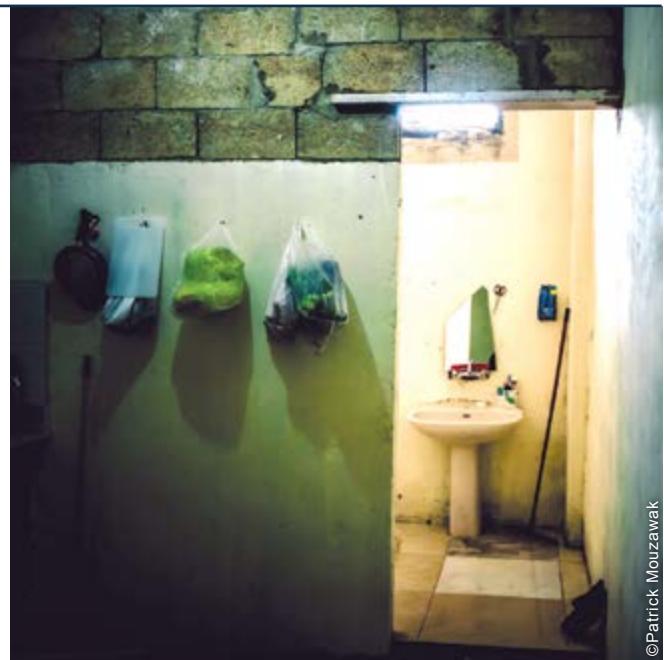
Bathrooms were also repaired and upgraded under the project.

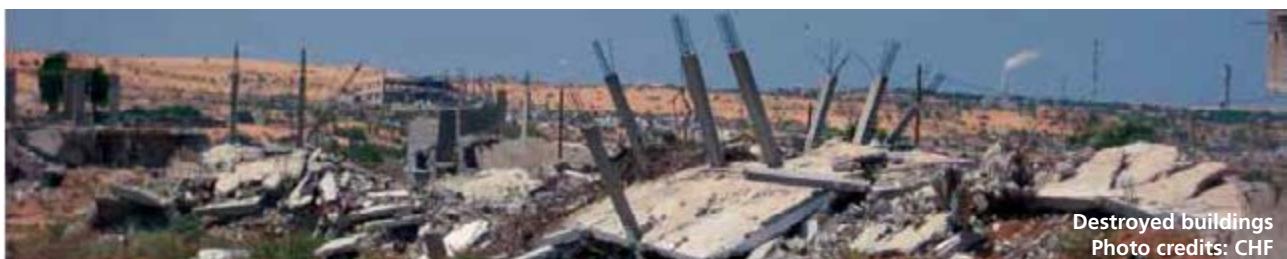
Destroyed buildings
Photo credits: CHF

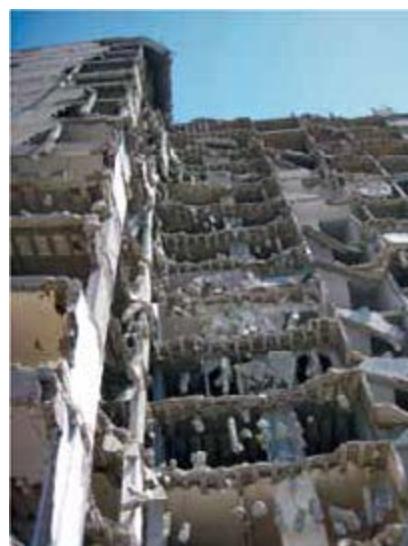
Where buildings had many tenants - different apartments were assessed separately from the building
Photo credits: CHF

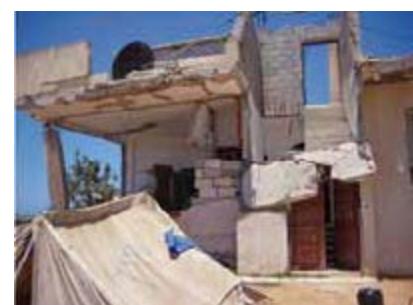
A blockade on construction materials prevented houses from being built.
Photo credits: CHF

However, after one year, construction still could not take place due to the blockade on construction materials into Gaza by the Israeli authorities.

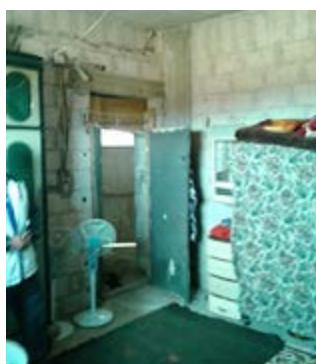
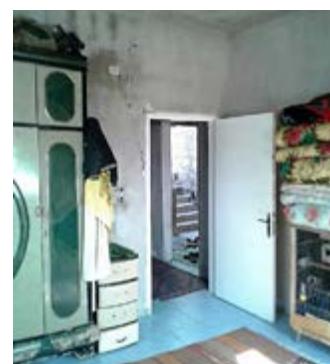
Rehabilitation works were conducted using local labour and materials.

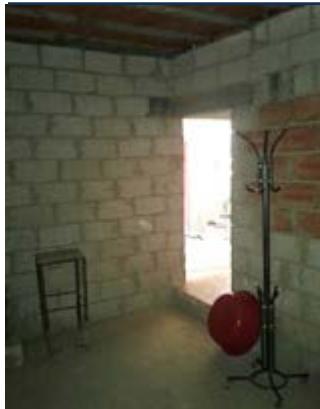
Where required, works included rehabilitation of household-level water and sanitation systems.

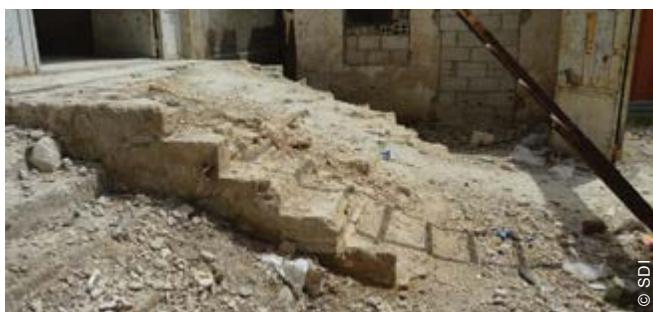
Before (above) and after (right) rehabilitation works in one collective centre.

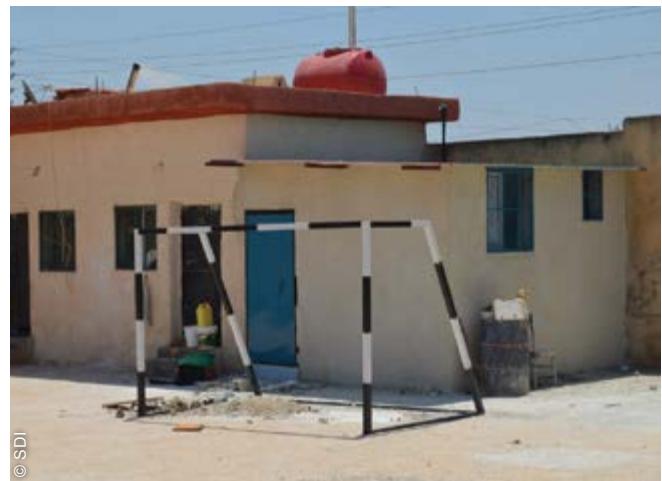
Doors and windows were repaired or replaced to increase security and privacy.

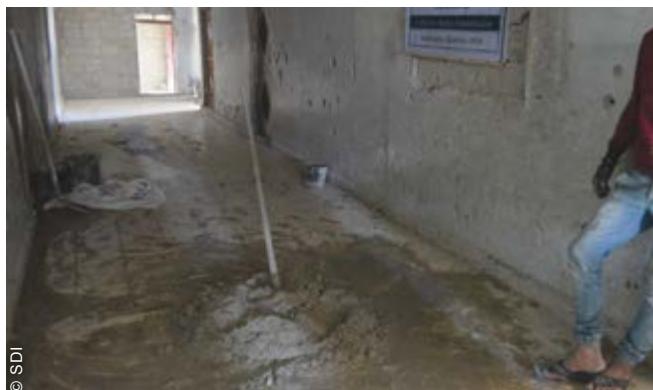
The shelter/protection committees provided valuable feedback which helped agree on priority interventions, such as location of facilities and lighting.

Throughout the project implementation, residents had the opportunity to provide feedback and this resulted in adaptations, such as agreeing on the location and arrangement of facilities. For example, some kitchens were moved to more suitable locations within the buildings, toilets were separated by family rather than sex for increased privacy, the location of opaque lockable partitions was agreed, as well as the location of lighting for communal spaces.

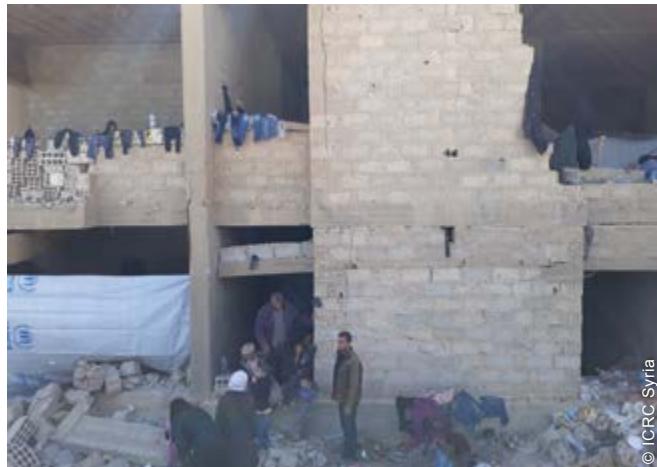
Collective centres included industrial buildings and schools and were often in very poor conditions. Locations were selected by the authorities.

All sites were owned by the government and structural safety was checked by accredited engineers upon request of the authorities.

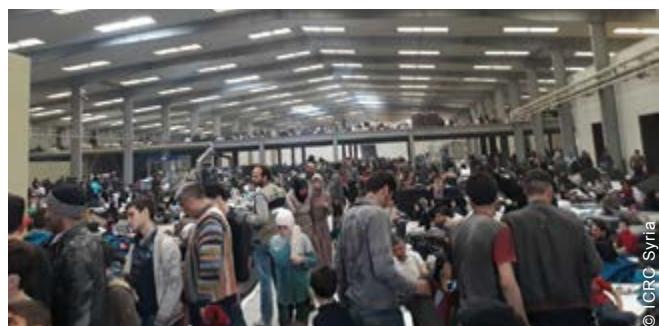
Little to no preparation could be done in the buildings, which soon became overcrowded due to the massive influx.

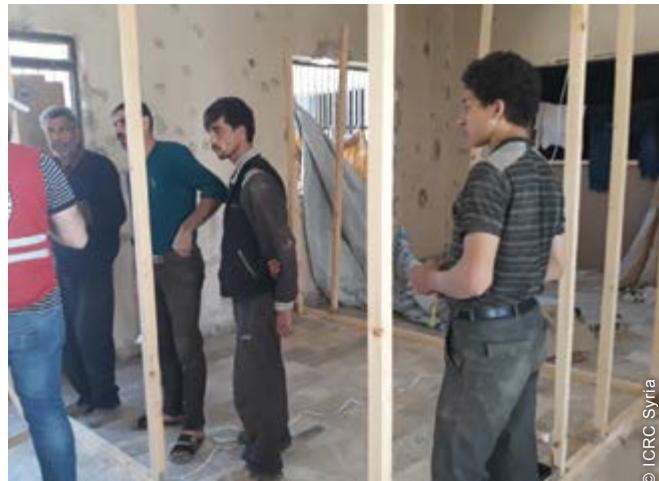
Shelter kits were used to build indoor partitions to increase privacy.

The shelter interventions consisted in light upgrades of walls and floors, installation or repair of doors and windows, erection of emergency shelters outside the buildings, and indoor partitioning to provide privacy to families. A total of 125 family tents were also erected and five large multipurpose tents used as collective shelters. Most of the shelter activities were conducted using over 1,500 standard shelter kits prefabricated by the organization and designed to be flexible enough to be used either as stand-alone or as components of partitions or walls. The standard unit that could be erected with a kit was of approximately 13m². Site levelling and preparation around the buildings were essential prior to the installation of shelters or tents, as well as water tanks, latrines and showers. Lighting (e.g. installation of lights and floodlights) and electrical works (e.g. sockets and generators) were complementary activities.

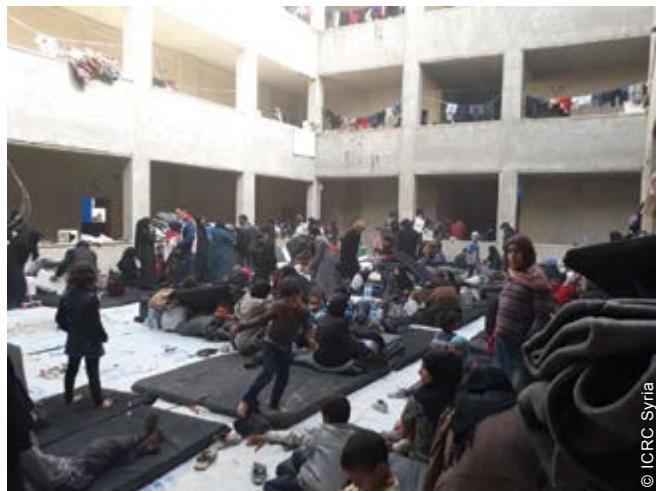
Buildings were upgraded through the set-up of rooms, installation of doors and windows, general repairs, rehabilitation or provision of water, as well as lighting.

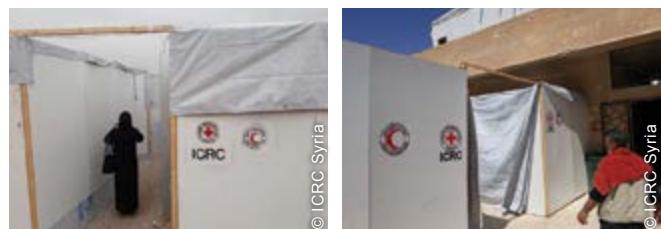
Shelters were also set up outdoors using the materials in the kits.

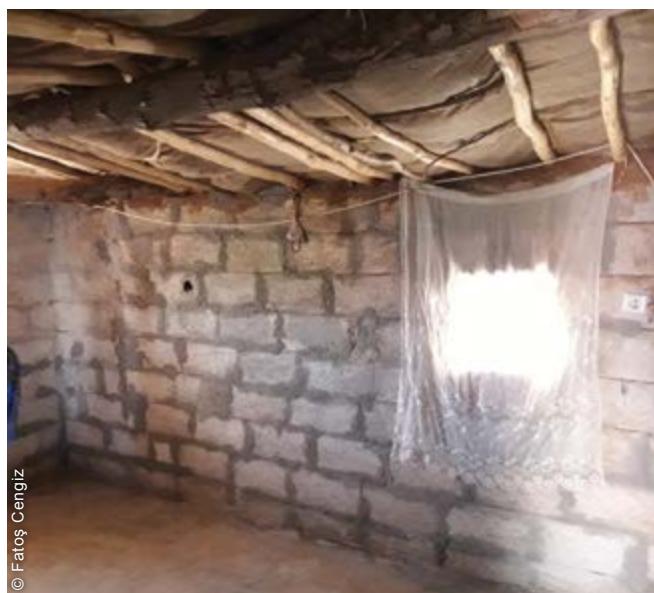
Repairs included roofing insulation, walls rehabilitation, electrical works, floor repairs, plumbing and replacement of doors and windows.

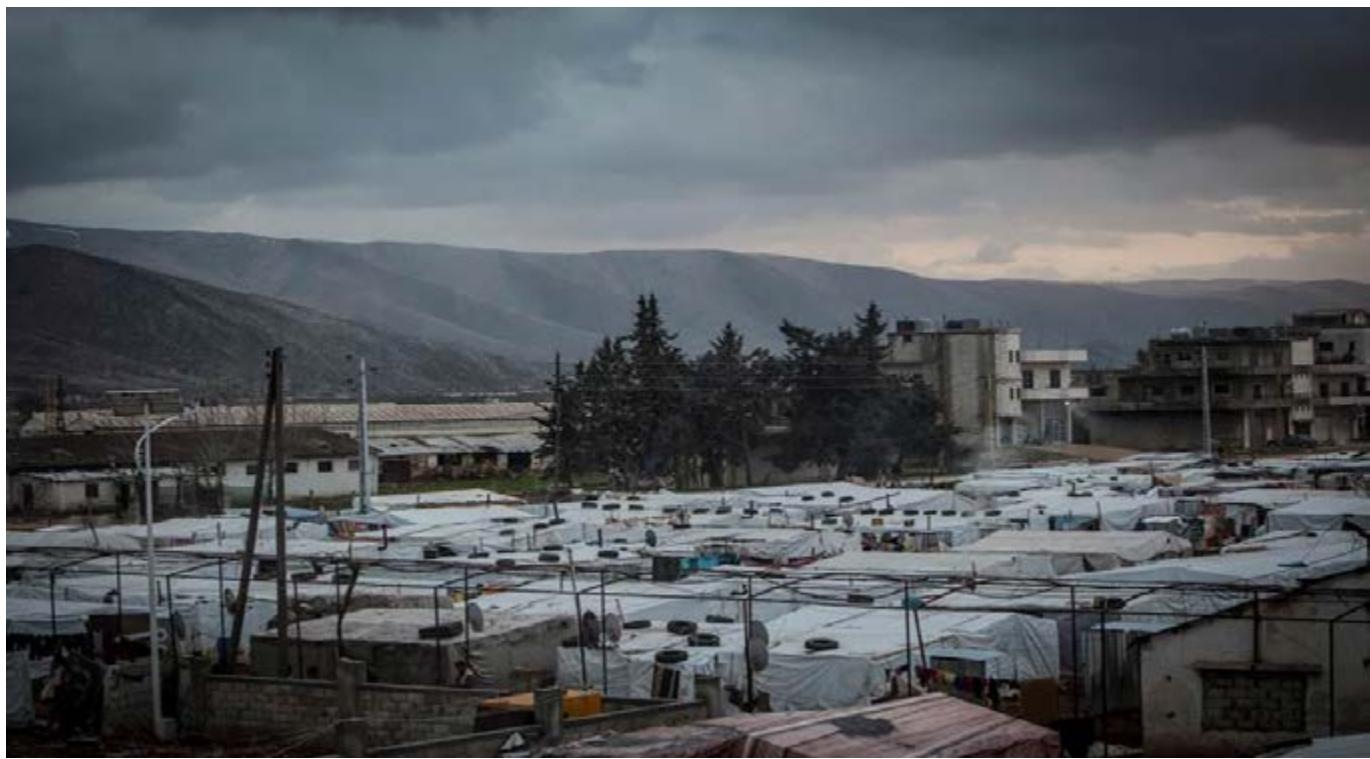
مستوطنة غير رسمية في وادي البقاع بعد توزيع أطقم مانعة لتسرب الماء. تم تصميم عدّة واقية من أحوال الطقس للحماية البدنية من البرد والشتاء وزيادة الأمان والخصوصية والكرامة. الصورة: دافيد ساكا

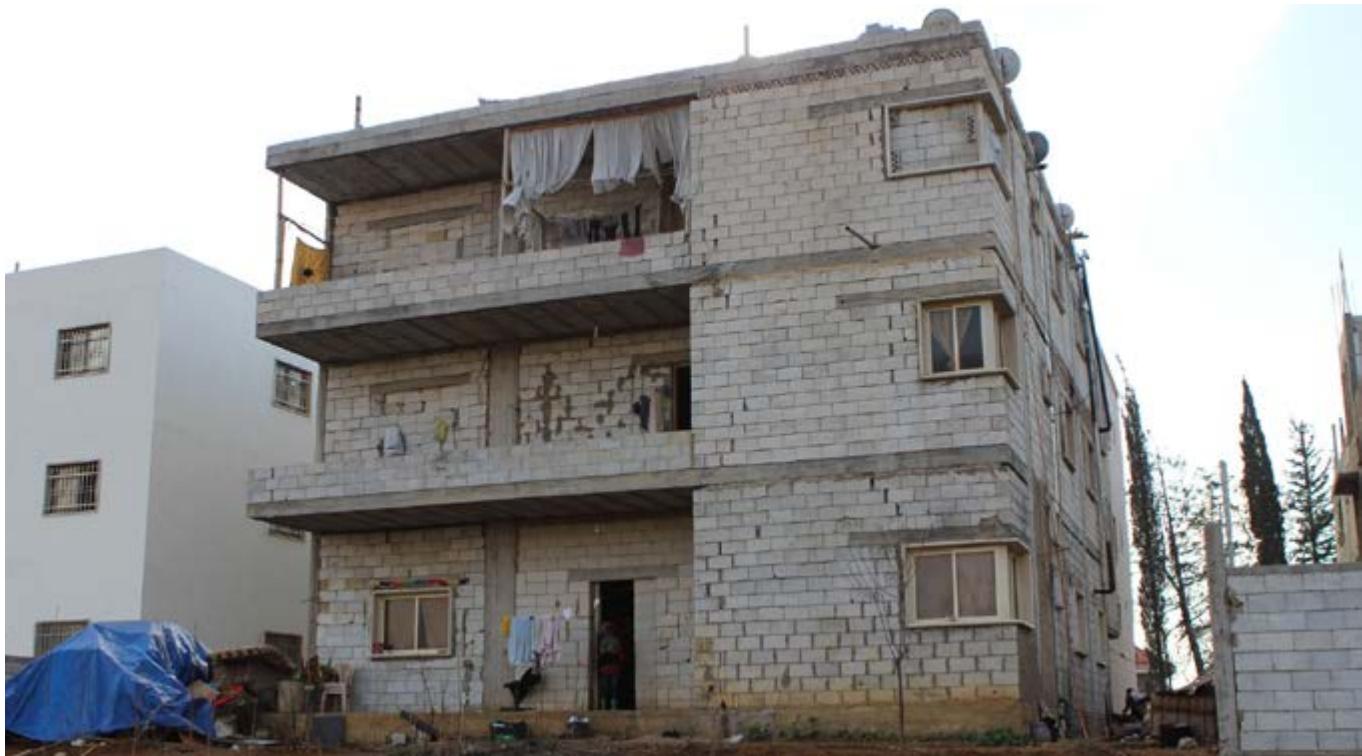
عادةً ما تفتقر المباني، مثل هذا المنزل غير المكتمل في وادي البقاع، إلى الوقاية الكافية من أحوال الطقس، والأمان والخصوصية والوصول الكافي للمياه والصرف الصحي. ويعيش ما يناهز ٢٥ في المائة من اللاجئين السوريين في هذا النوع من الظروف إلى جانب عدد متزايد من العائلات اللبنانية. الصورة: أحمد بارودي/مؤسسة أنقذوا الطفولة لبنان

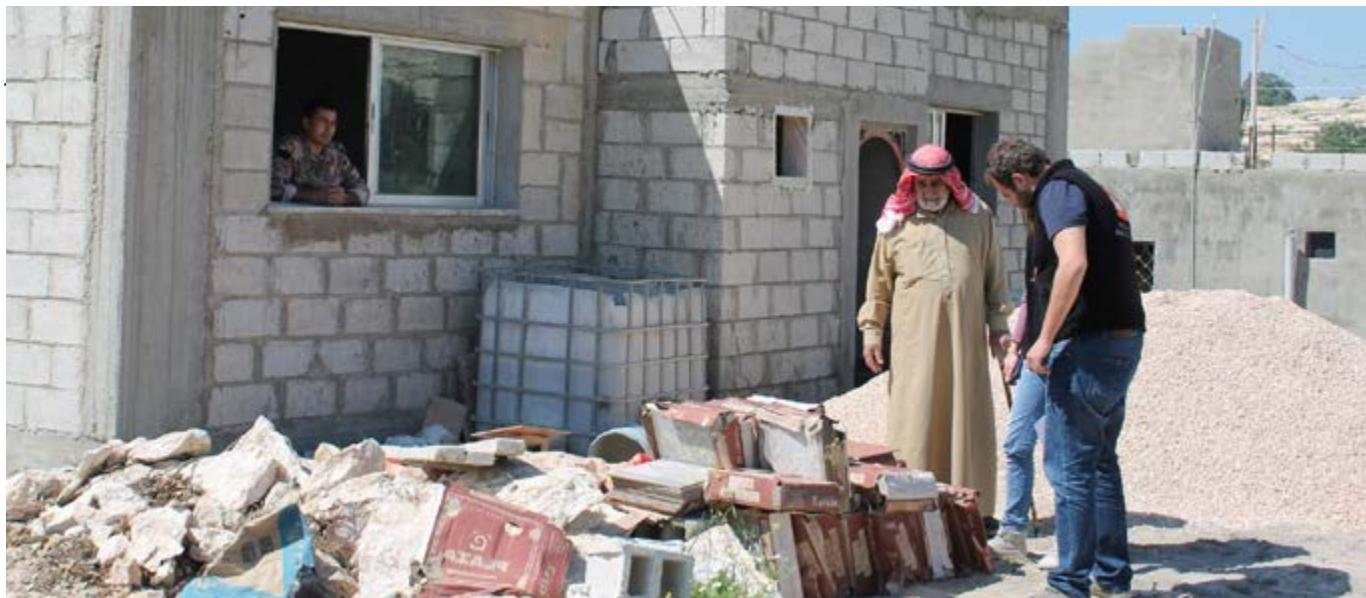
تُجرى عمليات تفتيش منتظمة لتقدم أعمال البناء؛ الصورة: روان بايبارز/المجلس النرويجي للاجئين
