B.2 Azerbaijan - 1992 - Conflict - People displaced

Case study: Upgrade of collective centres

Upgrade of collective centres

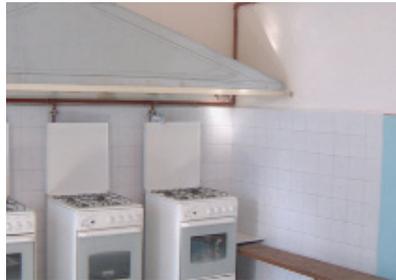
Kitchens before and after upgrade

The project was not always successful in solving problems with the water supply. A durable solution would have required dealing with the malfunctions outside the building, which was beyond the scope of the project. Cooking stoves and taps in the rehabilitated buildings had short lifespans because many people used them.

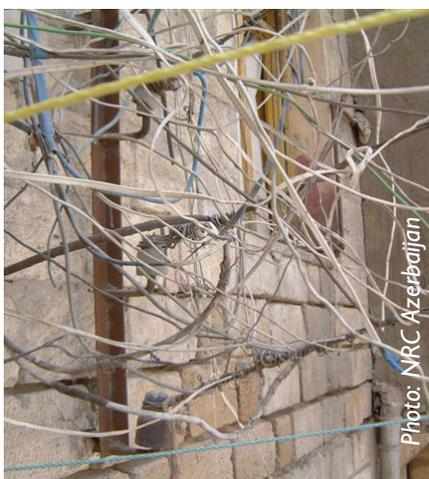
Wiring before upgrade

The most durable output of the project was the provision of electricity systems (including transformers and switchboards) and new roofs.

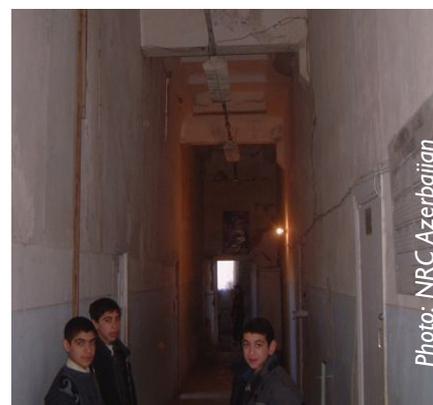
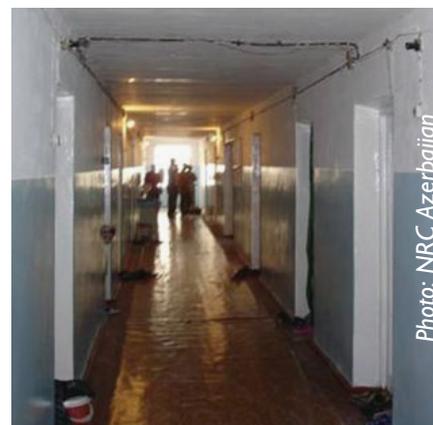
Corridors before and after upgrade

- rehabilitation of the shared areas - toilets, bathrooms, washing rooms, kitchens and corridors;
- infrastructure repairs - electricity, sewerage, water and sewerage pipes;
- repair of roofs;
- installation of new water heaters, sinks, stoves, faucets, showers, light bulbs, circuit breakers, switchboards, windows and doors;
- installation of electricity transformers (this was not costly but served a large number of IDPs).
