A.4 Kenya - 2007-2008 - Election violence

Transitional shelter kits

Pilot project providing transitional shelter kits
 Technical support for building
 Full construction for vulnerable households

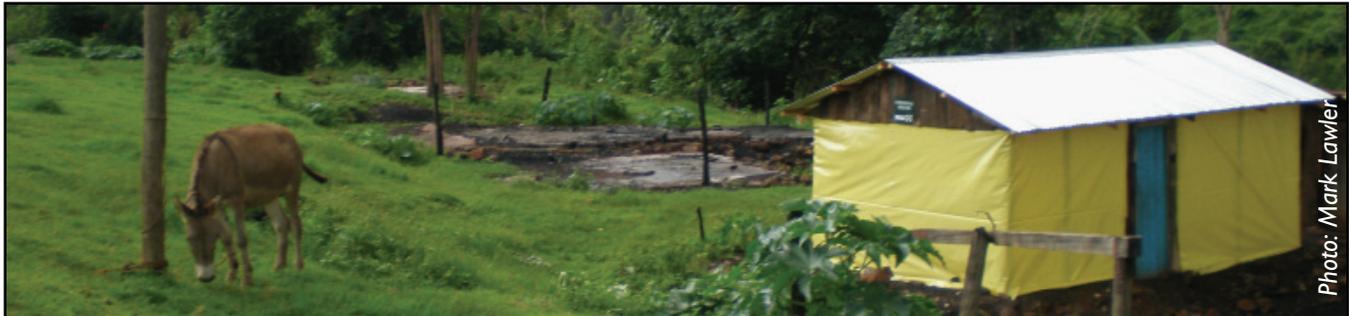
Transitional shelter built on the family's own land

The structure had a covered space of 18m² (6m x 3m), was split into two rooms, and had good clearance above head height.

The frame was made up of 10cm diameter cedar poles, dug into the

ground at a depth of around 60cm. The poles supported a timber ring beam, which in turn supported the timber rafters onto which an iron sheet was nailed.

Walls were clad in plastic sheeting and floors were compressed earth. The doors were flaps in the plastic sheeting and weighted with timber battens.

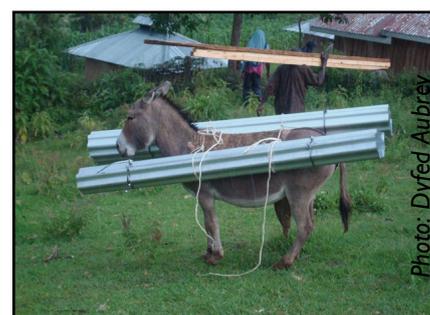
Transportation

The implementing agency then distributed the materials at three locations. Beneficiaries collected them and took them to their plots up to three kilometres away, using their own transportation (either by hand, by donkey, or by tractor and trailer).
