IASC Emergency Shelter Cluster

# SHELTER PROJECTS 2008

### Shelter Options 2008

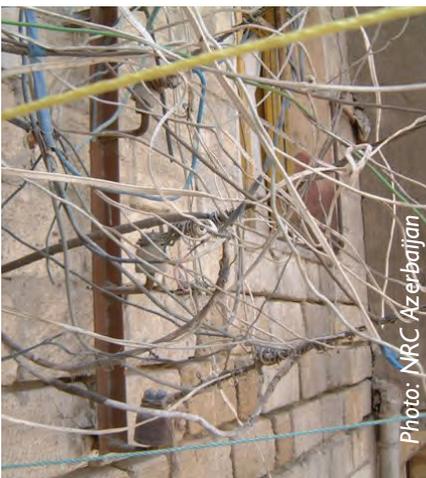
Wiring before upgrade

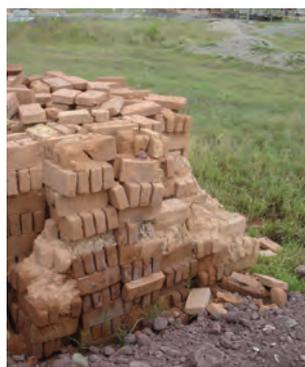
Obtaining good quality building materials remained problematic. These bricks decayed rapidly in the rain.

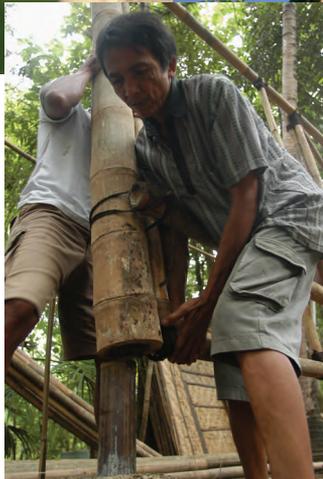
Connecting a vertical post to the foundation

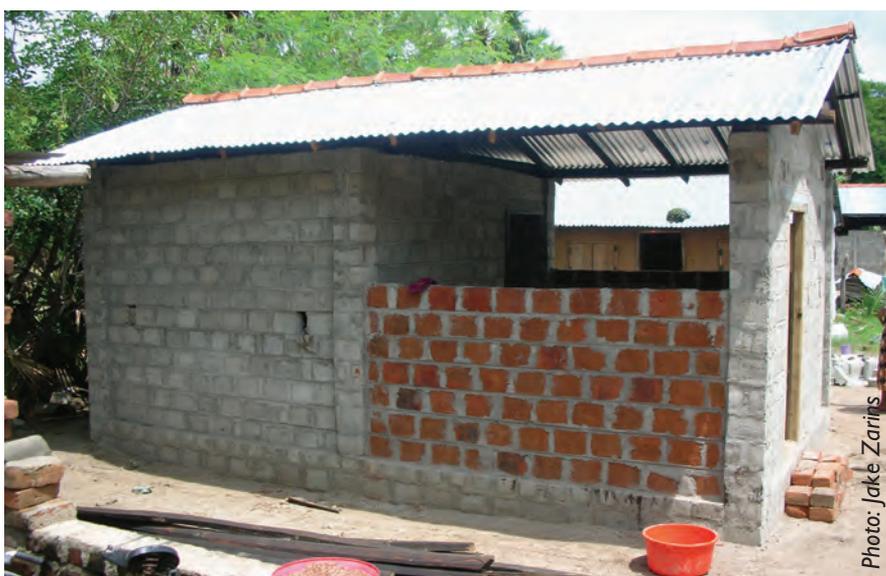
A durable upgrade of a core shelter

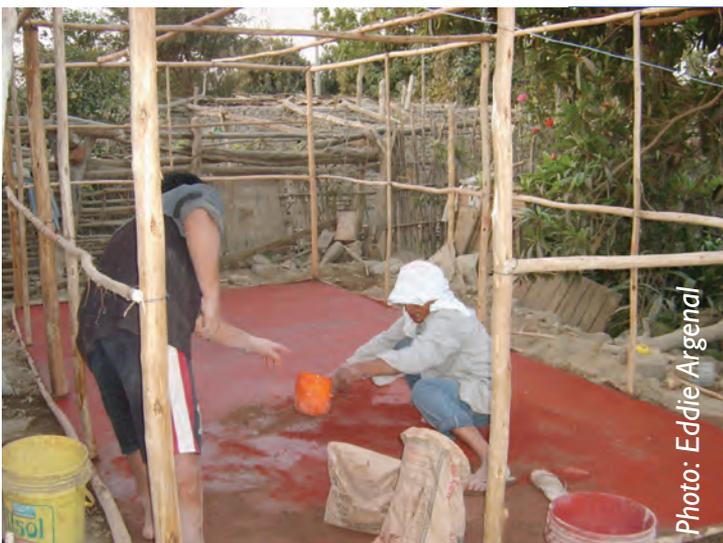
Making the concrete floor slab

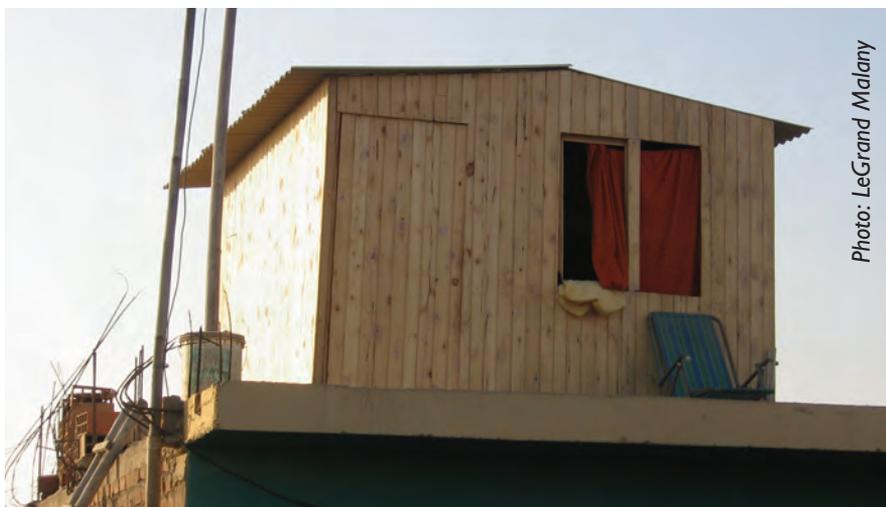
Completed shelter built on the roof of a damaged house
