C.5 Guatemala - 1976 - Earthquake

Case study: Materials and training

Guatemala earthquake

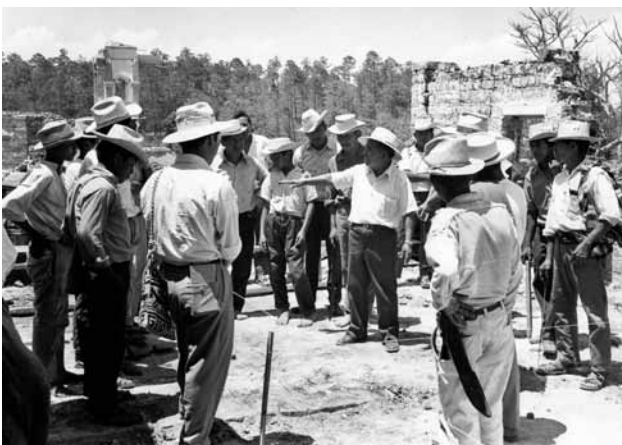
Earthquake resistant training in Guatemala.
Photo: Oxfam GB
