C.6 Haiti - 1982 - Shelter report

Case study: Report on shelter capacity

Summary

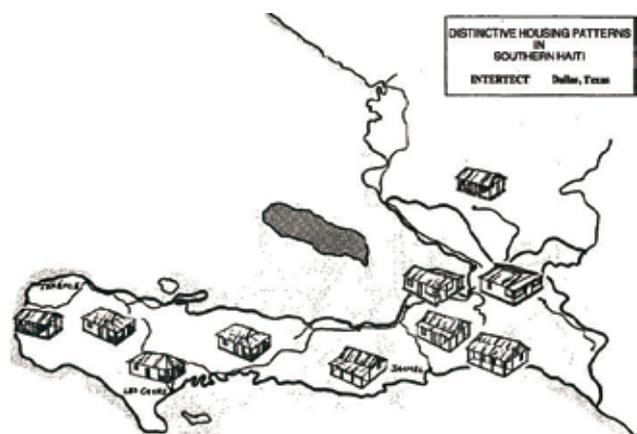
Housing patterns in southern Haiti
Illustrations: A. James Viet. and Juliana Marek

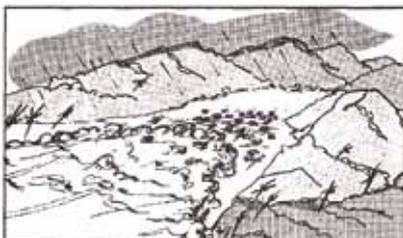
Risk of storm surge.

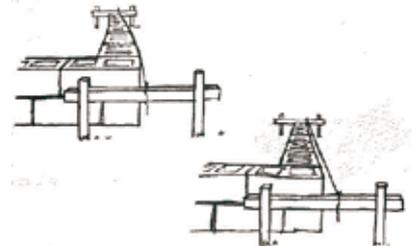
Kay an Planch (wood house): Wooden houses made of locally available timber or wood salvaged from urban construction sites. Deforestation had made wood scarce, so more houses were using palm wood.

The document noted that wooden houses tend to be more heavily damaged by hurricanes than other types of construction. Many of them, including those built by development agencies were poorly anchored to the ground

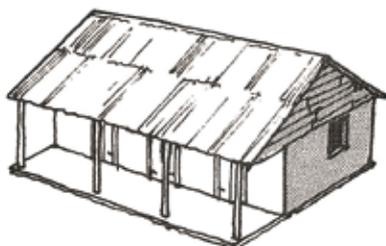
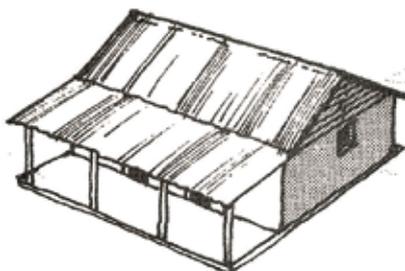
The arrangement below is preferable to the one above. If the verandah (above) was damaged by hurricanes the entire roof would be compromised, whilst in the verandah below damage to the verandah would not affect the rest of the roof

Different configurations of roofing and veranda lead to differing strengths of shelter. The designs with highest risk are where the veranda allows wind to get underneath, damaging the entire roof.

Safer designs are those where the veranda roofing sheets are separate to the main roof—damage to the veranda will not affect the main roof.

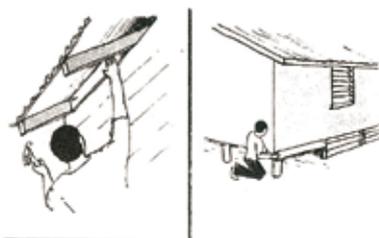
Hurricane preparedness: blocking gaps in the eaves and under shelters, securing walling and roofing sheets

- Place heavy objects on the roof to reduce suction.
- Seal areas below houses on blocks or piers with stones and mud to prevent air from entering underneath houses and lifting them off their foundations.
- Seal openings between roof and walls to prevent wind from entering the eaves.

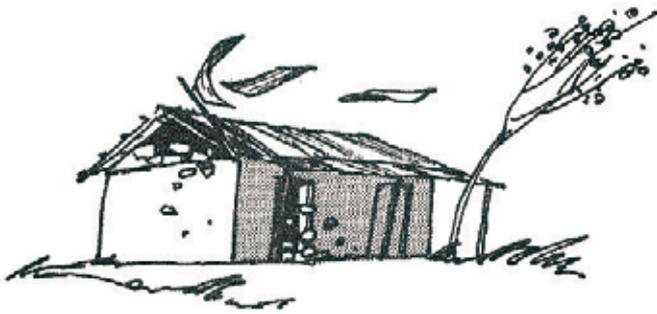
Risk of roof damage

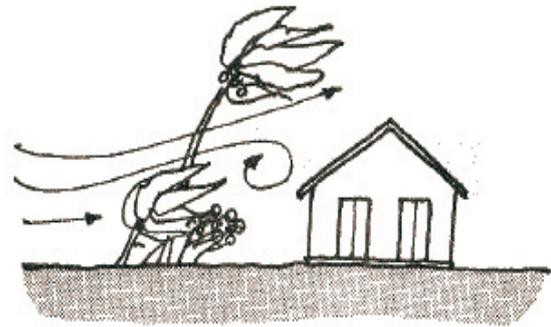
Trees can help protect houses from wind damage

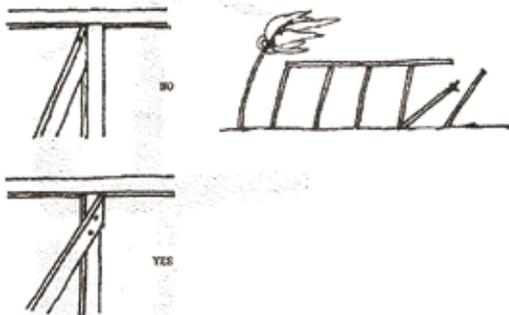
diagonal bracing can reinforce structures but should be correctly attached

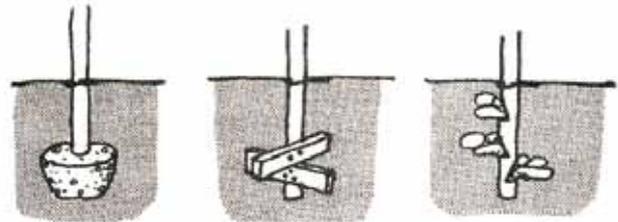
Different foundation details
