## A.16 Kyrgyzstan - 2010 - Conflict

### Case study:

Kyrgyzstan

Civil disturbances

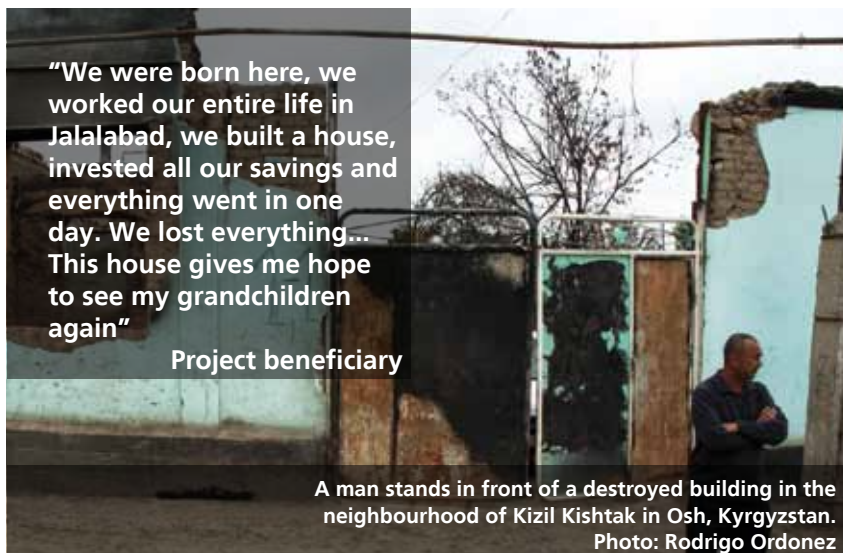
A man stands in front of a destroyed building in the neighbourhood of Kizil Kishtak in Osh, Kyrgyzstan.  
Photo: Rodrigo Ordóñez
