A.17 Malawi - 2009 - Earthquake

Case study:

Malawi

Earthquake

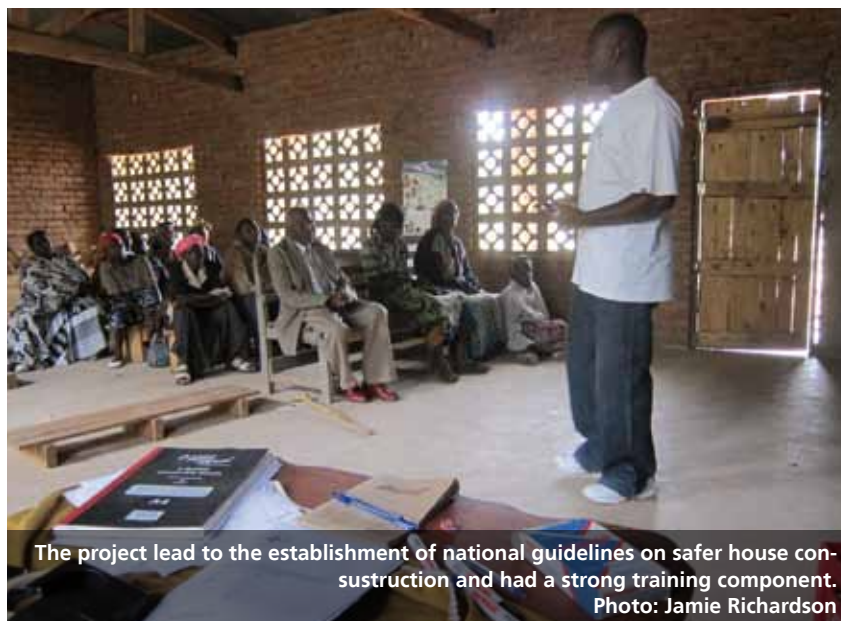
The project led to the establishment of national guidelines on safer house construction and had a strong training component. Photo: Jamie Richardson

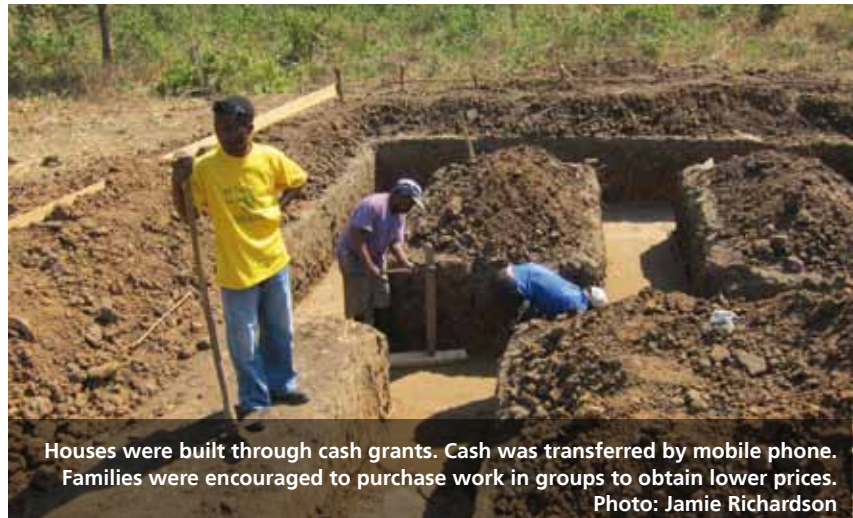
Houses were built through cash grants. Cash was transferred by mobile phone. Families were encouraged to purchase work in groups to obtain lower prices. Photo: Jamie Richardson
