A.21 Pakistan - 2009 - Conflict

Case study:

North Pakistan, FATA and KPK

IDP (Internally displaced people) crisis

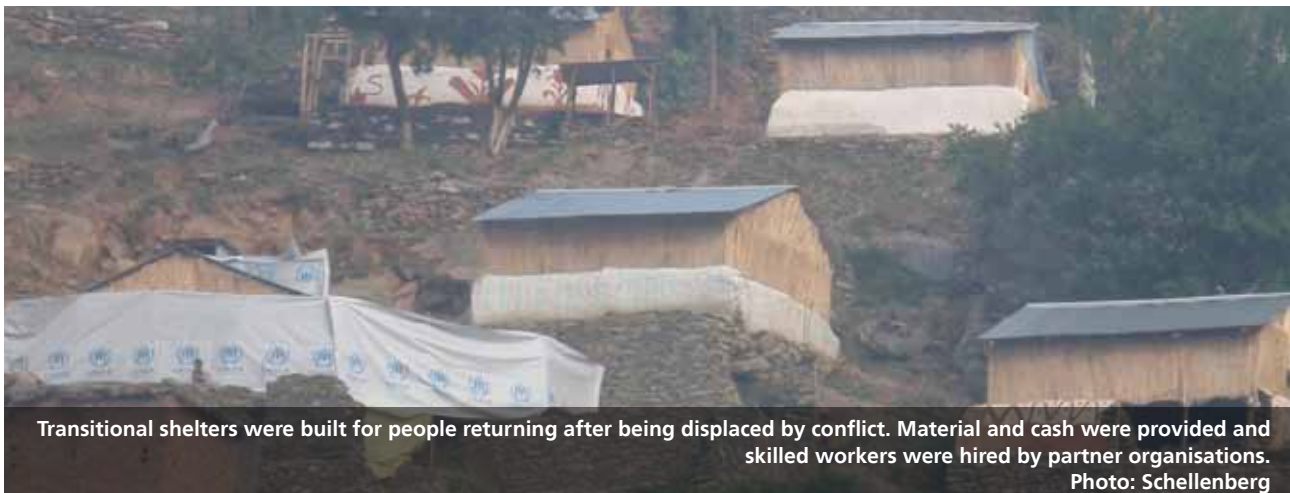
Transitional shelters were built for people returning after being displaced by conflict. Material and cash were provided and skilled workers were hired by partner organisations.
Photo: Schellenberg

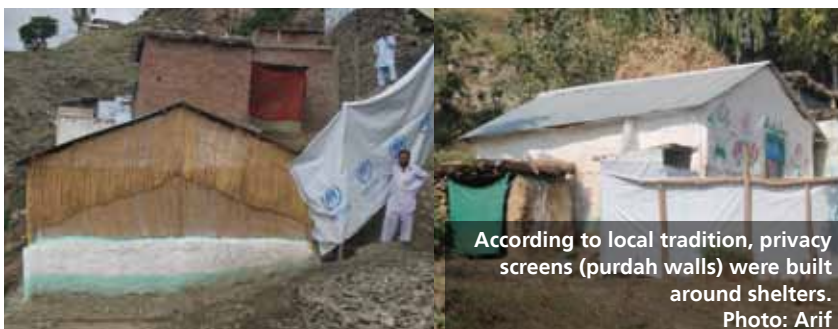
According to local tradition, privacy screens (purdah walls) were built around shelters.
Photo: Arif

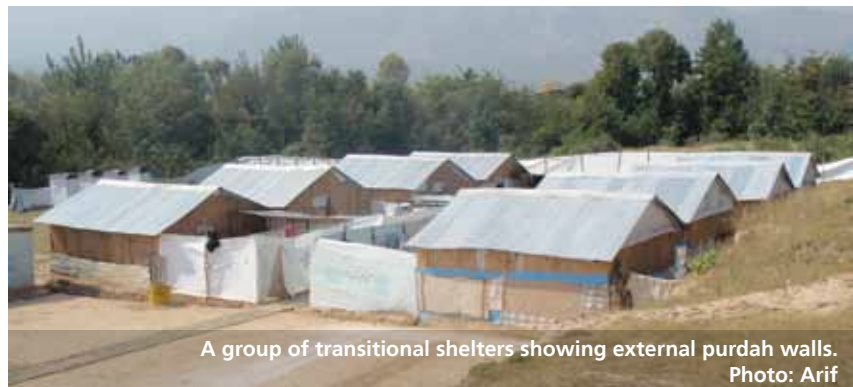
A group of transitional shelters showing external purdah walls.
Photo: Arif

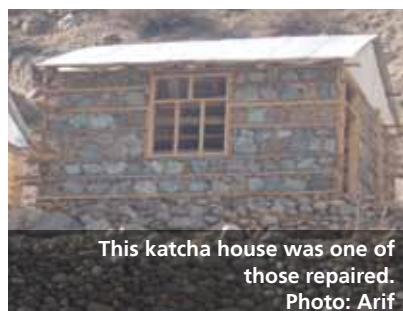
This katcha house was one of those repaired.
Photo: Arif

- *Pucca houses* with a reinforced cement concrete frame and foundation. The walls are made out of burnt bricks, blocks or stone, with sand and cement mortar. The roof is made from tiles, slates, reinforced concrete, cement sheets, or metal sheeting.
- *Semi-pucca* houses are similar to pucca houses but do not have a reinforced concrete frame. They have good quality masonry walls cement mortar and a reinforced cement concrete or corrugated galvanised iron (CGI) sheet roof.
- *Katcha* are houses with mud or dry stone masonry walls and a mud roof with wooden panels, wooden beams or CGI sheets. Most Katcha houses have a timber frame.

- *Pucca houses*: the reinforced concrete structure remained in good condition, even if walls were completely destroyed.
- *Semi-pucca houses*: the structure was in good condition and damage to the walls or roof was away from the corners.
- *Katcha houses*: damage was limited to a small section of the wall or roof away from the corners and not affecting the structural integrity.
