A.28 Sri Lanka - 2009 - Conflict Returns

Case study:

Sri Lanka

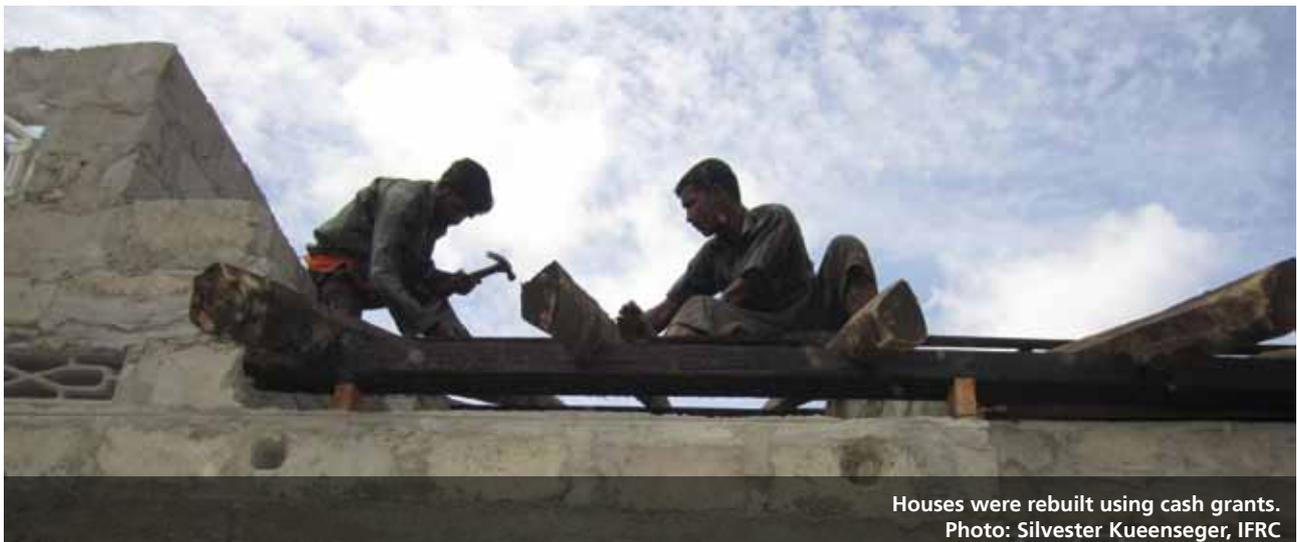
Houses were rebuilt using cash grants.
Photo: Silvester Kueenseger, IFRC

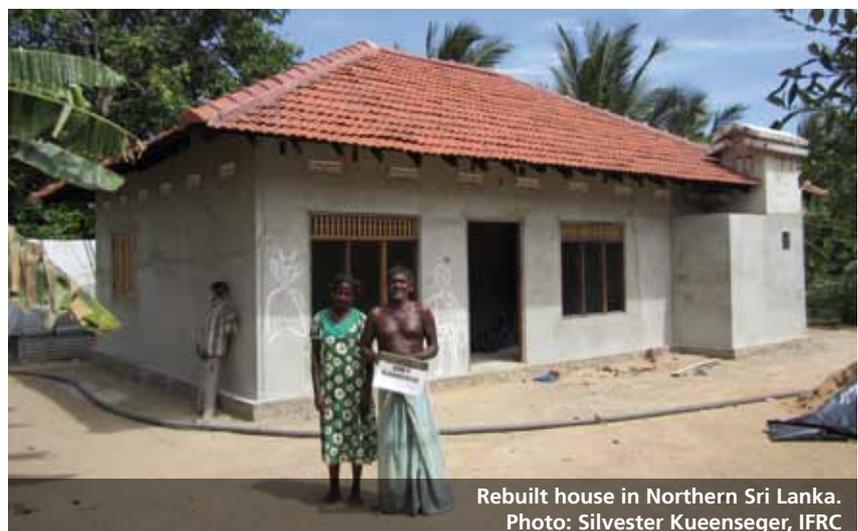
Rebuilt house in Northern Sri Lanka.
Photo: Silvester Kueenseger, IFRC

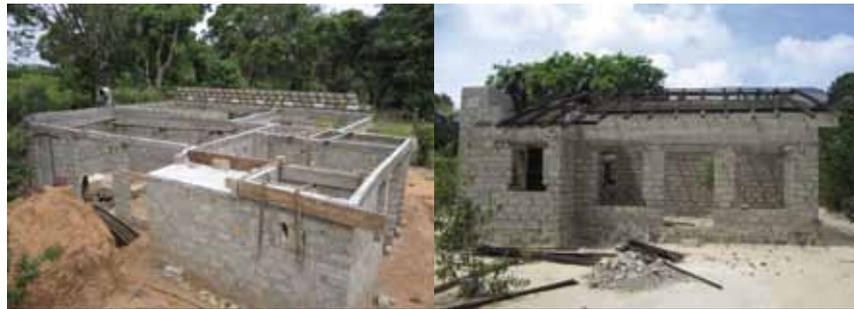
Grants were phased, and each grant was conditional upon the previous level of construction being attained. Photo: Ganga Kariyawasam, IFRC

A cash grant amount of 2,900 USD (LKR 325,000) was paid to each beneficiary through the bank in five instalments. An additional grant of 267 USD (LKR 30,000) was provided to construct the toilet and for the water supply.

Each stage was to be completed by the beneficiary within three weeks of receiving the instalment. On completion of each stage, the next grant should have been received within one week.
