A.30 Tonga - 2010 - Tsunami

Tsunami
(known as the Samoa Tsunami)

Project description

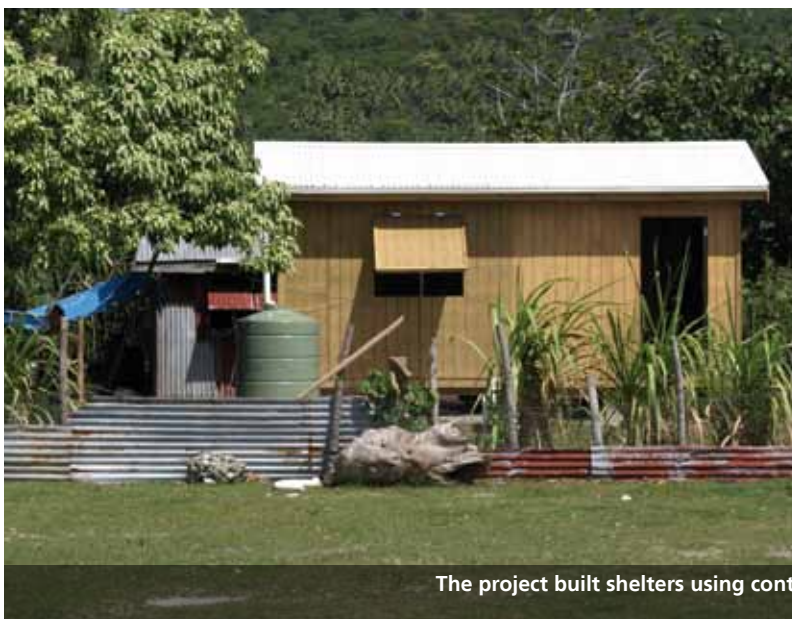
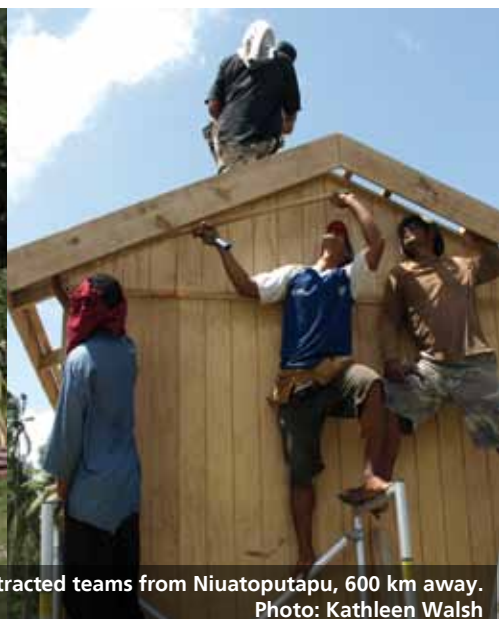
The project built shelters using contracted teams from Niuatoputapu, 600 km away.
Photo: Kathleen Walsh

The technical and resource capacity of Niuatoputapu is very limited. Therefore it was decided to fabricate transitional shelter kits in the capital. These could then be flat packed and shipped to the island. The erection of the prefabricated elements was undertaken by local trades people supported by the householders where appropriate.

The design of the shelters ensured they were simple enough to be built in a remote location and that they could be dismantled and re-built as the government was offering land further from the coast to encourage people to move for their future safety.
