SHELTER PROJECTS

2010

International Federation
of Red Cross and Red Crescent Societies

Spanning humanitarian responses from over 100 years, Shelter Projects 2010 is the third annual compilation of shelter programmes. The project summaries included aim to illustrate some of the project options available to organisations working in both post disaster and post conflict situations, as well as to support learning from the strengths and weaknesses of different projects. The focus of this book is on projects that maximise emergency response funds to support sustainable recovery.

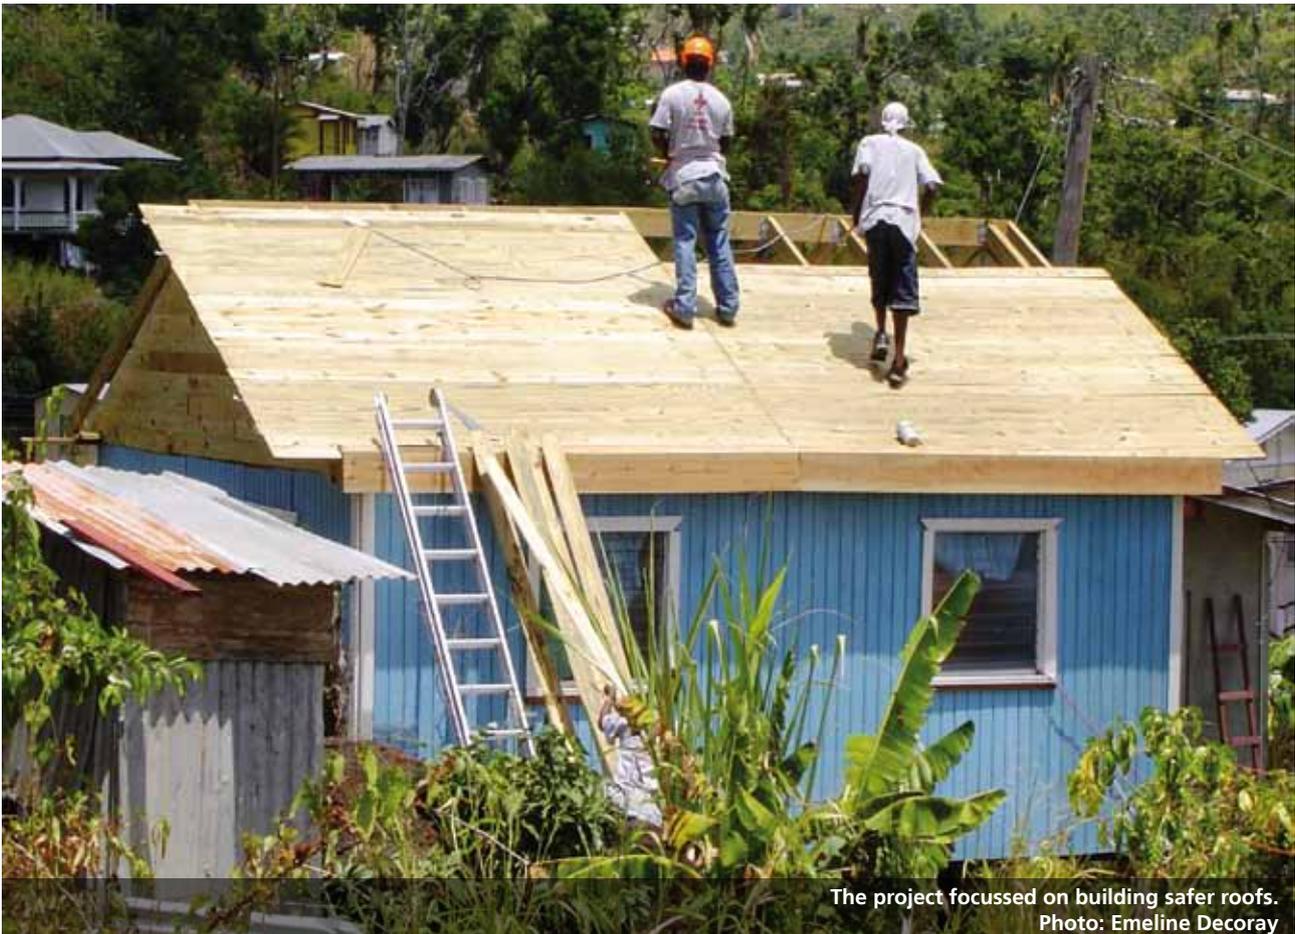
The project focussed on building safer roofs.
Photo: Emeline Decoray

The houses received some reinforcement, such as doubling studs in the corners, around doors and windows, bracing the corners in both directions, attaching the flooring beams to the pillars, and attaching them to the foundations with metal straps. The smallest houses received a gable roof with a 30° slope and 25cm eaves, while the largest one received a hip roof.

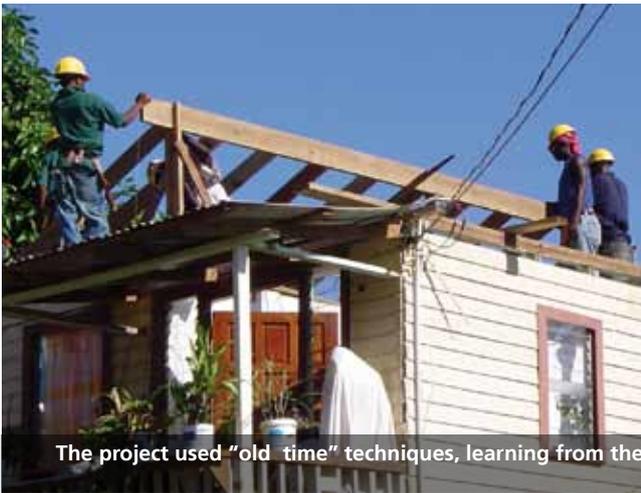
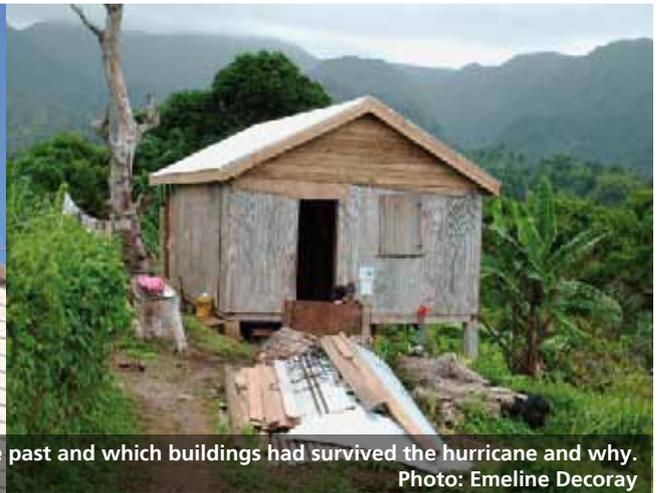
The project used "old time" techniques, learning from the past and which buildings had survived the hurricane and why. Photo: Emeline Decoray

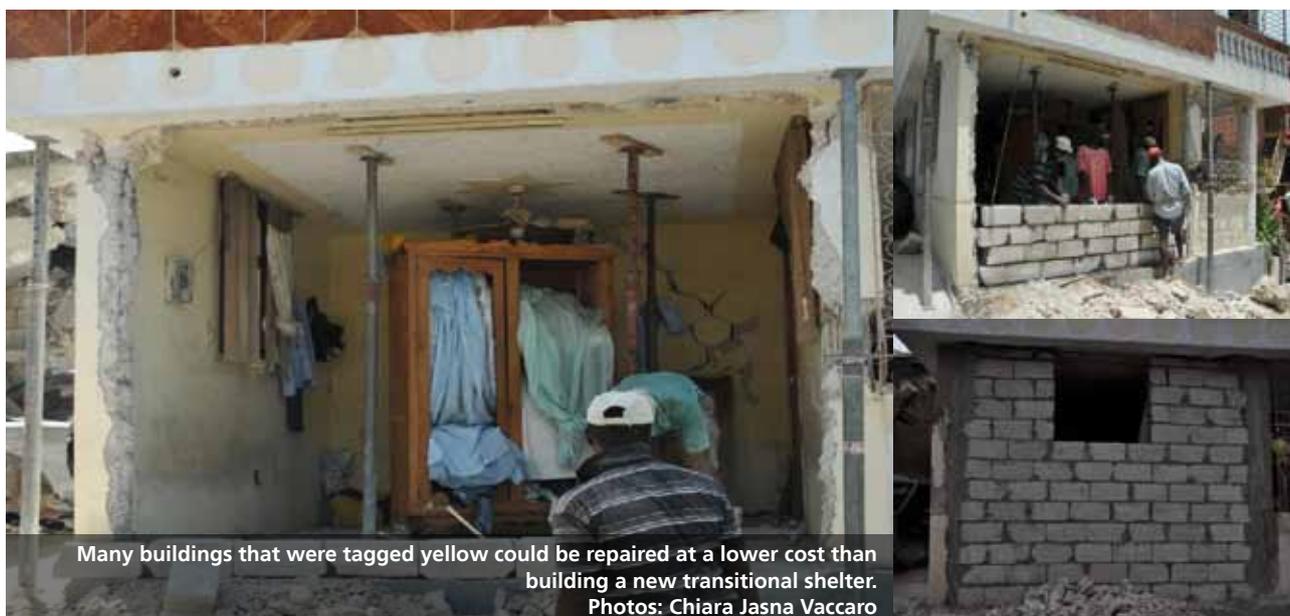
Many buildings that were tagged yellow could be repaired at a lower cost than building a new transitional shelter.
Photos: Chiara Jasna Vaccaro

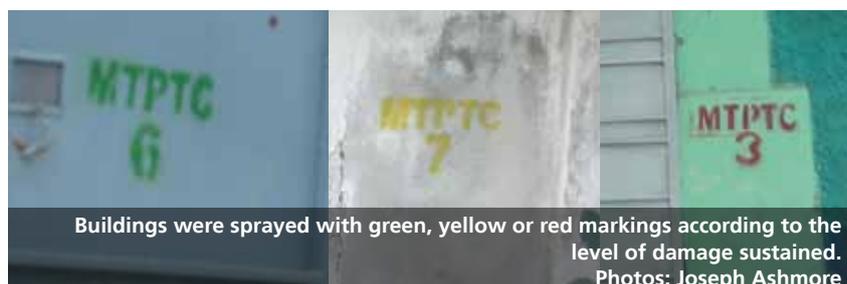
Buildings were sprayed with green, yellow or red markings according to the level of damage sustained.
Photos: Joseph Ashmore

During the assessment, over 400,000 structures were tagged; this was nearly every building in the Port-au-Prince metropolitan area that was impacted by the earthquake.

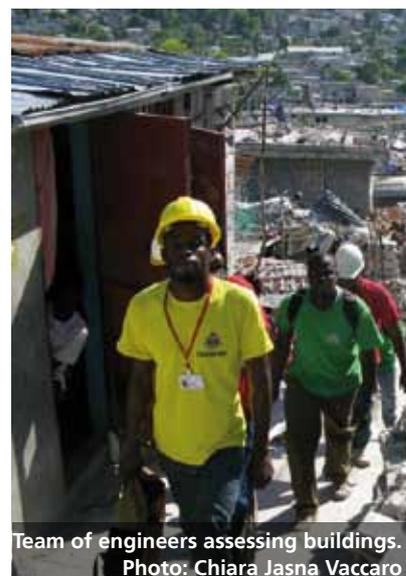
Team of engineers assessing buildings.
Photo: Chiara Jasna Vaccaro

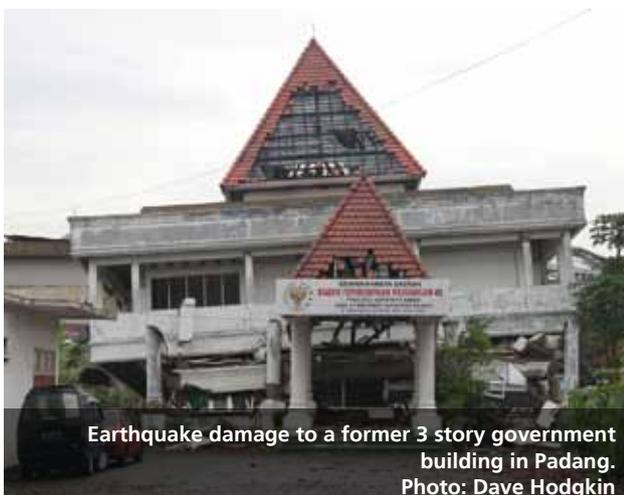
Earthquake damage to a former 3 story government building in Padang.
Photo: Dave Hodgkin

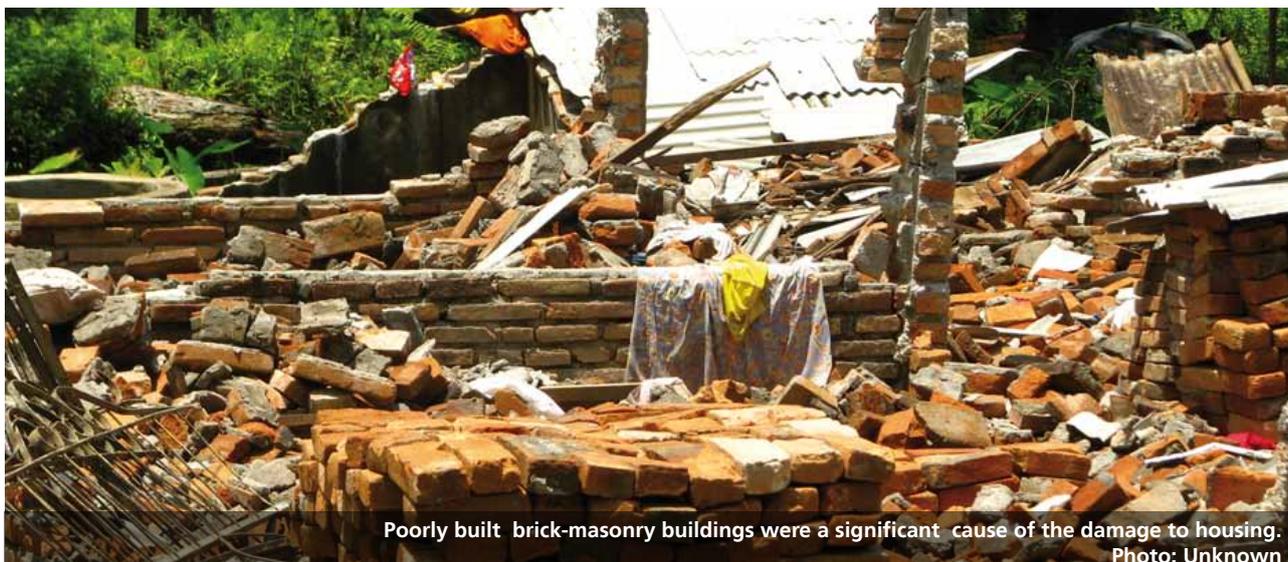
Poorly built brick-masonry buildings were a significant cause of the damage to housing. Photo: Unknown

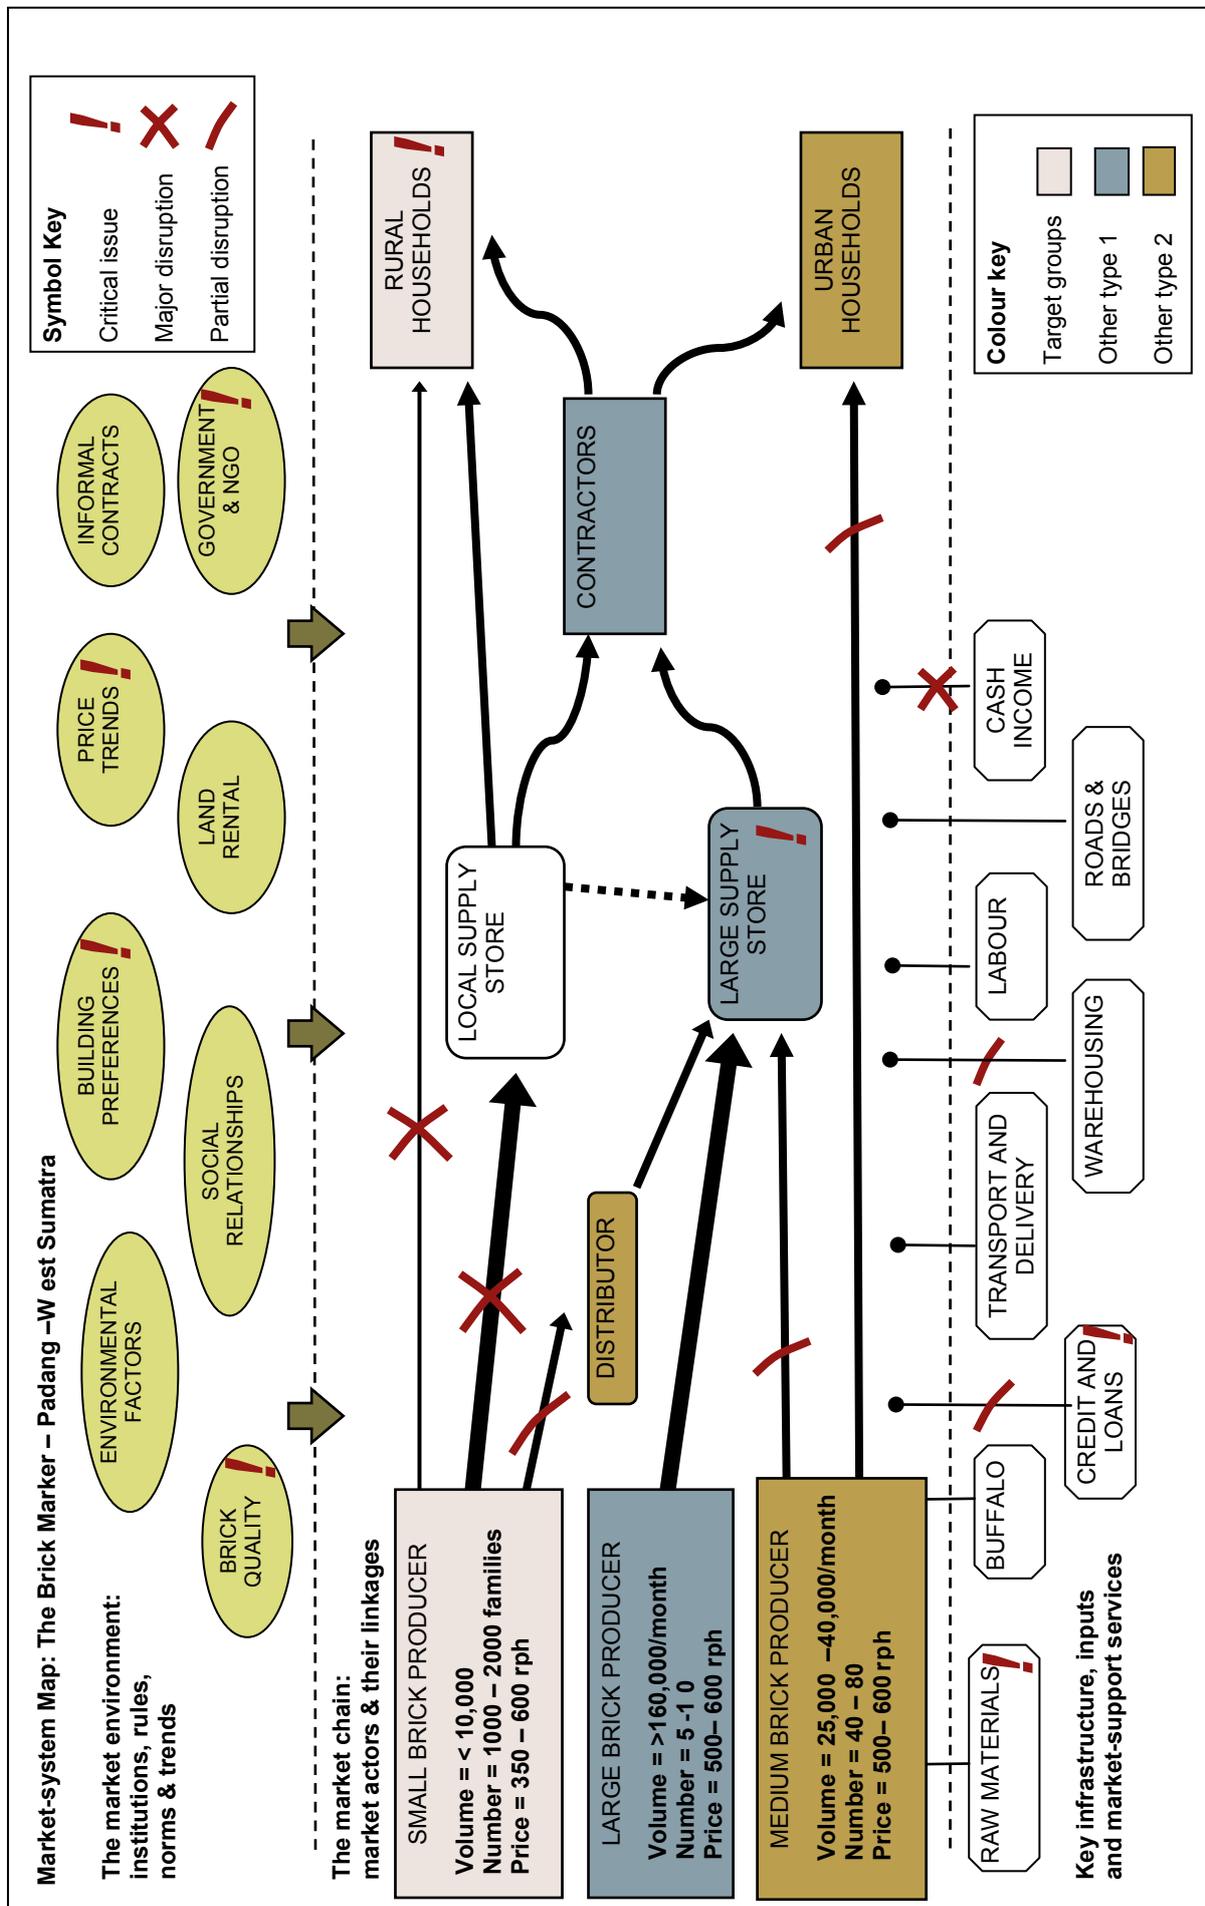
A main tool in EMMA is the Market-System Map. This helps to visualise the difference between the markets before and after the earthquake. This map is for the brick market in Padang following the earthquake. The black arrows show how bricks reached homeowners from the different scale suppliers, and the red lines show which supply routes were interrupted.

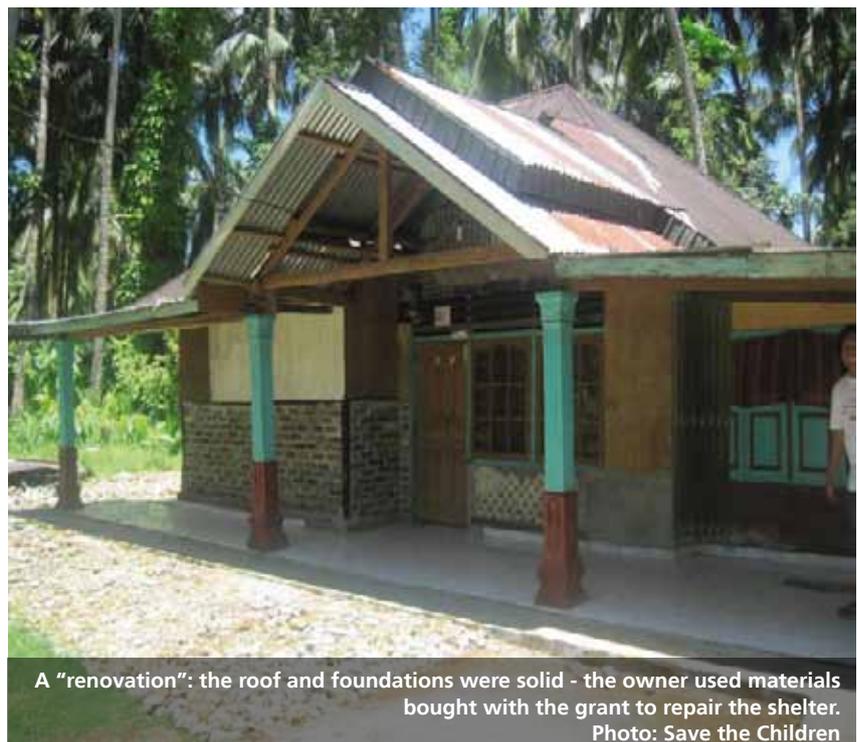
A "renovation": the roof and foundations were solid - the owner used materials bought with the grant to repair the shelter.
Photo: Save the Children
