A.15 Kenya (Dadaab) – 2011 – Famine / Conflict

Camp planning and site construction for 76,000 people on two sites

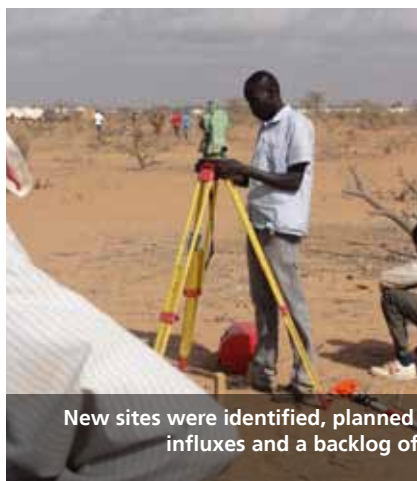
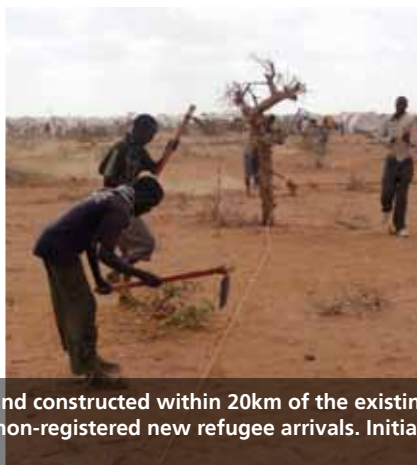
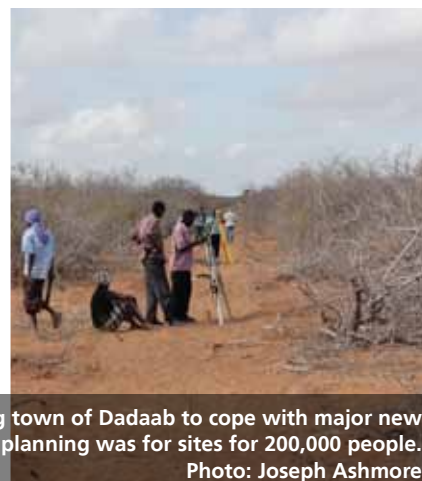
New sites were identified, planned and constructed within 20km of the existing town of Dadaab to cope with major new influxes and a backlog of non-registered new refugee arrivals. Initial planning was for sites for 200,000 people.

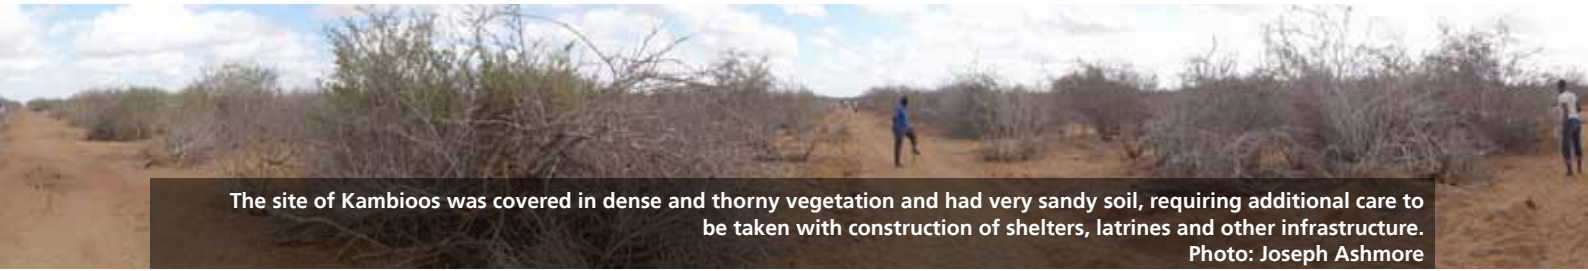
The site of Kambioos was covered in dense and thorny vegetation and had very sandy soil, requiring additional care to be taken with construction of shelters, latrines and other infrastructure. Photo: Joseph Ashmore

The site of Kambioos had fewer flooding issues, but there were initially concerns about the water scarcity, and the additional challenges caused by the sandy soil and a bedrock. This created issues in pitching tents and digging latrines, while access roads, both to and within the site were a challenge.

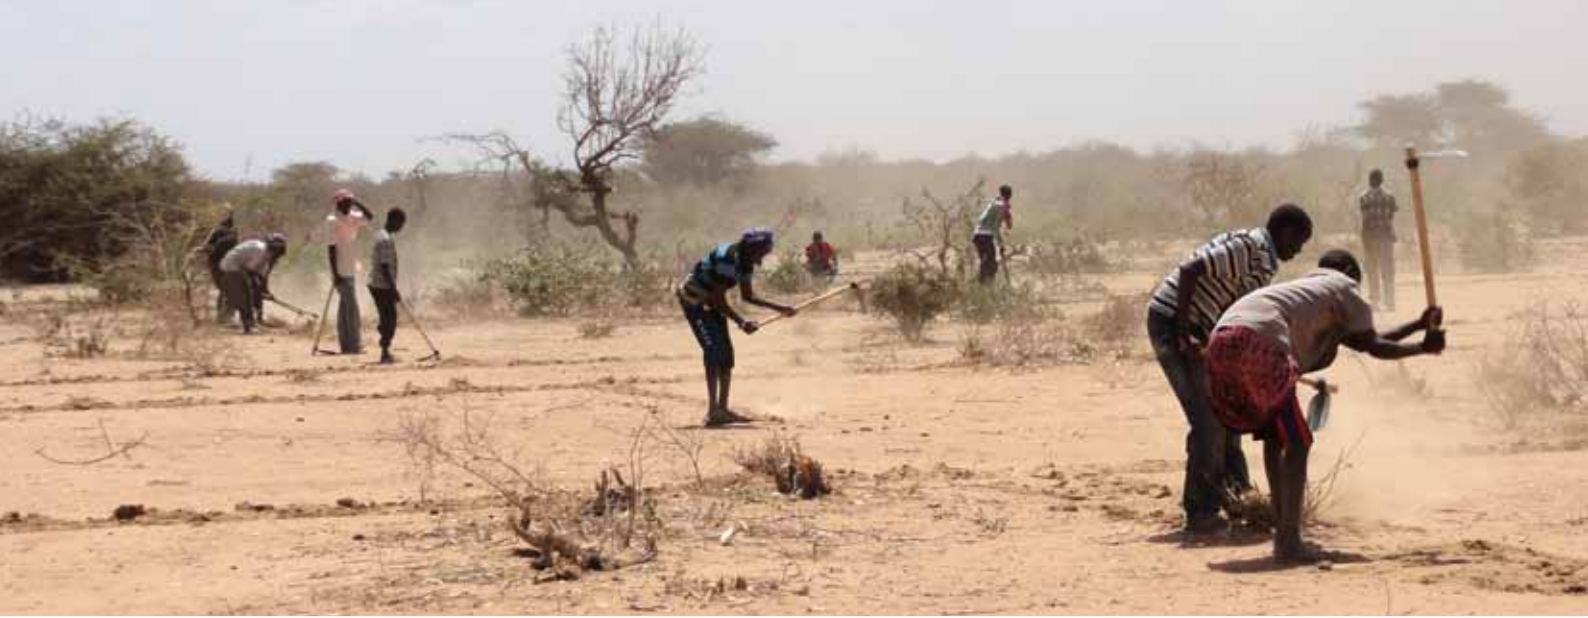
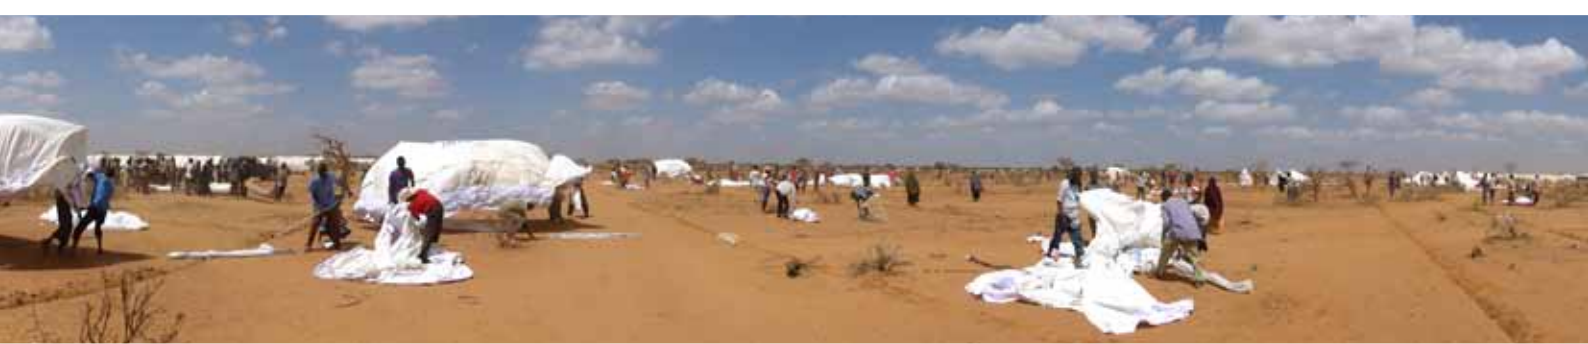
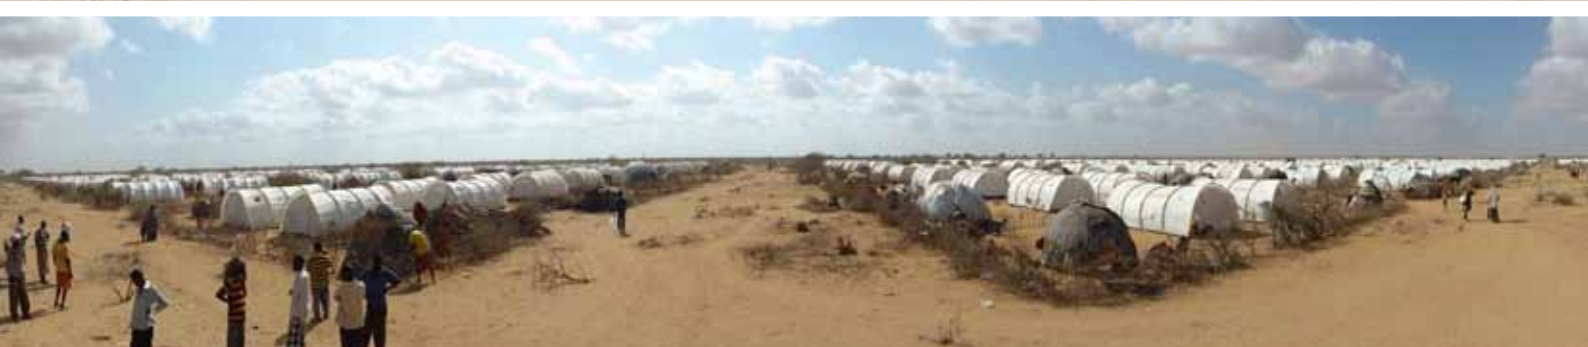
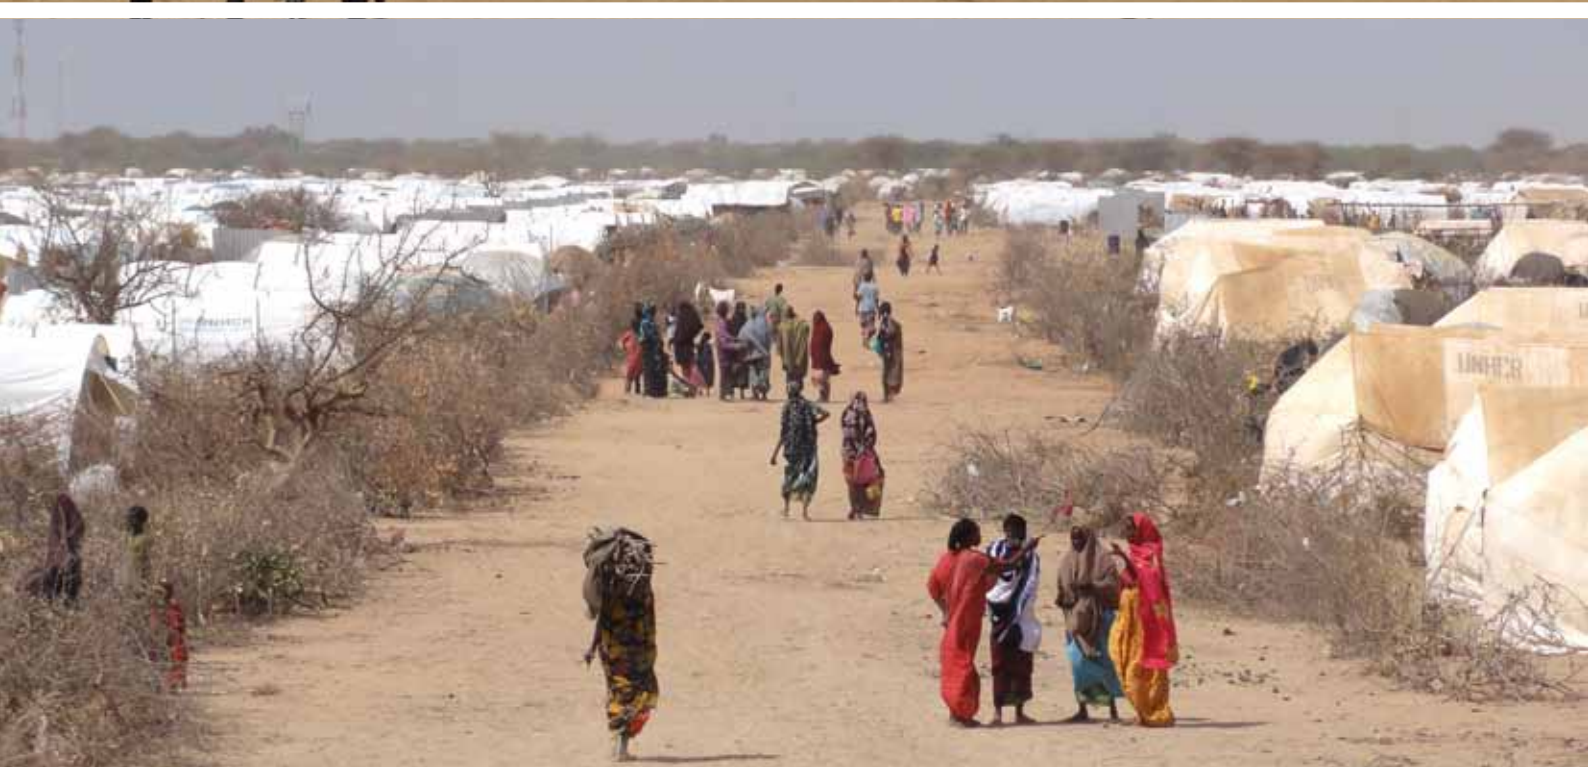
Top to bottom: Site marking; Tent erection on a windy day; Newly established blocks at IFO camp extension. Camps were organised into a) plots, b) communites, c) blocks, and d) sections. Photo: Joseph Ashmore

Both camps were planned based on a community concept with 10 or 12 shelters.

Each camp was planned with an 8m wide sanitation line between communities. This break was for sanitation facilities, including communal showers, latrines and garbage pits for the initial settlement. Roads were 15m wide.

The camps were built in phases. Each of the phases of "Ifo 2" camp was planned to measure 2.5km x 1.5km. Kambioos site was built in four planning phases each with 10 sections and seven residential blocks.

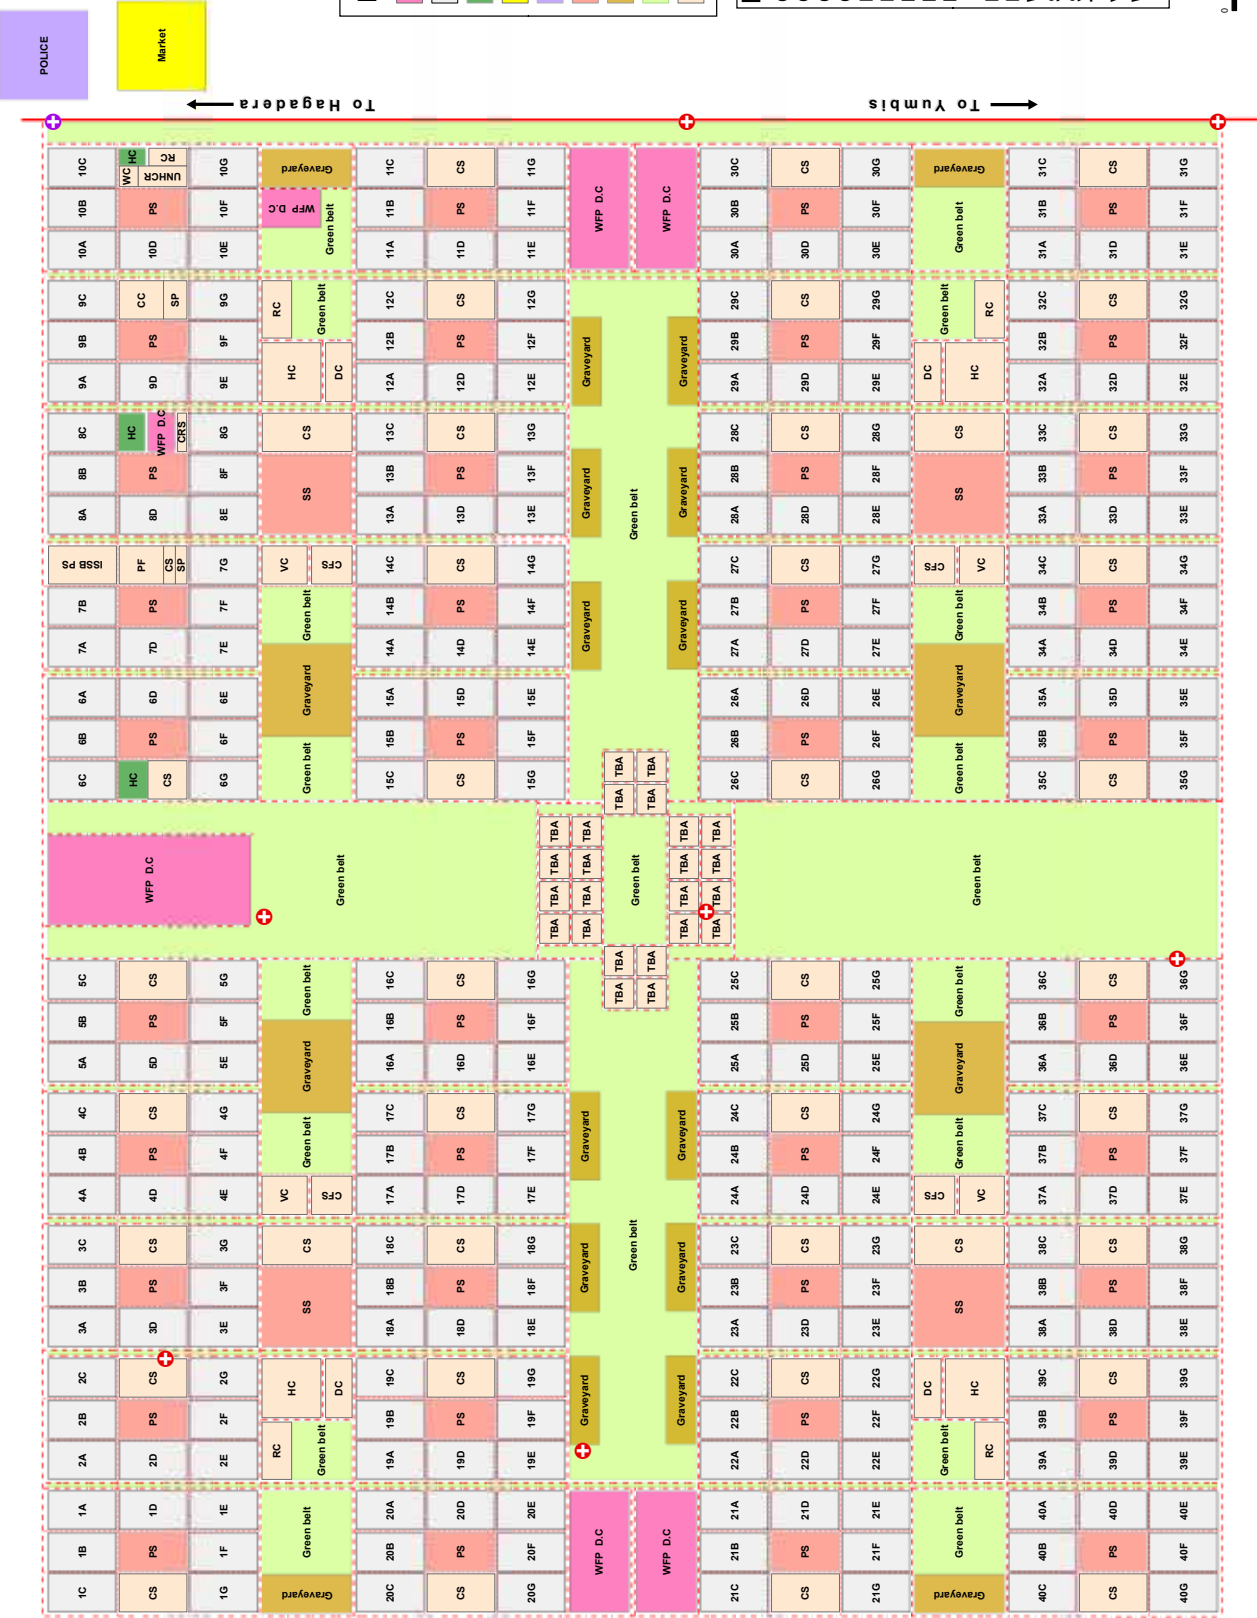
Kenya- Fafi District Kambioos Refugee Camp Overview

As of June 2012
