A.17 Lebanon – 2011 – Conflict

Case Study: **Keywords:** Hosting, Support for host families, Rental support, Housing repair and retrofitting, Cash / vouchers, structural assessment

Lebanon

Bekaa valley and Wadi Khalid (northern Lebanon)

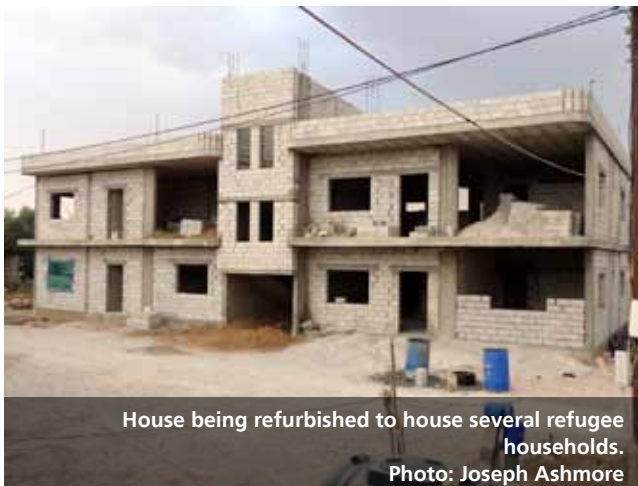
House being refurbished to house several refugee households.
Photo: Joseph Ashmore

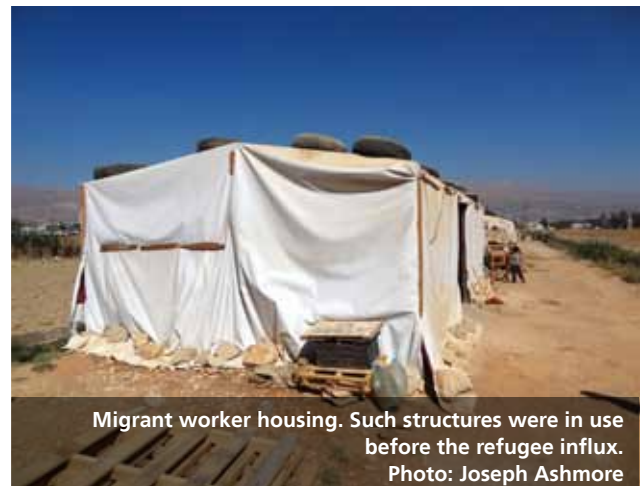
Migrant worker housing. Such structures were in use before the refugee influx.
Photo: Joseph Ashmore
