A.19 Nicaragua – 2007 – Hurricane

Case study: **Keywords:** Non-displaced, Construction materials, Core housing construction, Site planning, Training.

Project description

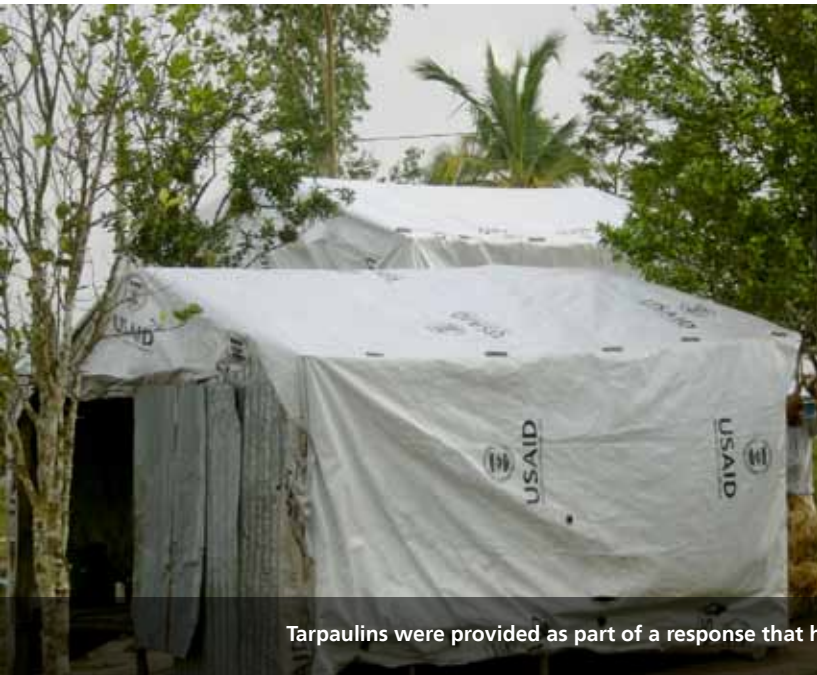
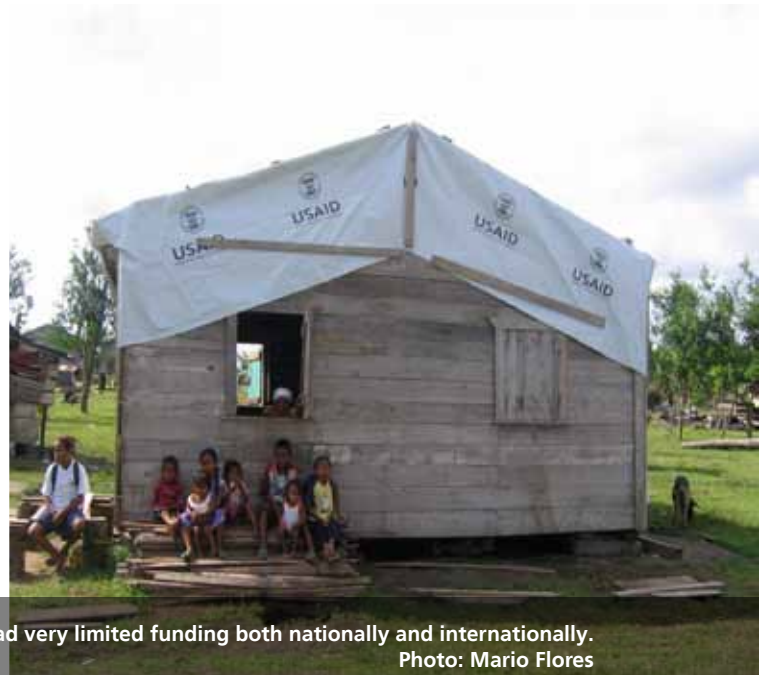
Tarpaulins were provided as part of a response that had very limited funding both nationally and internationally.
Photo: Mario Flores

Some tarpaulins were provided as emergency shelter by relief agencies to enable families to stay in their houses and prevent further displacement. Many families combined the sheeting with reclaimed materials to make shelters.

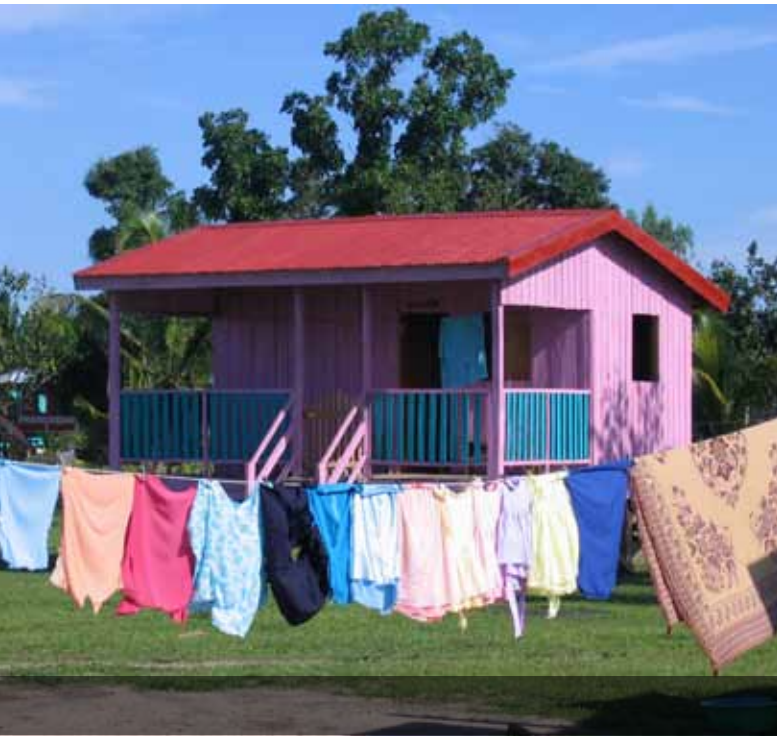
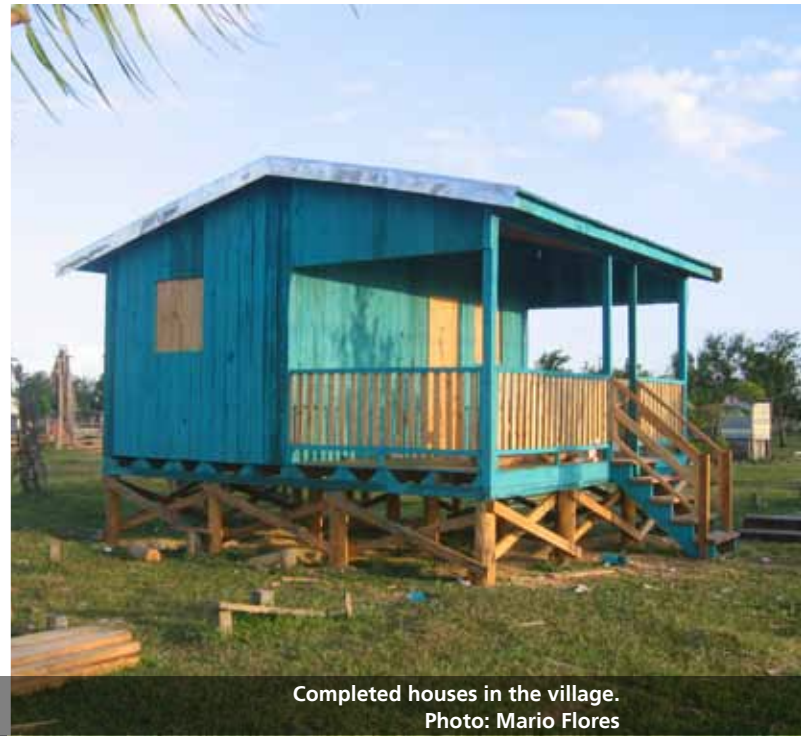
Completed houses in the village.
Photo: Mario Flores

The house design followed a local design, using familiar materials: timber for most of the house components and corrugated galvanized sheeting for the roof.

- elevating houses on stilts to reduce the risk of flooding
- cross-bracing supporting posts
- metal straps to reinforce connections of wooden elements
- a strengthened structural design
- use of twisted roofing nails to better secure roofing sheets.
