A.22 Pakistan – 2011 – Floods

Case Study: **Keywords:** Non-displaced / returns, Core housing construction, Cash, Training, Guidelines and training materials

A.23 Pakistan – 2011 – Floods

Case Study: **Keywords:** Non-displaced, Core housing construction, Housing repair and retrofitting, Training, Guidelines and training materials, Advocacy.

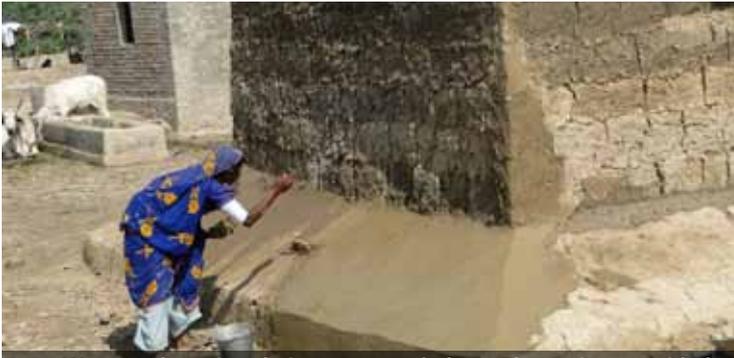
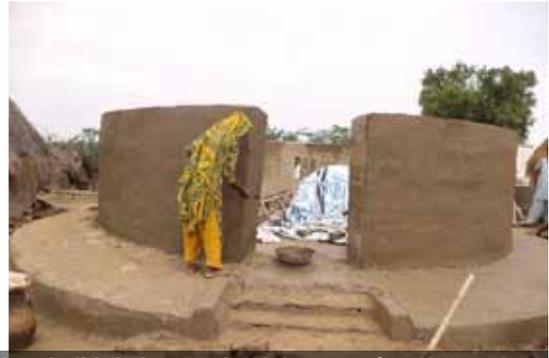
Women plastering their one room shelters. The project provided cash to build shelters and training on safer construction with incremental improvements such as stronger plinths and footings to walls. Households chose their own shelter design.

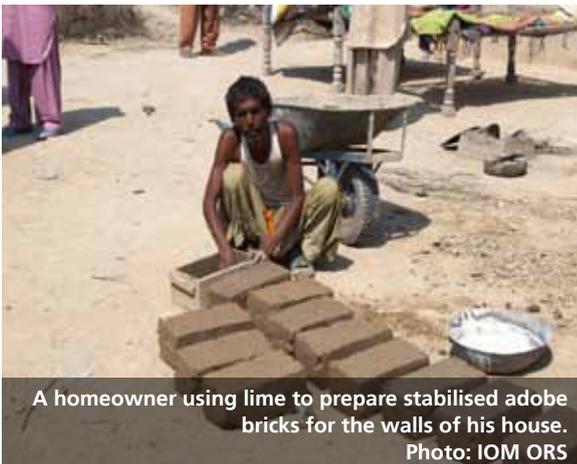
A homeowner using lime to prepare stabilised adobe bricks for the walls of his house.
Photo: IOM ORS

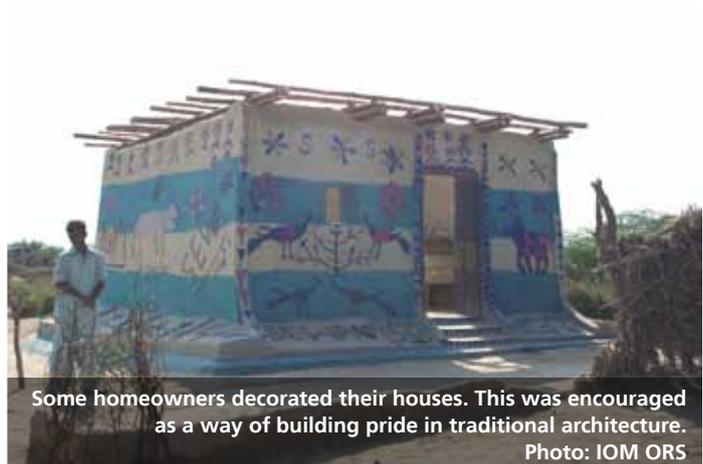
Some homeowners decorated their houses. This was encouraged as a way of building pride in traditional architecture.
Photo: IOM ORS

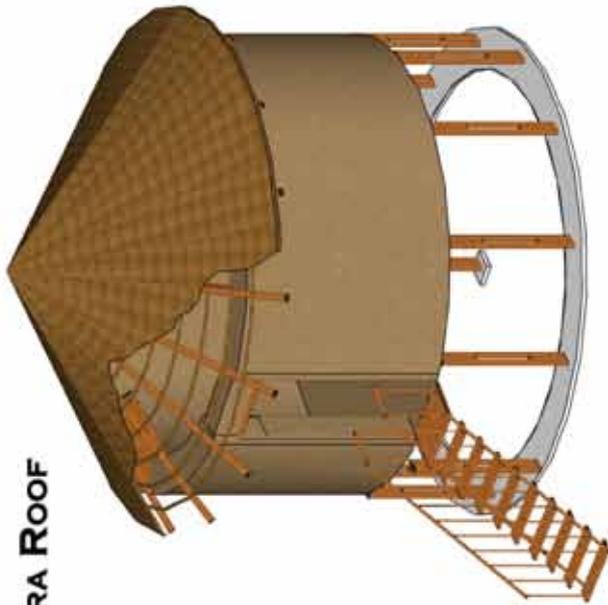
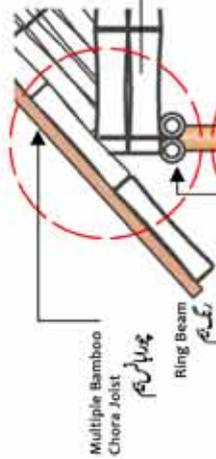
Multiple Bamboo Chora Joist
چوڑا لکڑی

Ring Beam
لکڑی

ROOF
چھت

WALL
دیوار

BASE AND TOE
پائے

- Plain Lime Concrete 1:2:4 (Lime : Sand : Aggregate)
- Plaster 1:2:3 (Lime : Sand : Soil)
- Karavan Roof Finish 1:2:4 (Lime : Sand : Brickdust)
- Non-accessible Roof Finish 1:2:3 (Lime : Sand : Soil)
- Mud Mortar 1:6 (Lime-Mud mixed with straw)

TYPE B-4 with KARAVAN CHAURA ROOF REED/LOH-KHAT MODULE CONSTRUCTION GUIDELINES

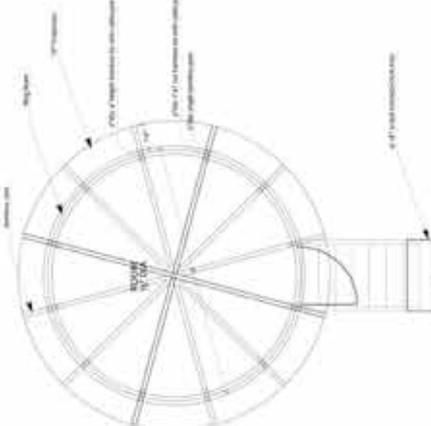
FLOOR PLAN
پلان

ADOBE / MUD - BAMBOO

- Use soil with 20% - 40% clay using bottle test.
- Soak soil for 1 week and mix thoroughly.
- Begin constructing from the corners. Thickness of the wall should not be less than 18".
- Use mature, well cured bamboo (3 yrs +).
- Do not use bamboo poles with vertical cracks.
- Make sure bamboo ends are protected by lime cream bio-degradable special masala.

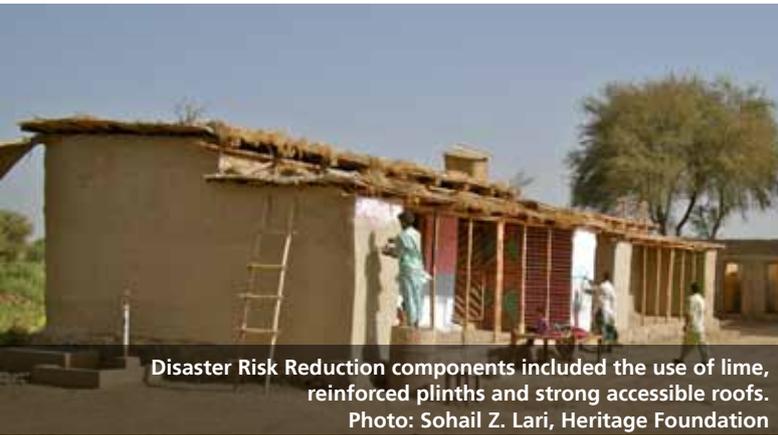
Disaster Risk Reduction components included the use of lime, reinforced plinths and strong accessible roofs.
Photo: Sohail Z. Lari, Heritage Foundation

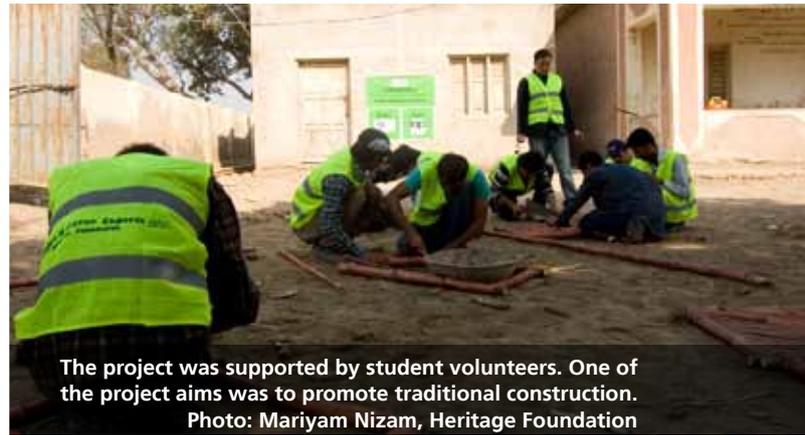
The project was supported by student volunteers. One of the project aims was to promote traditional construction.
Photo: Mariyam Nizam, Heritage Foundation

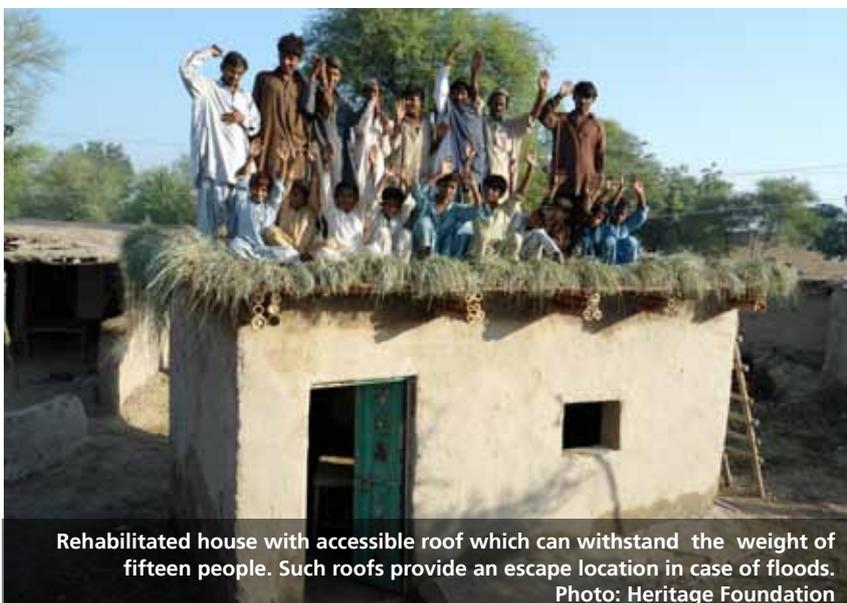
Rehabilitated house with accessible roof which can withstand the weight of fifteen people. Such roofs provide an escape location in case of floods. Photo: Heritage Foundation

Many mud walls that had been partially damaged were rehabilitated after an engineering review. The rehabilitation included repairs on walls, bases and plasters, along with the use of accessible roofs using bamboo.
