## A.25 Philippines – 2011 – Cyclone

## A.26 Philippines – 2012 – Cyclone

## A.27 Philippines – 2012 – Cyclone

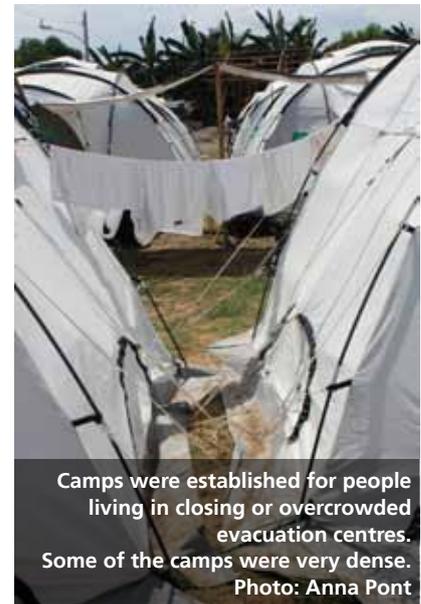
Camps were established for people living in closing or overcrowded evacuation centres. Some of the camps were very dense.  
Photo: Anna Pont

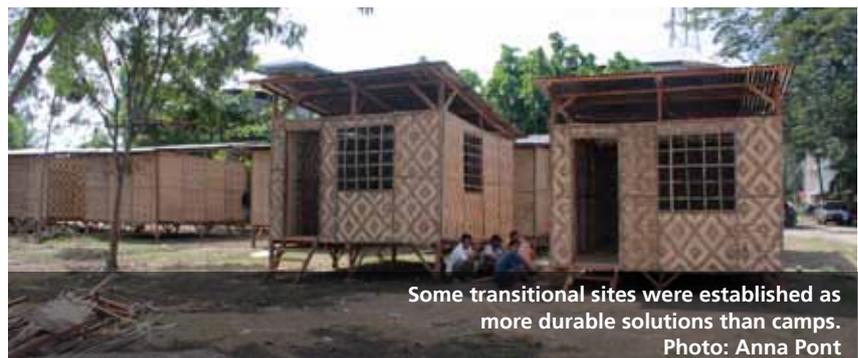
Some transitional sites were established as more durable solutions than camps.  
Photo: Anna Pont

Where temporarily available land could be found, transitional sites were established as a more durable solution to camps (See A.26).

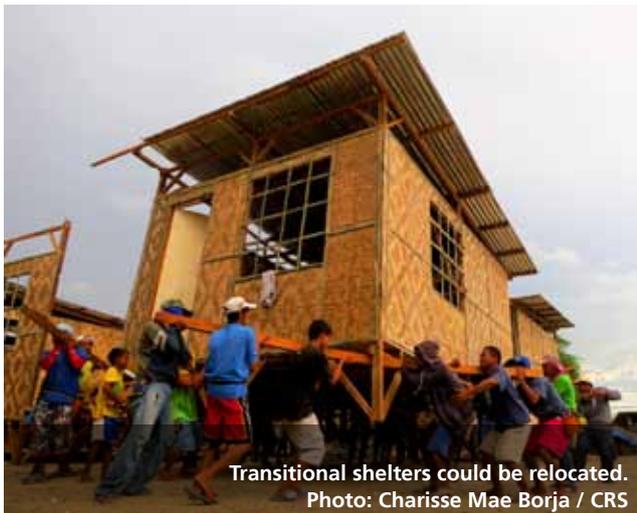
Transitional shelters could be relocated.  
Photo: Charisse Mae Borja / CRS

Transitional shelters erected on relocation sites needed to be moveable and make minimal impact on the land.

The agency worked with a local architect and local engineers to design an adaptation of the traditional *Amakan* (bamboo or palm leaf weave) house.

*Amakan* houses have been built for centuries and are well adapted to the tropical climate of the Philippines. They can also easily be repaired or rebuilt. The design used locally available *amakan* (palm was used) for the walls and coco lumber, which is durable and inexpensive, for the structural frames.

- Culturally appropriate: Provides privacy, uses local materials and provides protection from rain and heat
- Relocatable: Can be carried by 20 persons or easily dismantled
- Speed of construction: Can be built in 2-3 days
- Economical
- Flexible: Design can be adjusted for relocated families or those returning to original sites
- Upgradeable: Can be upgraded to a permanent home.

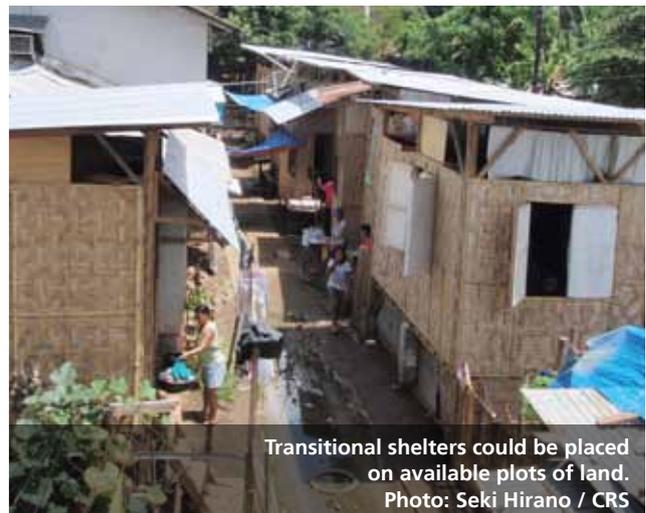
Transitional shelters could be placed on available plots of land.  
Photo: Seki Hirano / CRS

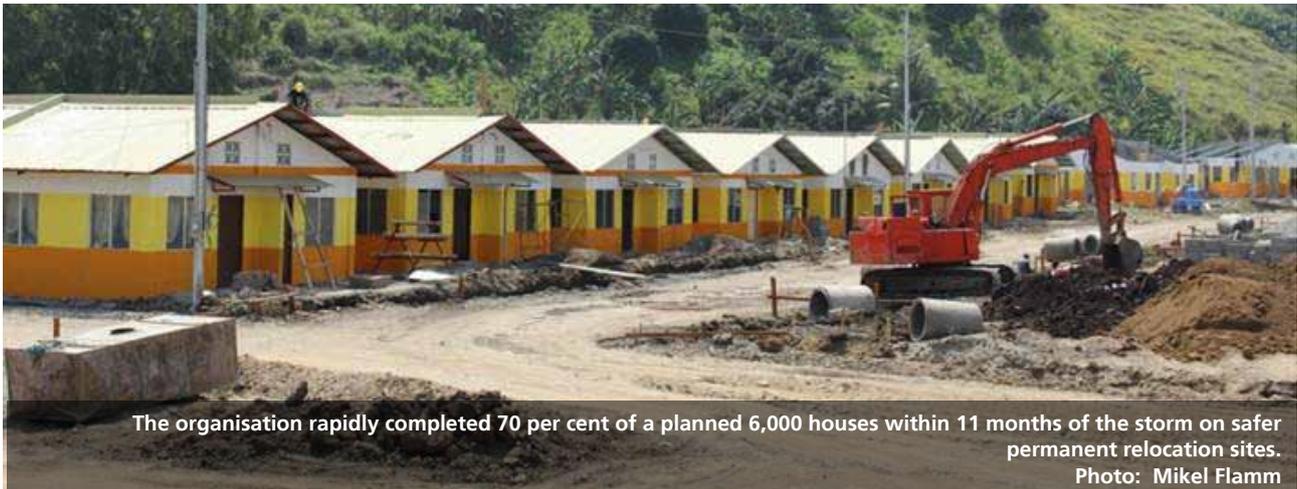
The organisation rapidly completed 70 per cent of a planned 6,000 houses within 11 months of the storm on safer permanent relocation sites.

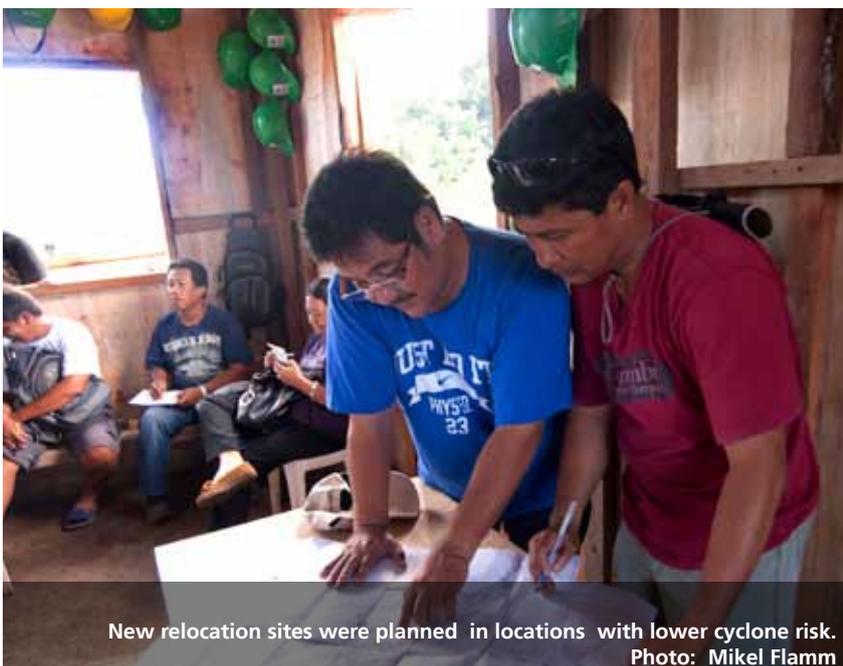
New relocation sites were planned in locations with lower cyclone risk.

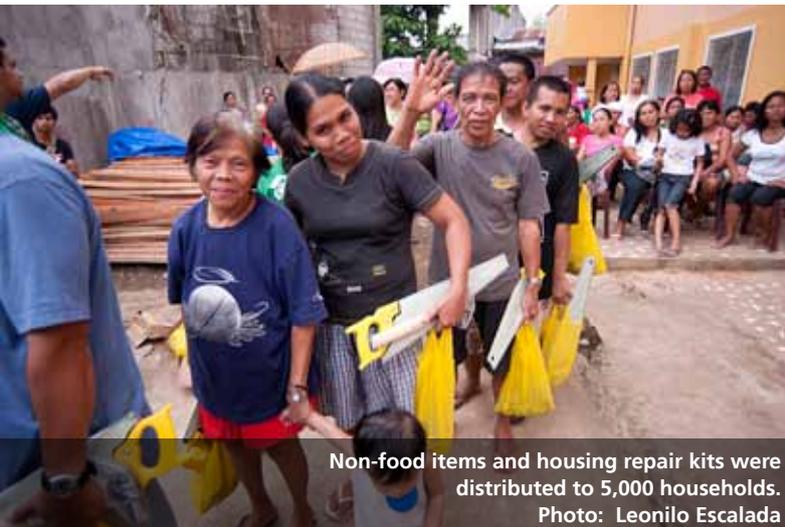
Non-food items and housing repair kits were distributed to 5,000 households.  
Photo: Leonilo Escalada

The organisation distributed 5,000 emergency shelter kits containing construction materials (timber, corrugated galvanised sheets, nails, etc.) and basic tools to support emergency repairs on damaged homes.

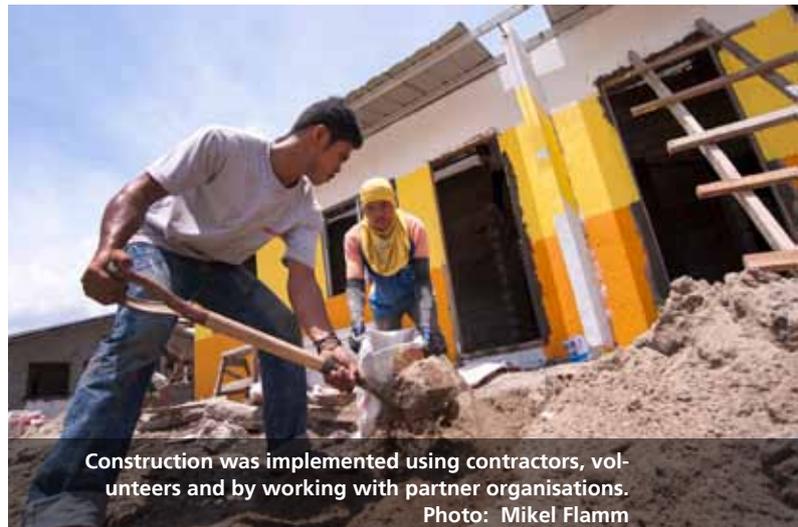
Construction was implemented using contractors, volunteers and by working with partner organisations.  
Photo: Mikel Flamm

The core house was built from concrete blocks, with a reinforced masonry design. There were steel reinforcement bars, both vertically and horizontally. The roof structure was made of metal trusses and purlins, with a cover of zinc/aluminium sheeting. Doors and windows used metal frames, and the floor was covered with ceramic tiles.

Each shelter unit had a multiple purpose room, an attached sanitary unit (toilet and bath area) and a small kitchen area. The height of the buildings allowed a mezzanine level to be built by occupants to create a raised sleeping area. This could potentially increase the living space from 21m<sup>2</sup> to 36m<sup>2</sup>.
