A.5 Dominican Rep. – 2012 – Hurricane Sandy

Case study

Emergency: Hurricane Sandy, Dominican Republic.

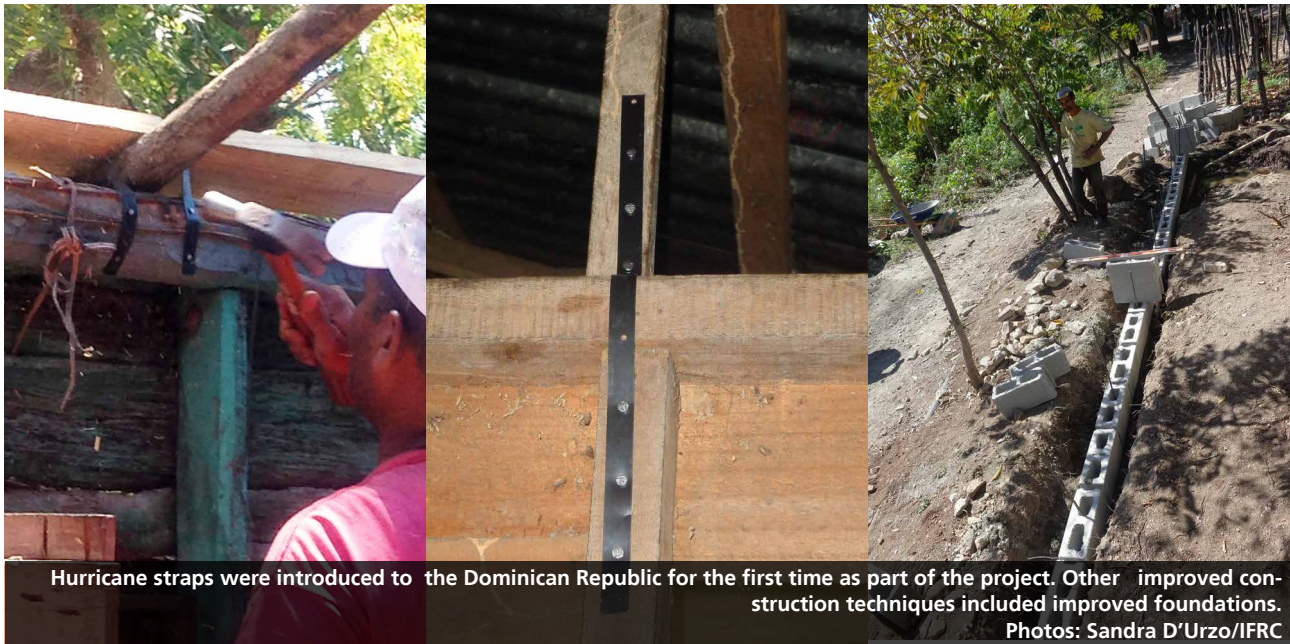
Roofs were not usually reinforced and often unsafe, with families using concrete blocks and tyres as counterweights to keep them in place during storms.

Roofs were typically covered in corrugated zinc sheets, with the frame and wall structures made from wood. Some walls were built out of a combination of mortar, wood and blocks and few were strong enough to resist damage by storms or earthquakes.

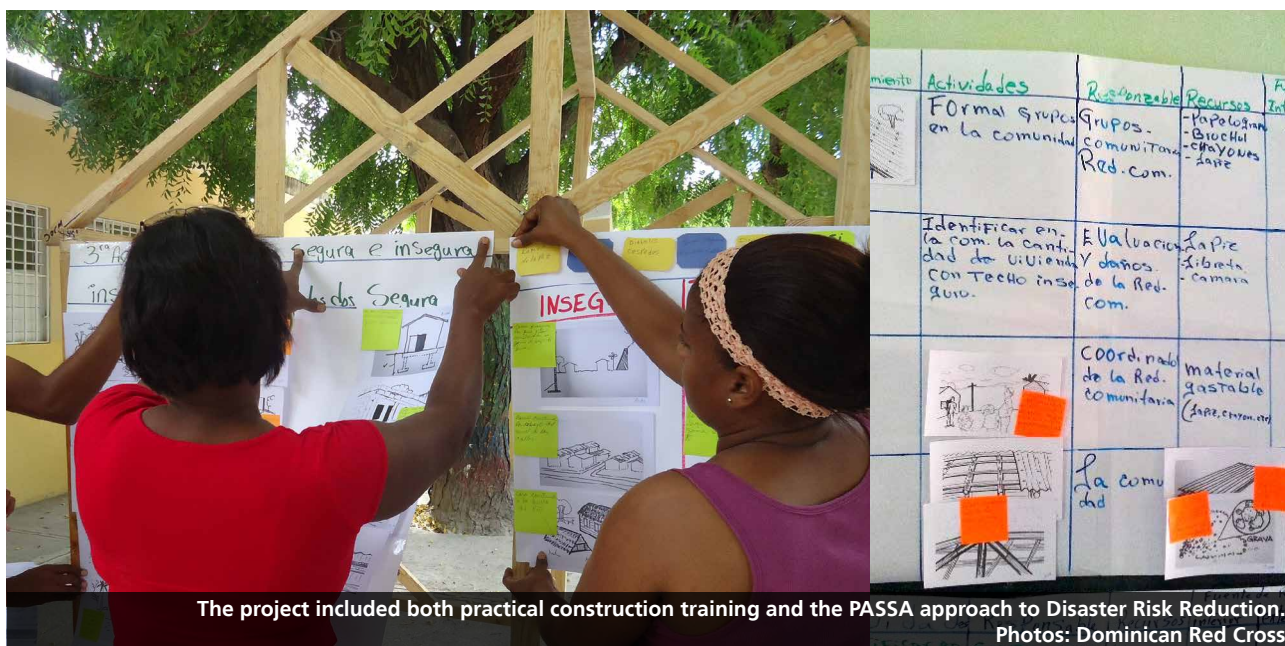
The project included both practical construction training and the PASSA approach to Disaster Risk Reduction. Photos: Dominican Red Cross
