A.7**Fiji – 2012 – Tropical Cyclone Evan****Case study****Keywords:** Transitional shelter / T-shelter; Advocacy / legal; Training.**Emergency:** Tropical Cyclone Evan, Fiji.**Date:** 17-19 December 2012.**Damage:** 8,500 houses damaged in the "formal" sector, 177 houses destroyed in the "informal" sector.**People affected:** Over 40,000 people affected in the formal sector and over 800 displaced in the informal sector.**Project location:** Coastal areas of Western Division.**Beneficiaries:** 254 households (approximately 1,250 people).**Outputs:** Phase 1: 120 T-shelters, Phase 2: 134 T-shelters (70 complete as of Sept. 2014, 66 for emergency stockpile)**Ocupancy rate:** 100% in Phase 1.**Shelter size:** 21m² (6m x 3.5m).**Cost:** Materials and labour per shelter: 3,200 Fijian dollars (FJD) (US\$ 1,800); total project cost per shelter: 5,300 FJD (US\$ 2,900).**Project description:**

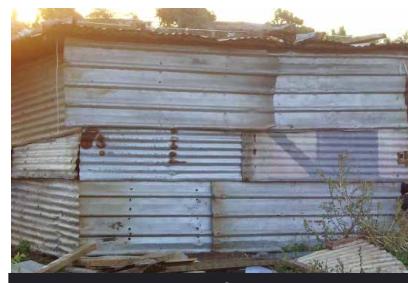
An example of the poor quality shelters characteristic of the "informal" sector.
Photo: Habitat for Humanity Fiji.

As construction in informal settlements was illegal, homes were built without any regulation. Compounded by the poverty of the inhabitants, the homes were constructed to a very low standard and were extremely vulnerable to natural disasters.

Those that stayed on the site of their destroyed homes pieced together shelters that were even more poorly built than their previous homes. Many continued to live under leaking tarpaulins and rusty sheets of roofing iron for up to a year after the cyclone hit.

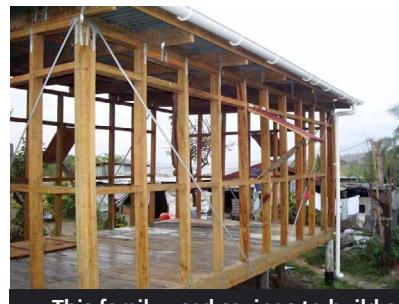
This family used savings to build a proper floor, despite contravening government regulations.

Though the structure was initially designed with rigid wall and floor lining, the government said that the use of permanent wall and floor lining would constitute a permanent dwelling and banned the use of those components in the early part of the design stage.

Tarpaulin walls were used instead, and floors were designed to be made of raised compacted earth. It was understood amongst Cluster members that homeowners would opt to use permanent wall lining as soon as they could afford it, so the structural frame was designed to withstand severe cyclonic wind loads in anticipation of the eventual replacement of the tarpaulin with a rigid material.

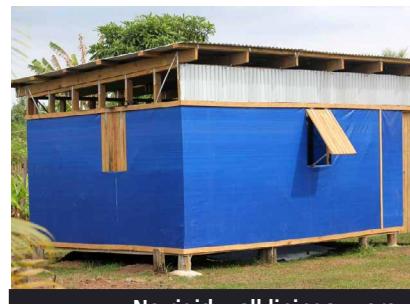
No rigid wall linings were permitted, so plastic sheeting was used instead.

Many families opted not to have the tarpaulin lining because they preferred to use roofing iron they had salvaged from their damaged homes as a more permanent wall lining solution.
