### Situation after the disaster

### Shelter strategy

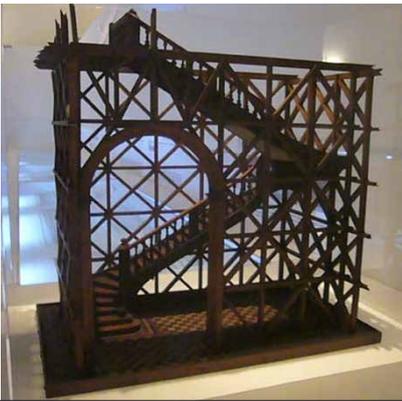
A model showing the Pombaline cage design. The design is said to have been tested by getting the army to walk up and down on the roof of a full-size model.

The design was apparently tested by running a stress-test on a full-scale model in the city's main square. The military were ordered to march in uncoordinated, uneven rhythms on top of the building to simulate the tremor conditions of an earthquake (Mata dos Santos 2008).

Recent studies by some Portuguese engineers (Cardoso, Lopes and Bento 2004, and Ramos, Lourenço 2000) suggest that many of Pombaline Cage buildings in the Baixa have been profoundly altered, driven mainly by commercial interests and changes in building use. This would suggest that some parts of the city might now be more vulnerable than they were 200 years ago.
