MALAWI 2015 / FLOODS

MALAWI 2015-2016 / FLOODS

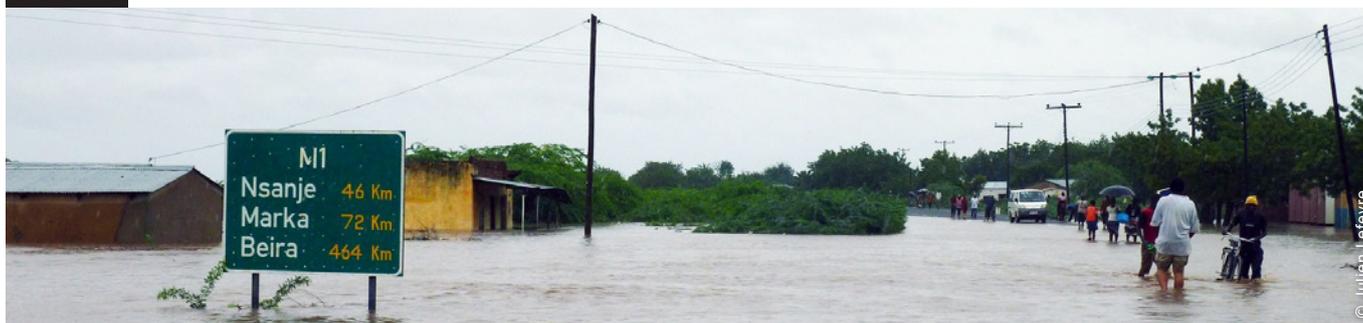
After several weeks of heavy rains, the Shire River reached the highest level in the past 30 years, burst its banks in several locations and caused widespread flooding.

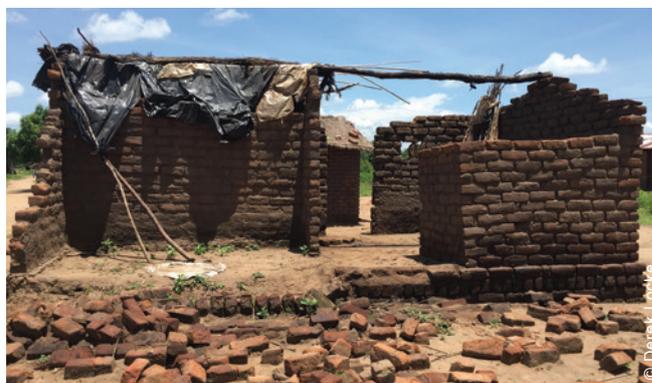
Some structures sustained significant damage due to the floods.

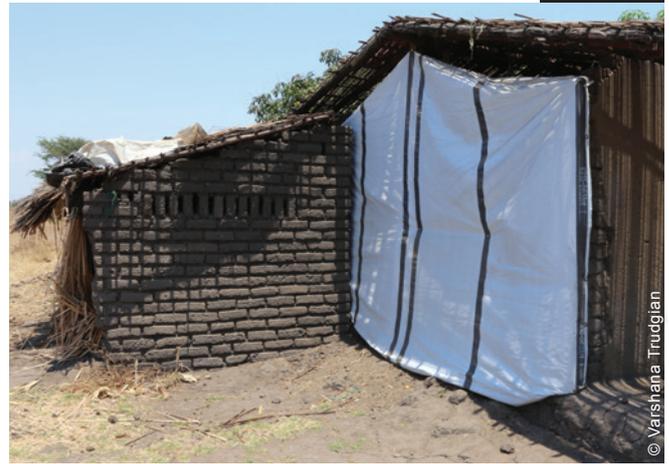
Tarpaulins from the shelter kits were used, amongst other purposes, to seal off damaged parts of the houses.

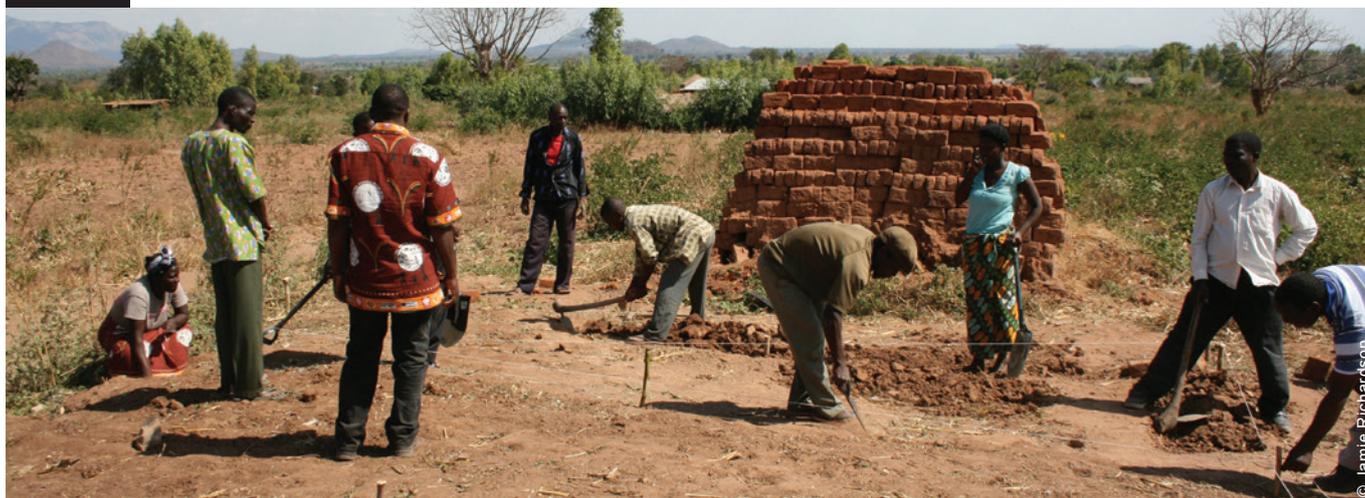
People were given technical trainings and built model houses as part of the project. Here they are working on setting out the foundations of a model house..

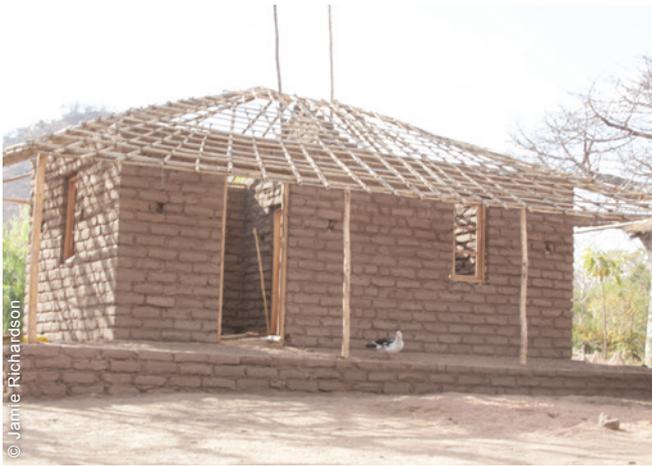
Model homes were built, according to traditional designs. Additionally, materials were provided and cash-for-work grants for the 10% most vulnerable households.

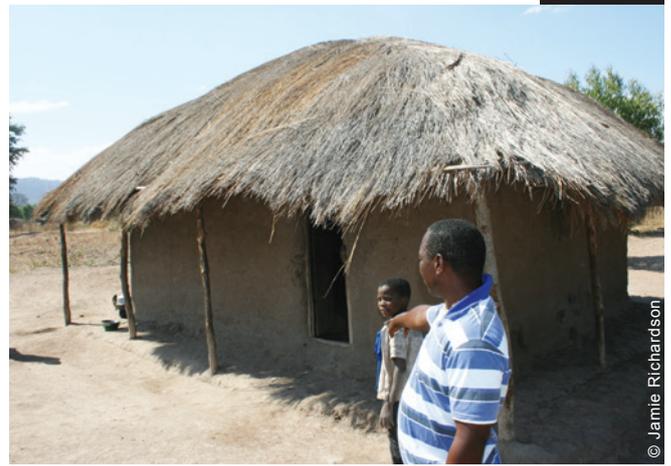
Many of the traditional houses withstood the floods, as they were built with contextually appropriate features, such as roof overhangs and raised platforms.

Many houses had survived with little or no damage, even after weeks of standing water, including those constructed using earth brick and render. This is because these traditional houses had raised platforms that protected the core structure from erosion, and the veranda and large roof overhangs ensured that the gables and walls were protected. This design, developed over centuries, provided protection from the elements and, other than some minor repairs to the veranda and walls, allowed many families to return to their homes once the floods had subsided.

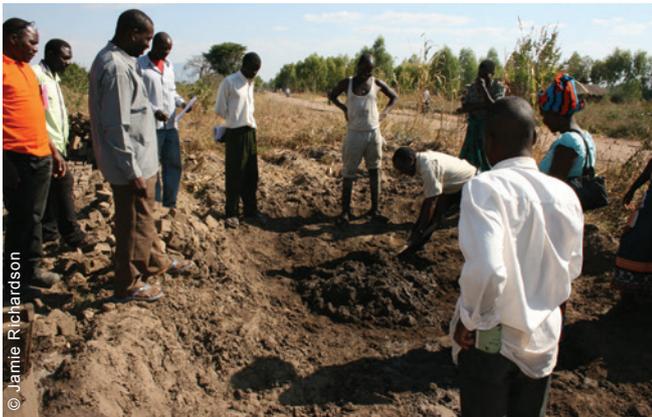
Trainings included the identification of good soils and mixing for block making.
