OVERVIEW

PHILIPPINES 2013 / TYPHOON HAIYAN

CASE STUDY

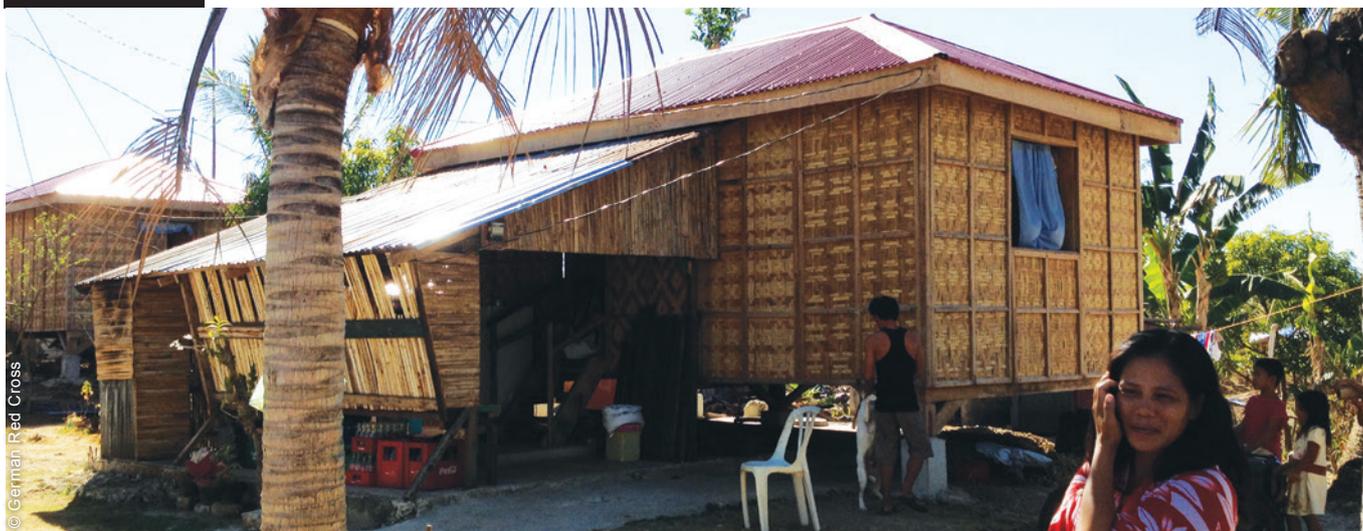
Multiple programme options were encouraged in response to Typhoon Haiyan, one of them being the construction of transitional or core shelters.

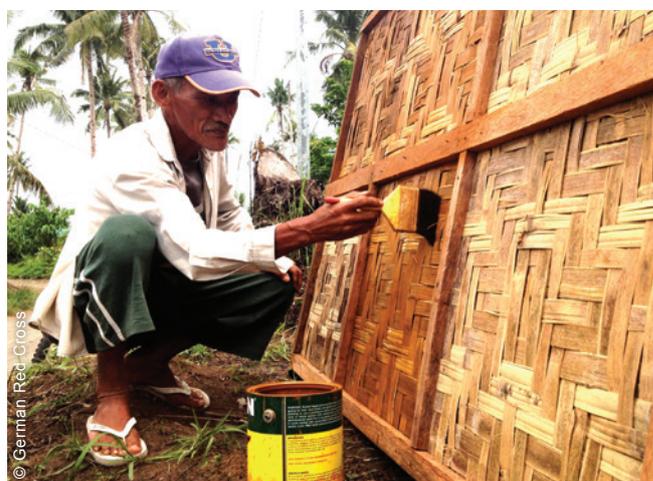
In some projects, materials were treated to improve the durability of the shelters.

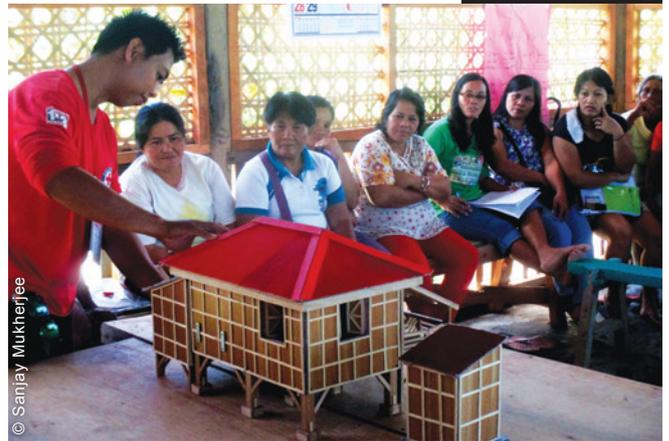
Core shelters and latrines were built to a set design, which was presented at community meetings to explain its features and receive feedback.

The Core Shelter construction was **executed in several batches to allow certain learning and development**, and minimize risks. Each Core Shelter included a household toilet. Since the project area was mostly on a high water table,

with water points randomly installed around the settlement and congested dwellings, **finding an appropriate sanitation solution was a sensitive topic**; the team studied various design options and adopted a two-chamber septic tank design, adjusting the elevation depending on specific site conditions and ground water level.

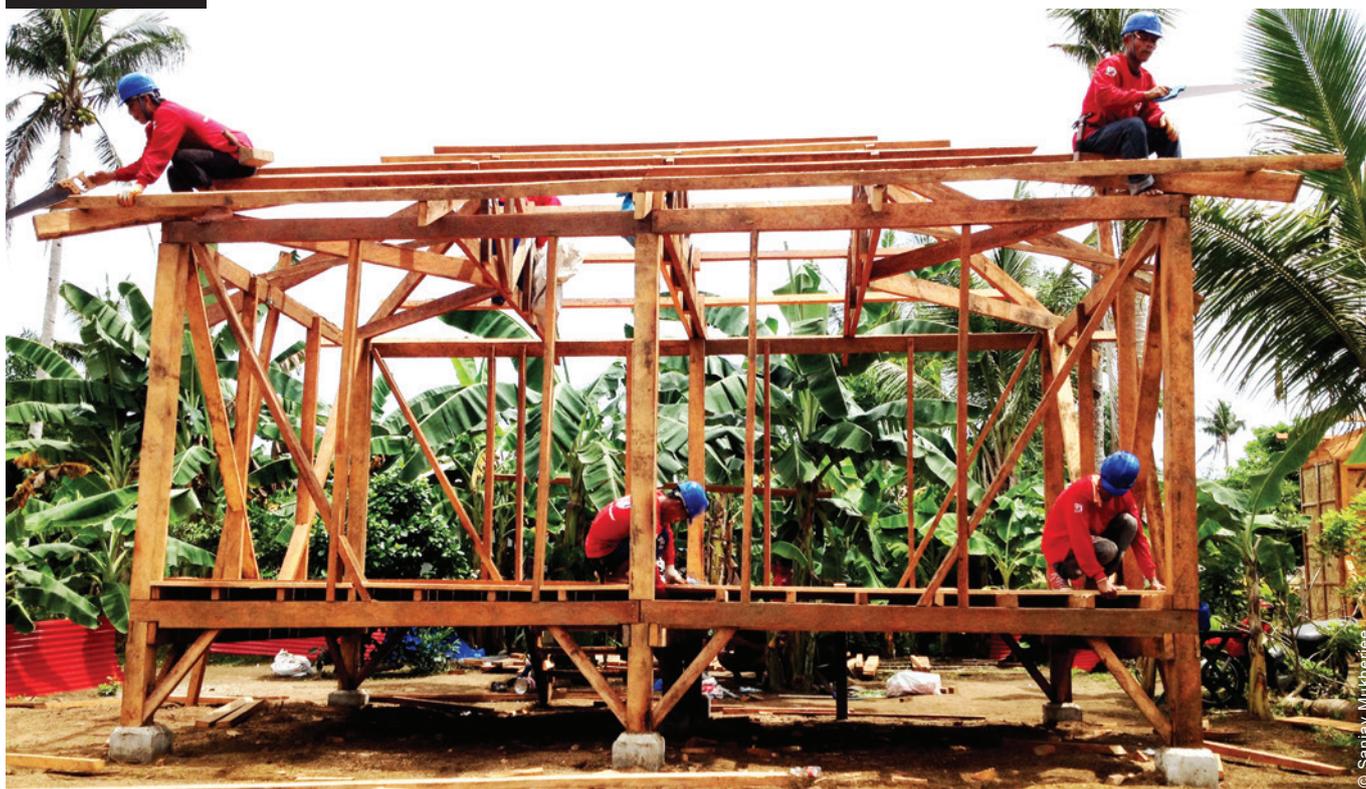
Core shelters were built in several batches by construction teams that included the beneficiaries. Material supply and monitoring were managed by the organization.

For the Core Shelter construction, the project recruited local carpenters and provided on-the-job training. Since very few skilled carpenters and masons were available in the community, **the pilot phase focused on training and skills enhancement**. Each team consisted of two skilled carpenters and two unskilled workers, supported by one beneficiary or representative. A trained monitoring team conducted several interactive sessions at community level to impart knowledge on safer construction, identify problems and make improvements on the construction details and process. 35 carpenter teams and 25 mason teams were trained over a period of time, both on-the-job and through formal trainings by an official institute.

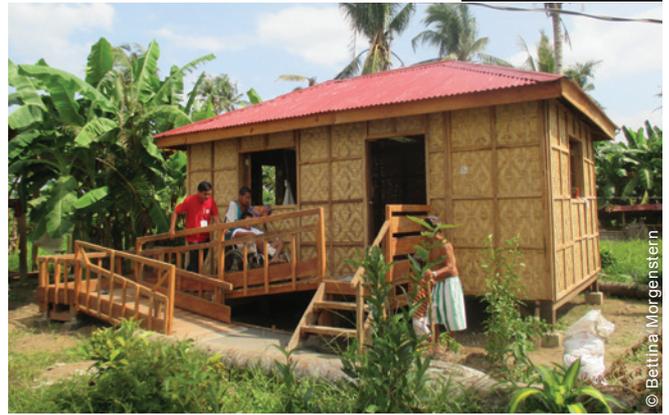
Some of the core shelters included ramps to improve accessibility.

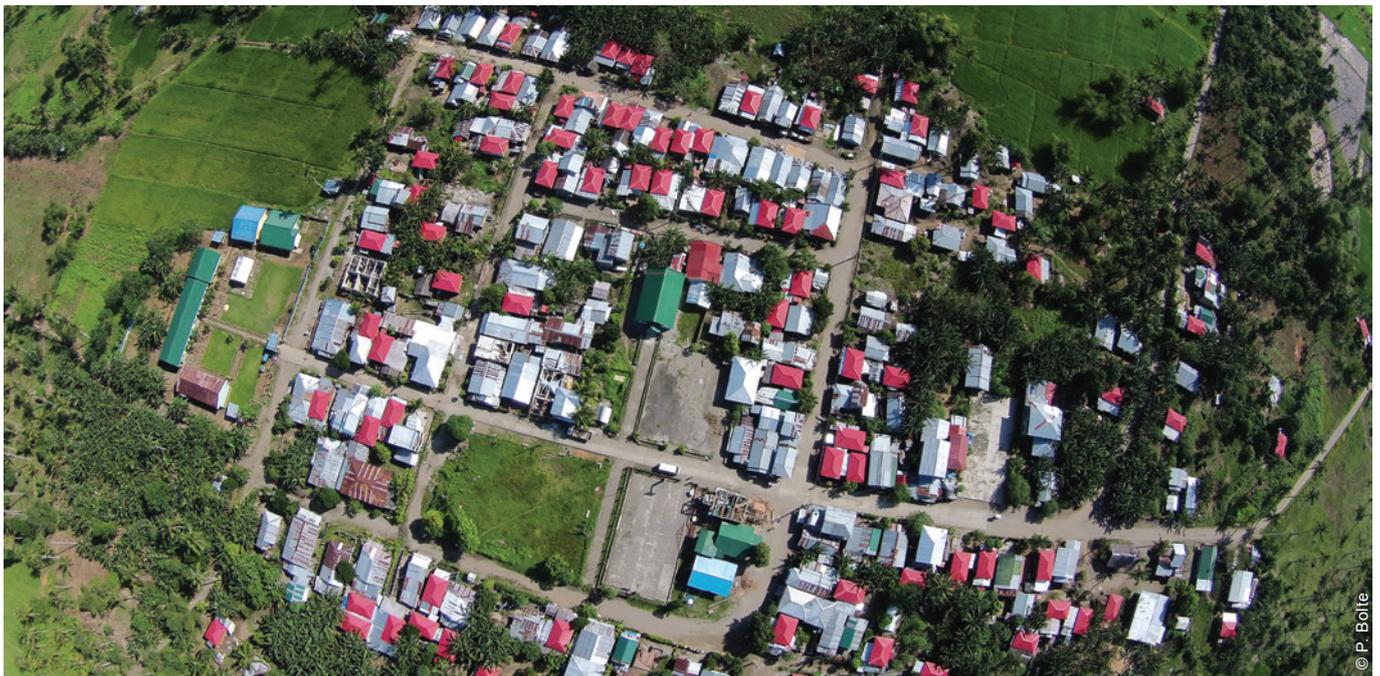
Aerial view of one of the areas where the project was implemented. The shelters with red roofs were built by the organization, while other structures were self-built.

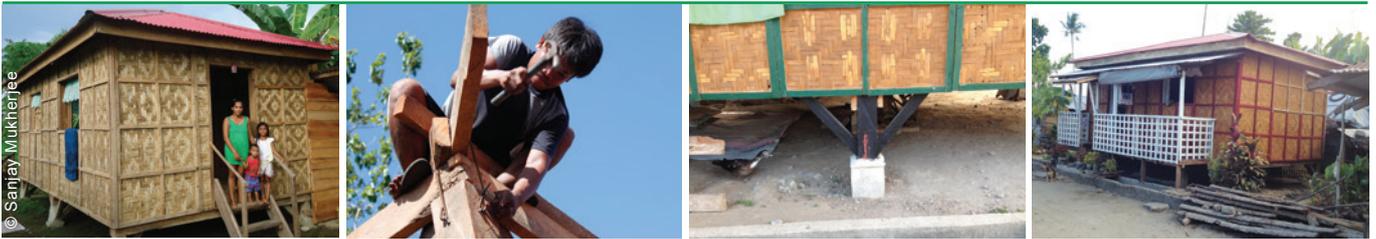
Safer building practices were promoted, such as strapping of roof structures, bracing and proper detailing of the foundations (raised and made of reinforced concrete).

“Care and maintenance” were discussed in various focus groups. The project included the use of a treatment (solignum) in the lower exposed portion of the structure, to enhance termite protection and prevent decay; a concrete footing, to increase the distance of the wooden post from the soil; and a galvanized iron sheet above the concrete, to protect the edge of the wooden post.

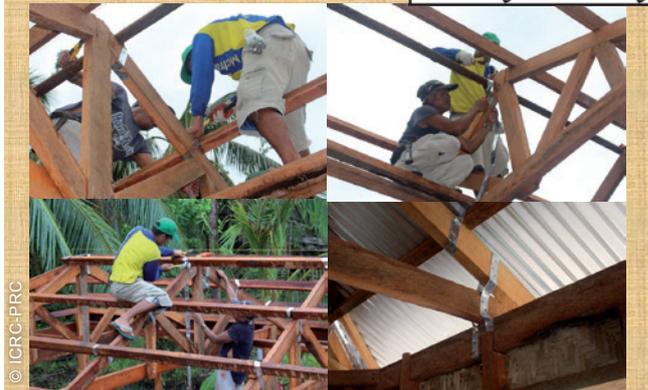
Roof: Hurricane Straps / Tie wire installed using pliers and hammer, nails from bottom.

The project had a strong focus on safer construction techniques.

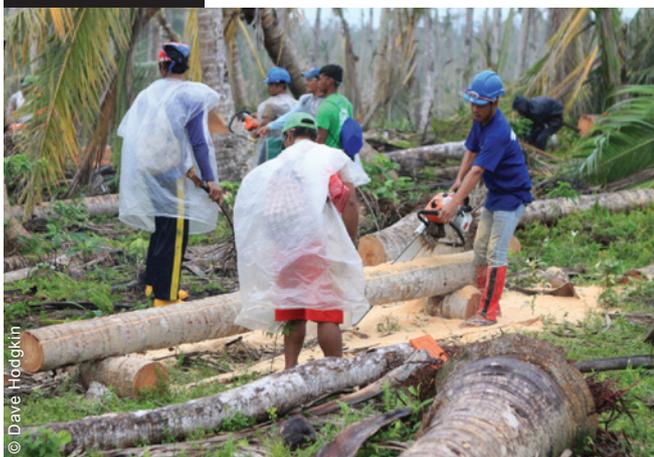
The project used a flexible approach to reuse fallen coconut trees to set up a large-scale shelter response. Most of the milling was done by licensed chainsaw operators, directly where the coco-lumber was sourced.

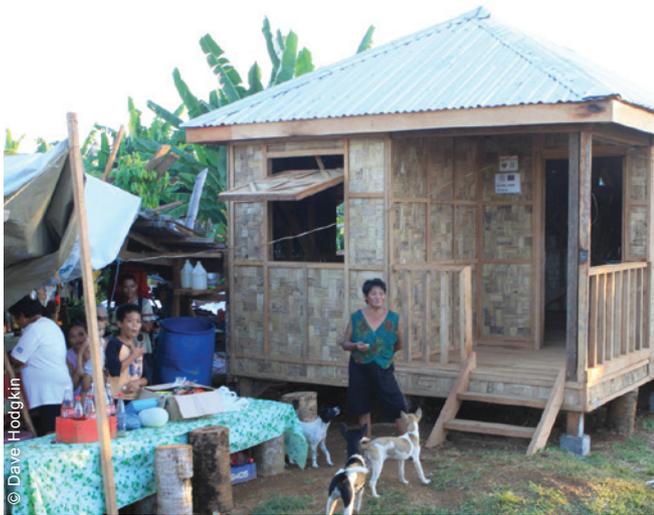
Transitional shelters were used as a basis to recover. Families would personalize the shelters and add small stores and other temporary structures outside the shelters, which served as places for livelihood activities.

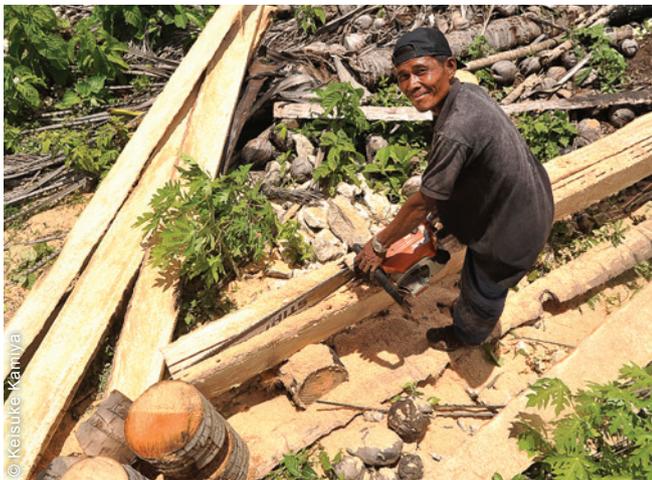
Local people cut fallen coconut trees into planks with chainsaws (Guiuan).

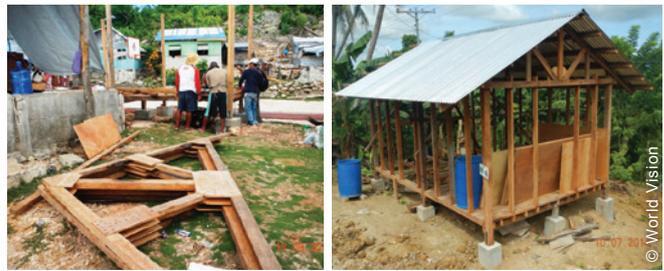
The project prefabricated trusses and built transitional shelters.

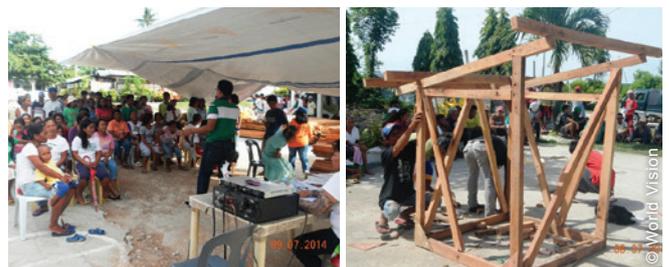
The project included distributions (North Cebu, left) and built model structures for Build Back Safer trainings delivered to communities (right).

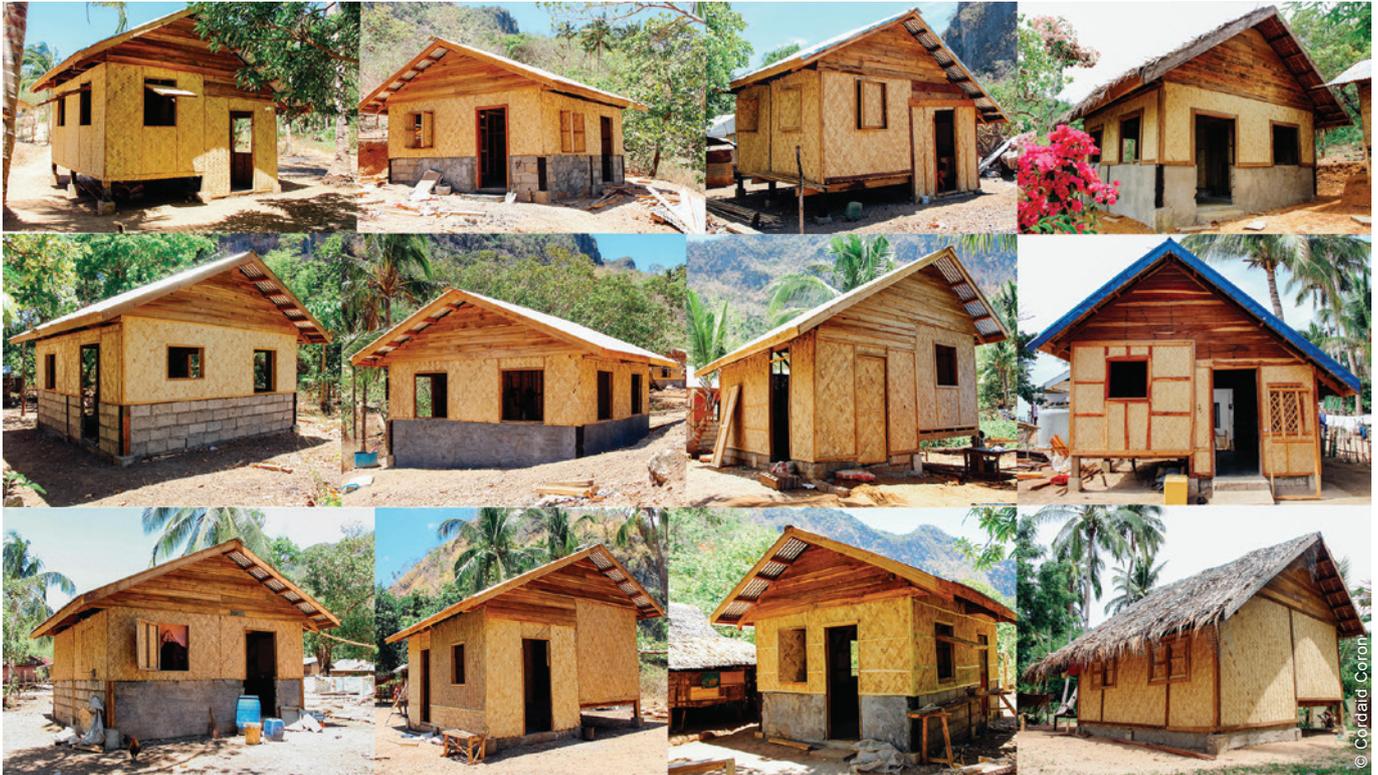
Examples of the houses built through the programme. Each household was free to adopt a different design, and manage the construction directly.

² Some of the contextually new features introduced to local communities included bolts on major connections (e.g. columns to trusses), bracing and cross bracing in the walls and roof, minimum numbers of nails for each connection, poured concrete pad foundations (as opposed to the less durable timber post foundation used locally), connecting the timber column dry footing to the foundations to withstand wind uplift forces, nailed blocking to fasten purlins to joists, and timber treatment for termite protection.
