CASE STUDY

# SOUTH SUDAN 2018 / CONFLICT (IDP)

**KEYWORDS:** Site planning, Site rehabilitation, Shelter construction, Coordination, Community engagement

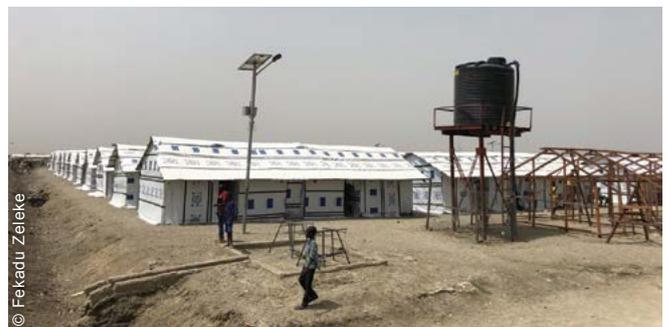
The project rehabilitated a sector of the Malakal PoC through a phased approach.

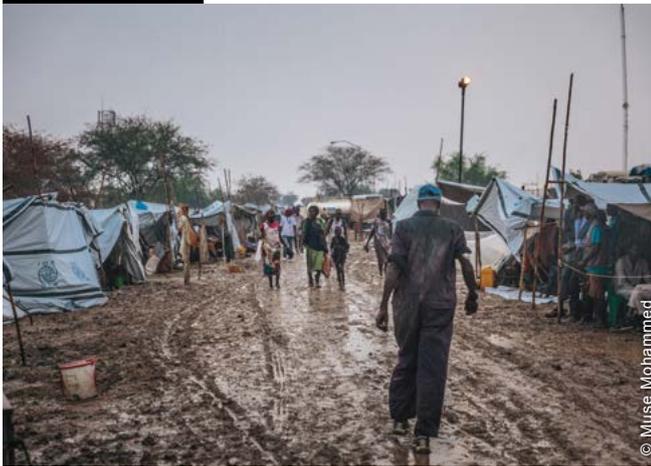
The conditions in the Malakal PoC were particularly grim, especially after the new population influxes in 2017 and during the rainy season.

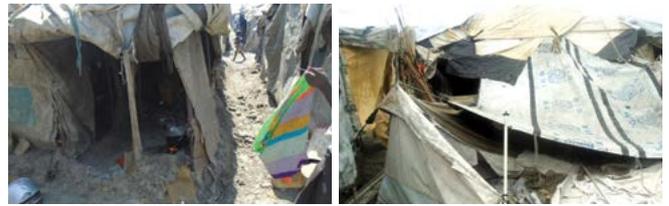
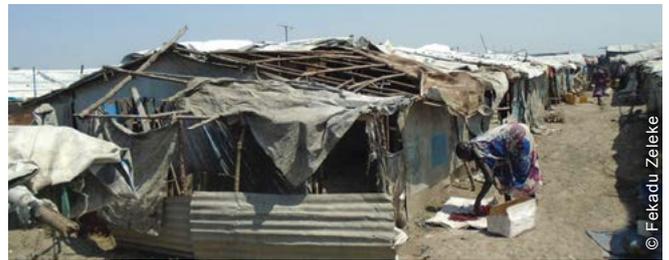
Before rehabilitation, the site offered very poor shelter conditions and was overcrowded, with related fire and safety risks for its residents.

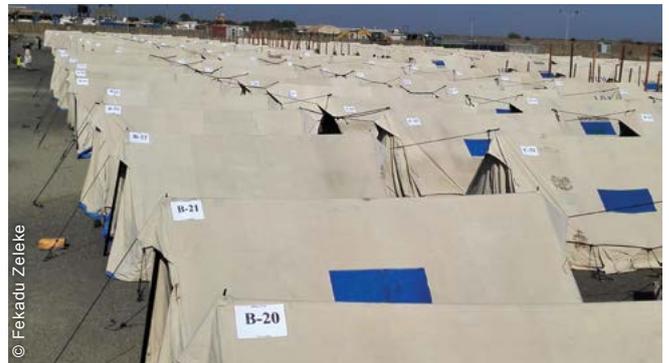
A transit site was established next to sector 4 and used to gradually move people and clear areas of the old site. Due to its small size, the speed of the relocation and rehabilitation process was slow.

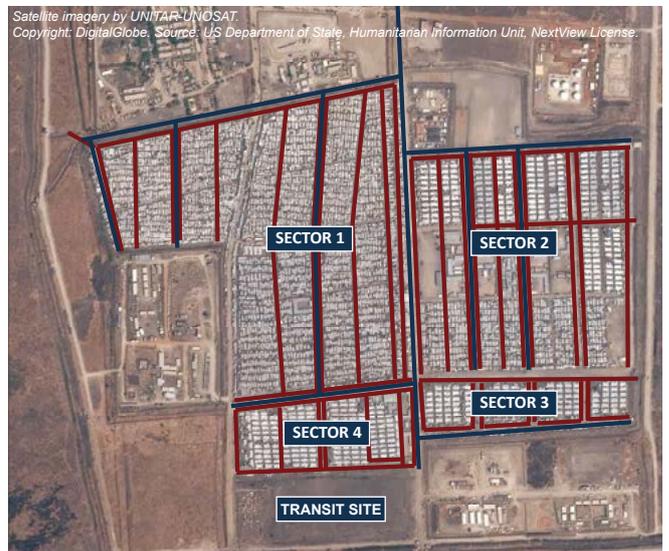
Map showing the drainages (in dark red) and roads (in dark blue) rehabilitated as part of the site upgrade. This case study focuses on sector 4 of the site.

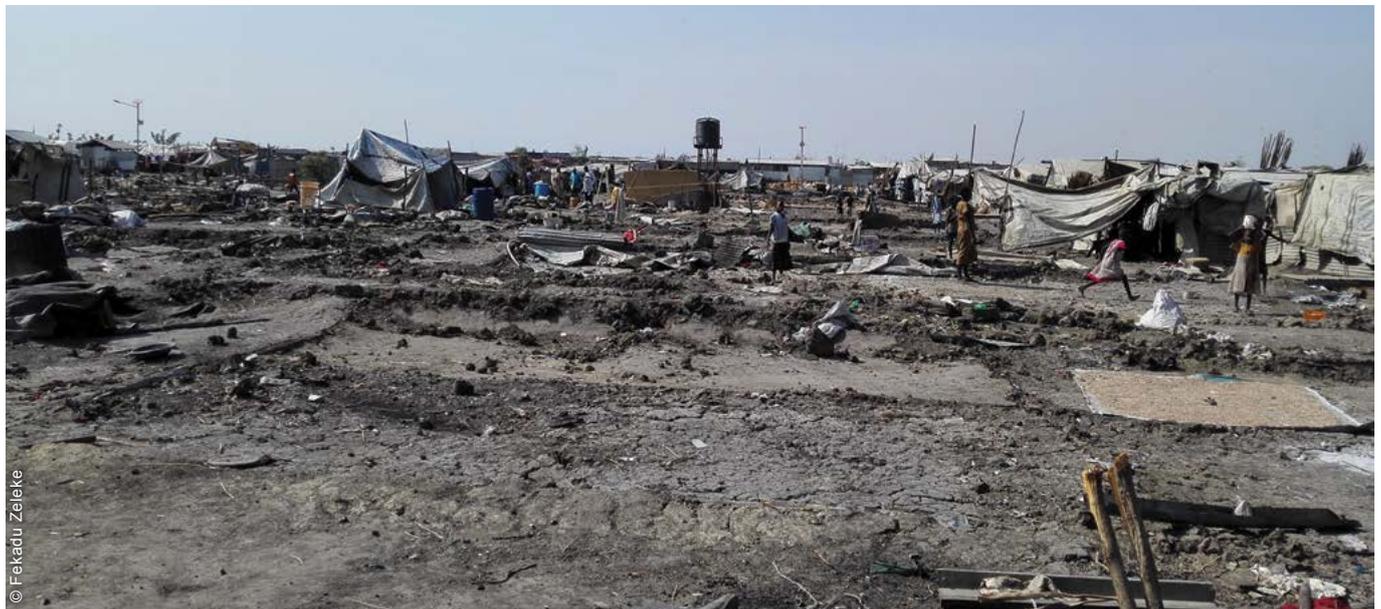
After residents of a block had moved to the transit site, old shelters were dismantled and the area cleared.

In blocks where people had already moved, old shelters were dismantled and the site cleared, mainly through community mobilization. Organization B conducted the initial earthworks, including grading and levelling, decommissioned the old drainage and excavated the new channels and roads according to the site plan. Soil was sourced from a nearby quarry and transported on site for backfilling, grading and compacting of the ground for the blocks. Finally, tertiary drainage around shelter blocks was excavated.

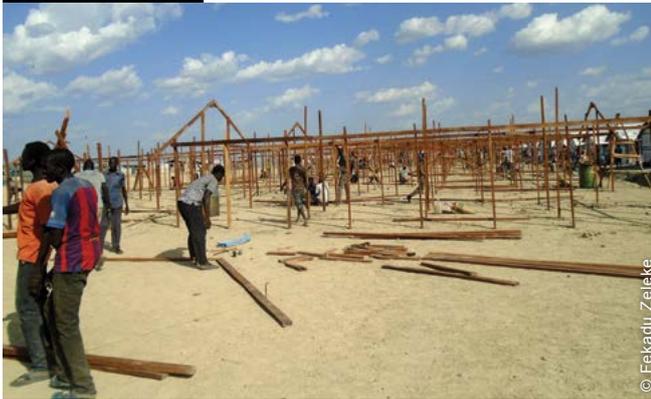
*New shelters were built by local community members after ground levelling.*

New shelters in each rehabilitated blocks were built involving site residents. Local carpenters were trained on shelter construction and maintenance, and were responsible for plot demarcation and sizing of materials to ensure speed and efficiency. Fifty-four community members were trained in demarcation, set-out, shelter construction and maintenance. These then trained their assistants on-the-job. Shelters were built through cash for work in blocks of four to six units, aiming to maximize available space for infrastructure and services.

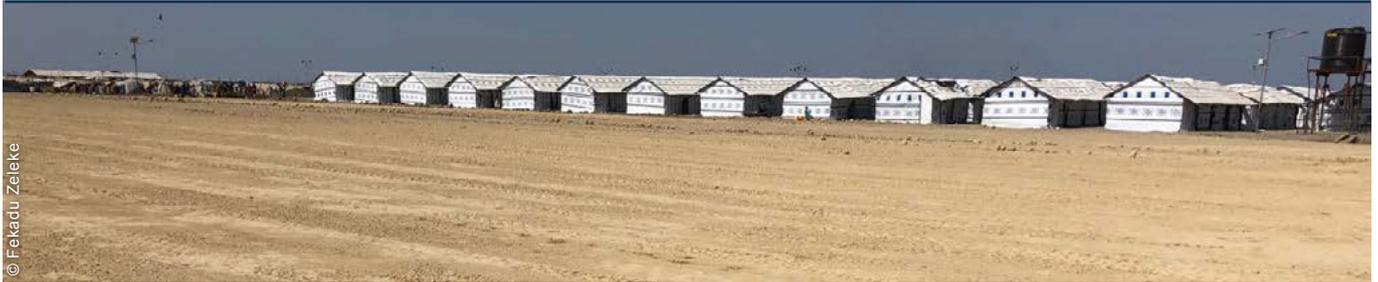
Priority activities in the rehabilitation included backfilling, ground levelling, reconstruction of drainage and rehabilitation of secondary roads, as well as reorganization of the space to improve access to services.

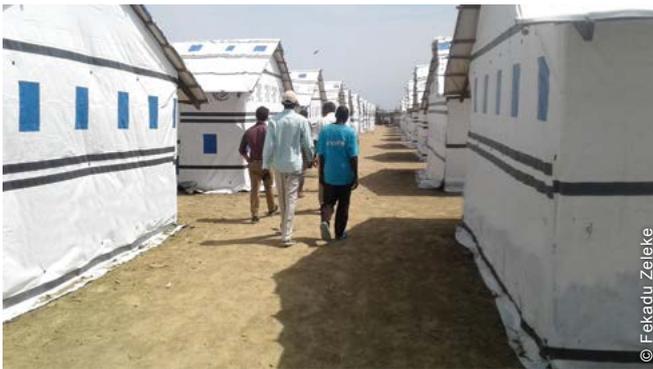
The new shelters were taller and larger to provide better ventilation and privacy.

The objectives of the new shelter design were to increase the minimum covered living space, improve privacy and dignity for users and provide a more robust and durable solution, compared to the existing communal shelters. New shelters were taller than the old ones, to enable better ventilation and had roof overhangs to provide shading for outdoor activities.
