CASE STUDY

NEPAL 2017–2018 / FLOODS

KEYWORDS: Emergency shelter, Local construction techniques, Training, Links to recovery

CRISIS	Floods, 11 August 2017

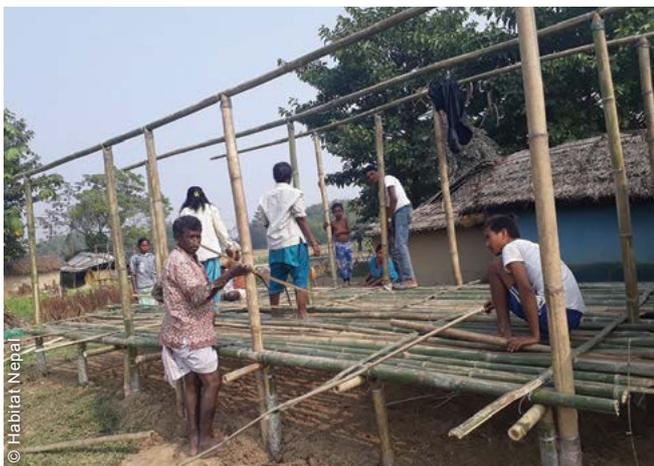
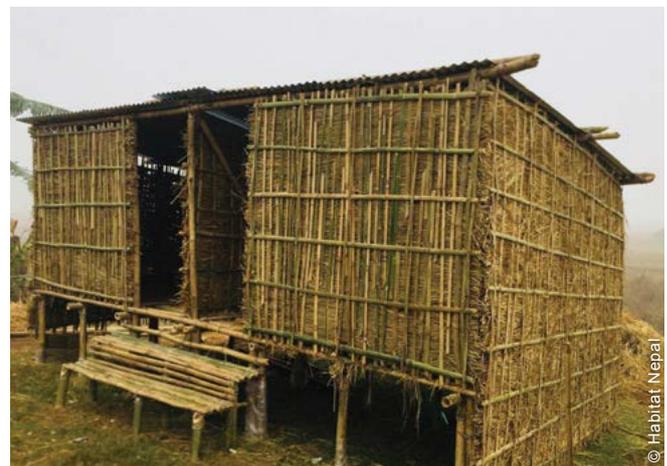
The project provided emergency shelters for flood-affected populations using local materials, and was implemented by local organizations who trained community members on bamboo construction techniques.

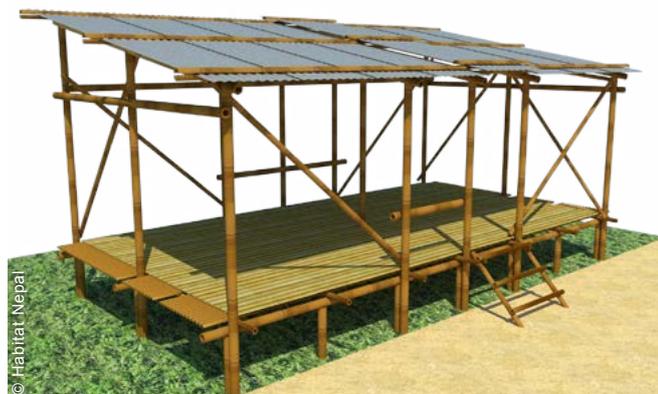
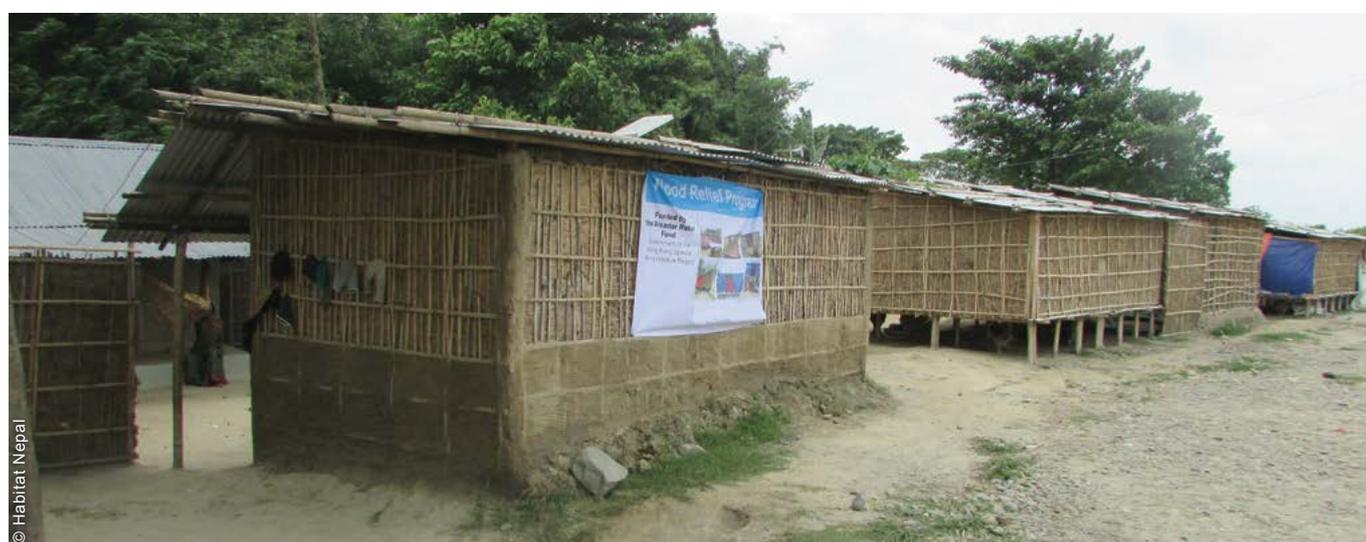
Shelters included mitigation features, such as raised floors, bracing and secure connections, and allowed for some adaptations, such as the upgrade of floors and walls.

The main frame of the shelter was made of untreated bamboo. Treatment was not used due to the temporary nature of the shelters and the decision to prioritize the scale and timeliness of the response. The walls were made of tarpaulins that could be later replaced, while the roofing was made of corrugated galvanized iron (CGI) sheets.

- **The posts were wrapped** in plastic sheets for the portion underground, to protect them from damp and water and increase the shelter lifespan.
- **Bamboo was used to tie down the roofing sheets** with lashing connections and not nailed down onto the rafters; this way, the CGI sheets were not perforated and could be reused to build permanent houses in the future.

- **The central CGI sheets were raised** by an extra layer of purlins to allow the heat to escape from the gap created at the top. The high ceiling was also aimed at providing better ventilation.

- **Bamboo bracings** were used to strengthen the frame by making it a single structural unit.
- **Connections** were done with lashings.
- **Anchorage** was used to increase stability.

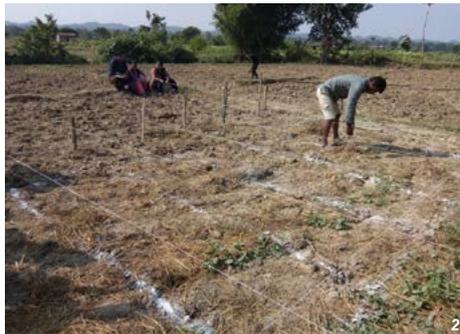
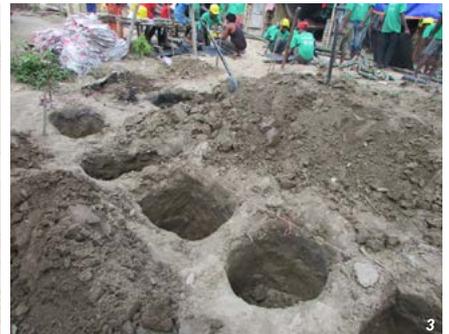
Left (1): Draw lines for foundation according to the dimensions and place the stakes in the ground. Check whether the stakes are at right angle using the 3-4-5 method. Centre and Right (2-3): Dig 21 post holes of 2' x 2' in the ground. (Photo credits: Habitat Nepal).

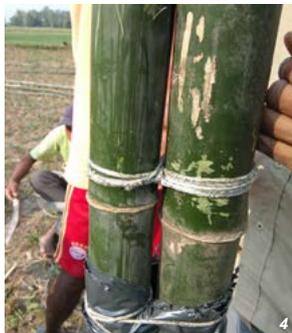
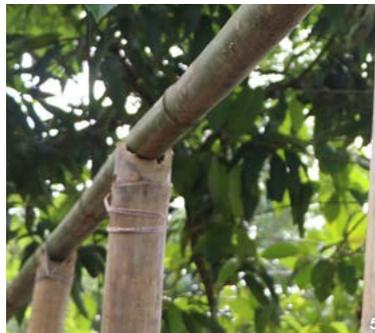
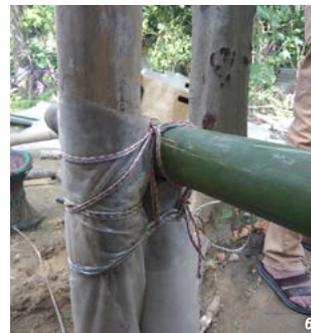
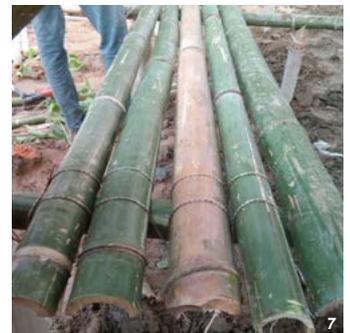
Left (4-5): Cut the required length of floor and roof posts with saw, tie them together and wrap them with polythene sheet. Cut the upper ends of the posts with a fish-mouth cut. Right (6-7): Place and tie floor beams to the bamboo floor post with rope. Place the next set of beams on top, perpendicular to the beam below. Place split bamboo joists above the floor beams. (Photo credits: Habitat Nepal).

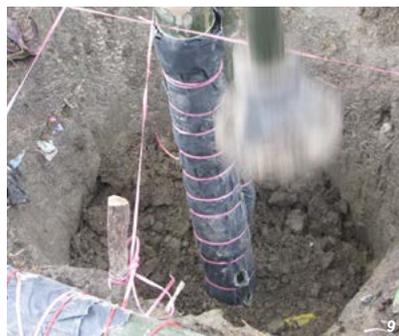
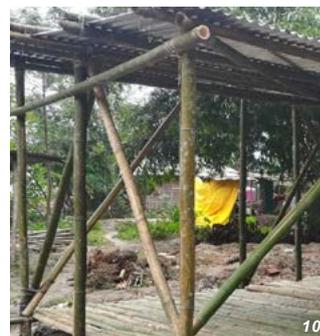
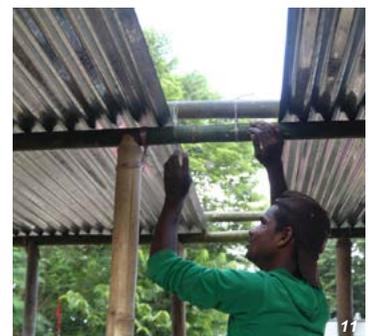
Left (8-9): Tie bamboo posts to the anchorage and place it inside the post hole. Then fill the hole with debris and tamp using wooden tamper. Right (10): Tie diagonal bracings of required dimensions to the roof post. Then tie the horizontal bracing at lintel level. Place the roof beams on top of the bamboo post and tie with rope. Place the cross bracings at roof level and then tie to the beams with rope. Right (11): Place bamboo purlins on top of the roof beam and tie with rope. Arrange 8 CGI sheets over them leaving one sheet width vacant in the middle. Tie 2 layers of purlins together to hold the CGI sheets in place. Place the remaining CGI sheet over the void and place 3' length purlins on top of each purlins below to hold the sheet down. This provides air movement inside the shelter through the roof. (Photo credits: Habitat Nepal).

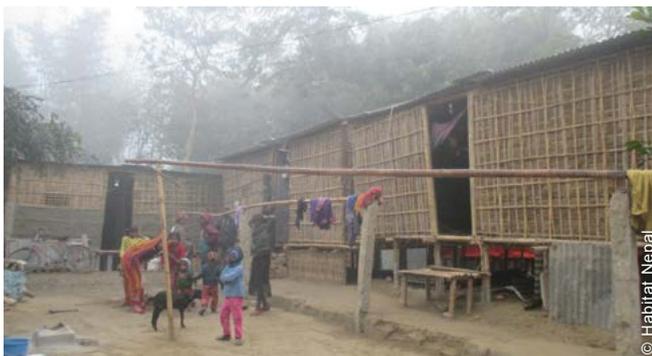
Materials and designs were culturally appropriate and designed in consultation with the affected households. After the project ended, families were already upgrading the shelters and it was expected that these could last for up to two more years, if properly maintained.

The minimum lifespan for the shelters was estimated at six months, but it could be prolonged with regular maintenance, repairs and protection measures from the elements. Early observations after the project was finished showed that beneficiaries were already upgrading the original shelters, for example by substituting worn plastic sheeting on walls with bamboo mats and plastering, improving floor finishes and installing more secure windows and doors. This was mainly because bamboo was a locally known material and households and local masons had been involved in the construction process. A year after the completion of the project, families were still living in the shelters and it was expected that the structures could last for at least another year or two. It was also anticipated that, depending on the longer-term solutions for each household, the temporary shelters would continue to be used, either by recycling the materials or giving alternative uses to the shelters.
