CASE STUDY

IRAQ 2016–2017 / CONFLICT

PROJECT SUMMARY

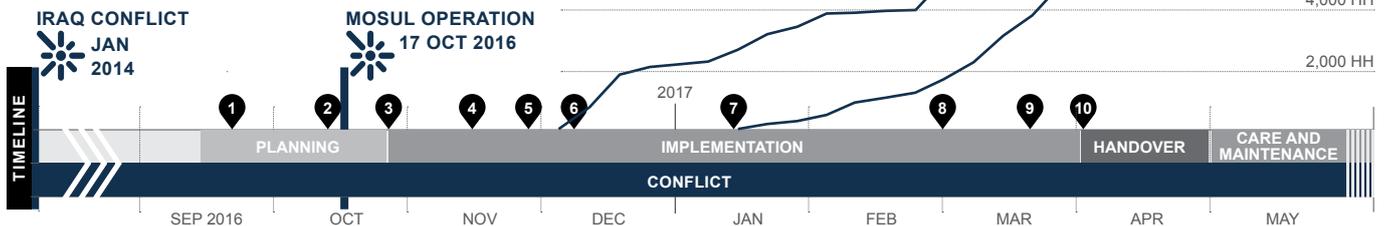
| <ul style="list-style-type: none"> 1 21 Sep 2016: Initial site assessments. 2 15 Oct 2016: Government approval of Qayyarah Airstrip emergency site. 3 27 Oct 2016: Site development and construction start. 4 14 Nov 2016: First 1,200 tents installed at Qayyarah site. 5 End-Nov 2016: Installation of communal facilities and upgrade works begin in phases. | <ul style="list-style-type: none"> 6 6 Dec 2016: First 180 IDP families arrive at Qayyarah site. 7 5–26 Jan 2017 East Mosul offensive leads to another IDP influx in the sites. 8 Feb–Mar 2017: West Mosul offensive triggers new surge. 9 23 Mar 2017: Qayyarah site completed (capacity 10,000 households). 10 1 Apr 2017: Haj Ali emergency site completed (capacity 7,500 households). |

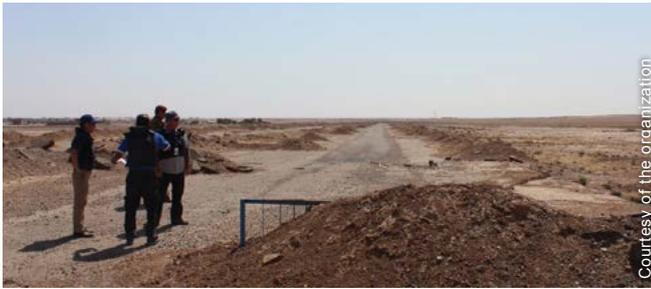
Before mine clearance was completed, sites were only accessible from the perimeter. Planning was done remotely, by observation and thanks to satellite images.

+ **Remote site planning.** In the initial planning stage, the site could not be accessed and so topographic analysis and measurement of site boundaries were done by a mix of observation from the perimeter and analysis of satellite imagery. Plans were then adjusted during the implementation phase. Such remote planning worked well thanks to the high-resolution satellite images acquired from authorized agencies.

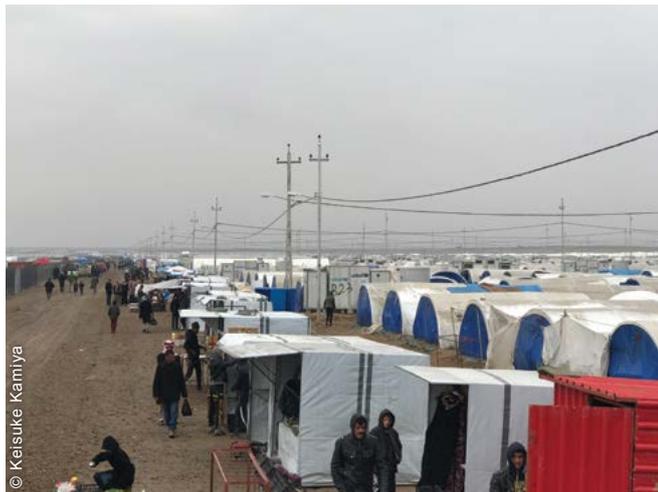
In less than six months, capacity for 17,500 households was established in two sites. The main roads were used for small shops and storage of materials.

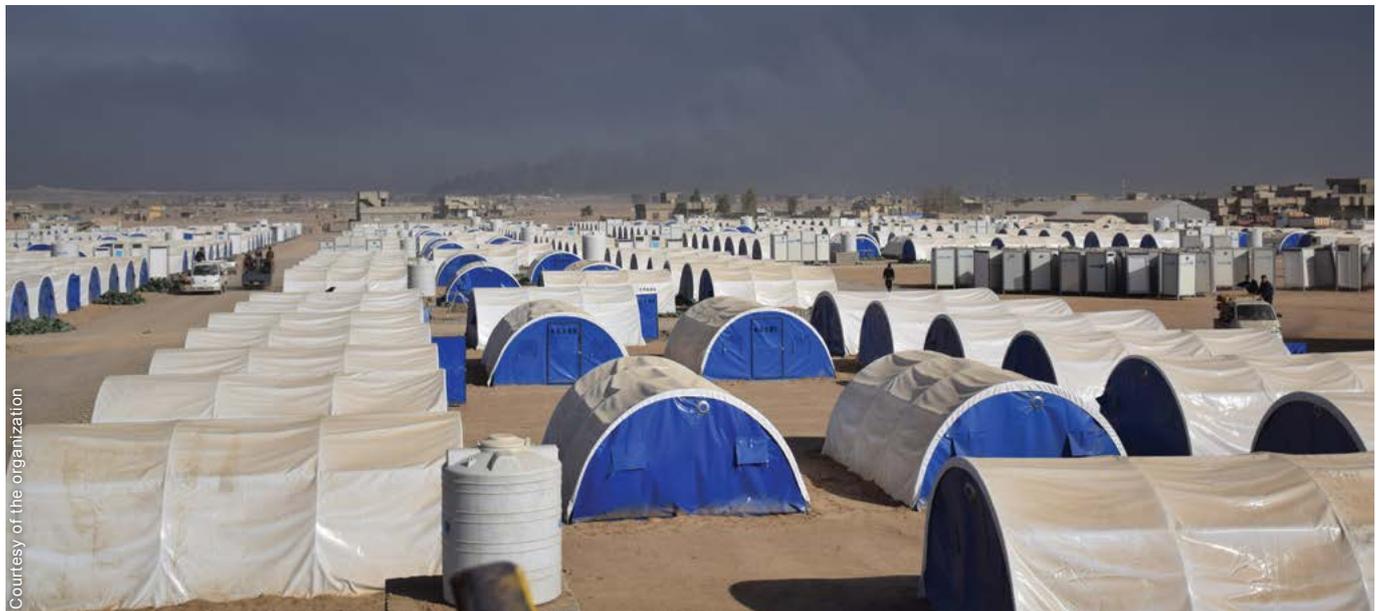
Government standard tents of 6x4m were installed in clustered blocks of 20 each. Space for extensions was minimal but, after families had moved in, upgrades were conducted to the floor and electricity was installed. Partners could then build service facilities in specific blocks pre-allocated in the site plan.

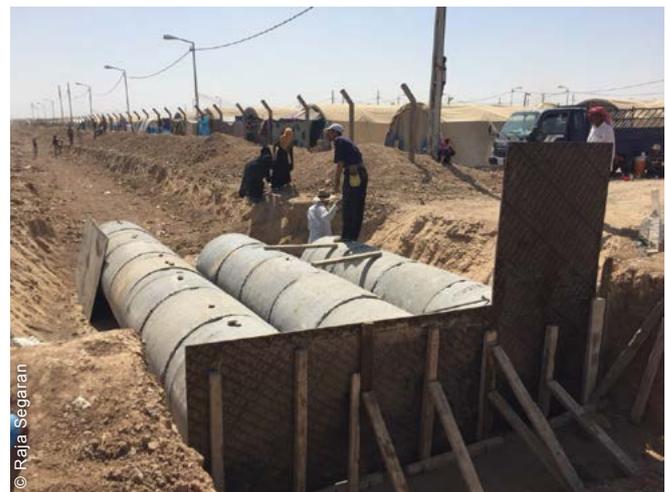
One site was vulnerable to heavy rains and suffered minor flooding during winter. In 2018, storm-water drainage channels and culverts were upgraded.

In 2017, after unprecedented levels of rainfall, low-lying sectors of the sites were flooded mainly because of the surcharge of water from an adjacent site and poorly constructed culverts in surrounding residential neighbourhoods.

Storm-water drainage was later expanded in early 2018, after five new sites were built around the main Qayyarah Airstrip site. This consisted in wide earthen channels with protective berms and large concrete culverts.

In late 2018, minor flooding occurred due to the blocking of culverts by informal settlements outside the site.

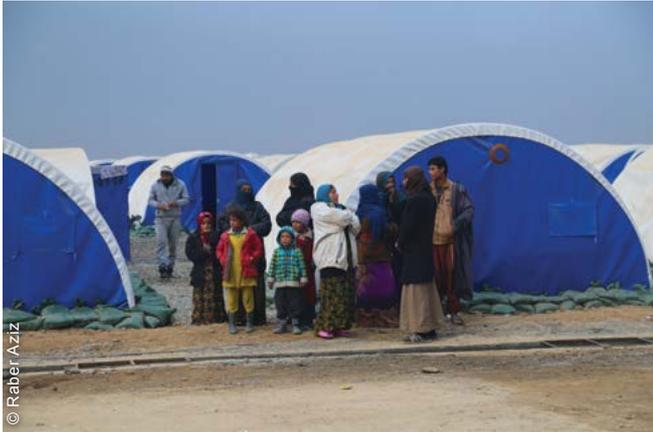
Using a rapid settlement approach, families were accommodated before all facilities and infrastructure were installed. Gravel was added in the shelter areas and roads excavated 20cm lower than the blocks, to prevent flooding.

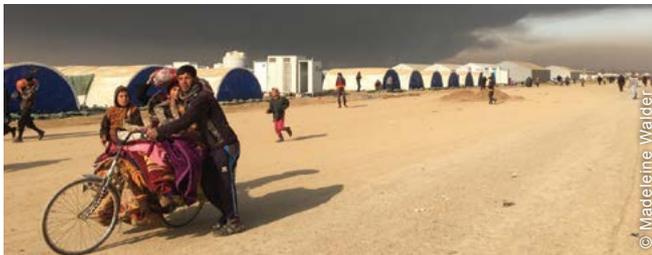
105,000 IDPs fleeing Mosul found shelter in the two sites. About two years later, the majority of the site residents did not intend to return to their homes yet.
