SHELTER PROJECTS

2017-2018

CASE STUDIES OF HUMANITARIAN SHELTER AND SETTLEMENT RESPONSES

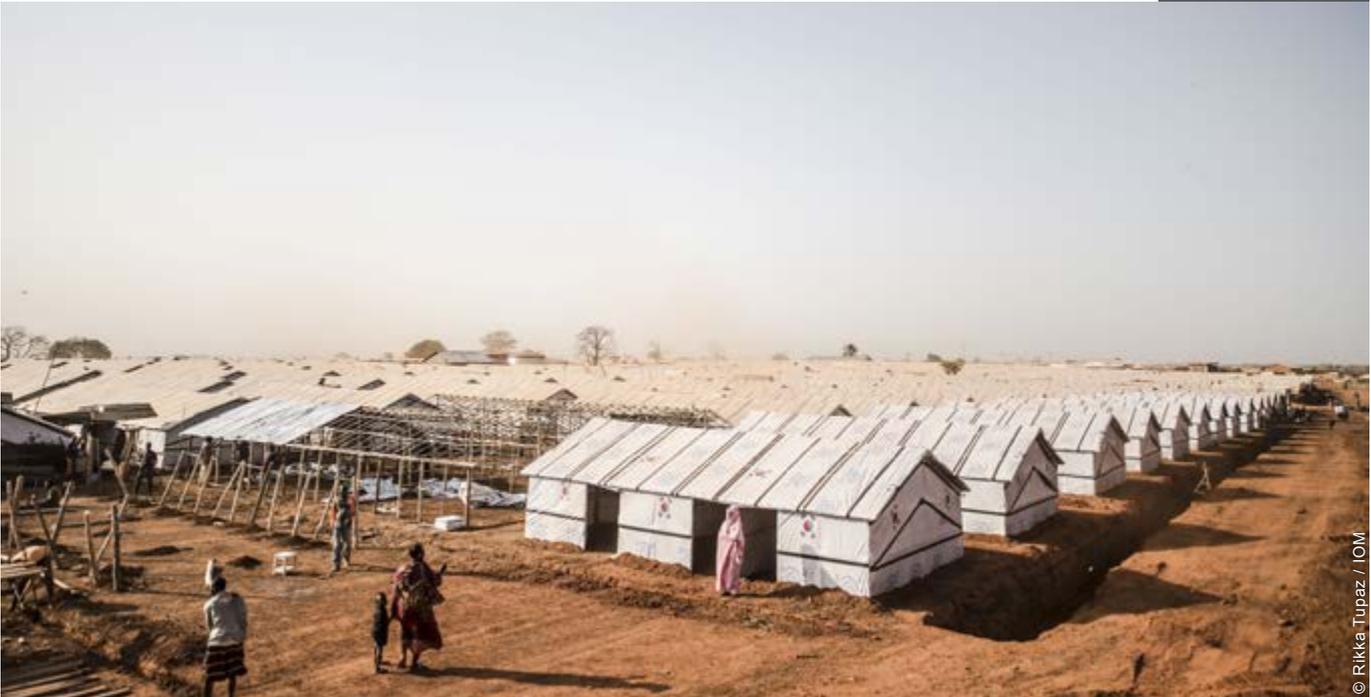
Ongoing shelter construction in Wau, South Sudan. This site hosts internally displaced people fleeing conflict that started in late 2013. Shelter interventions in South Sudan mainly target sites of protracted displacement and, to a lesser extent, return areas.

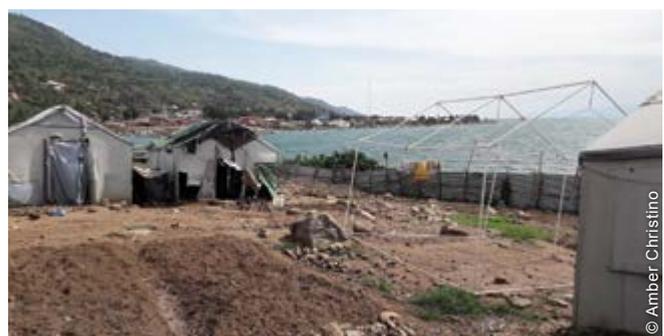
The tents provided in the camps were intended to last about six months, but families lived there for two years, in battered tents like these at Cashi camp.

The shelter kits initially provided were intended to last approximately six months, though families lived there for more than two years. Living conditions rapidly deteriorated; tents were in dire need of repair; rain poured in from holes in the roofs, creating a muddy sleeping area and leading to increased incidence of pneumonia and other illnesses. In January 2018, the camps of Mushasha I and II were partially destroyed by floods. Many inhabitants expressed their desire to leave and requested assistance for a more durable shelter solution.

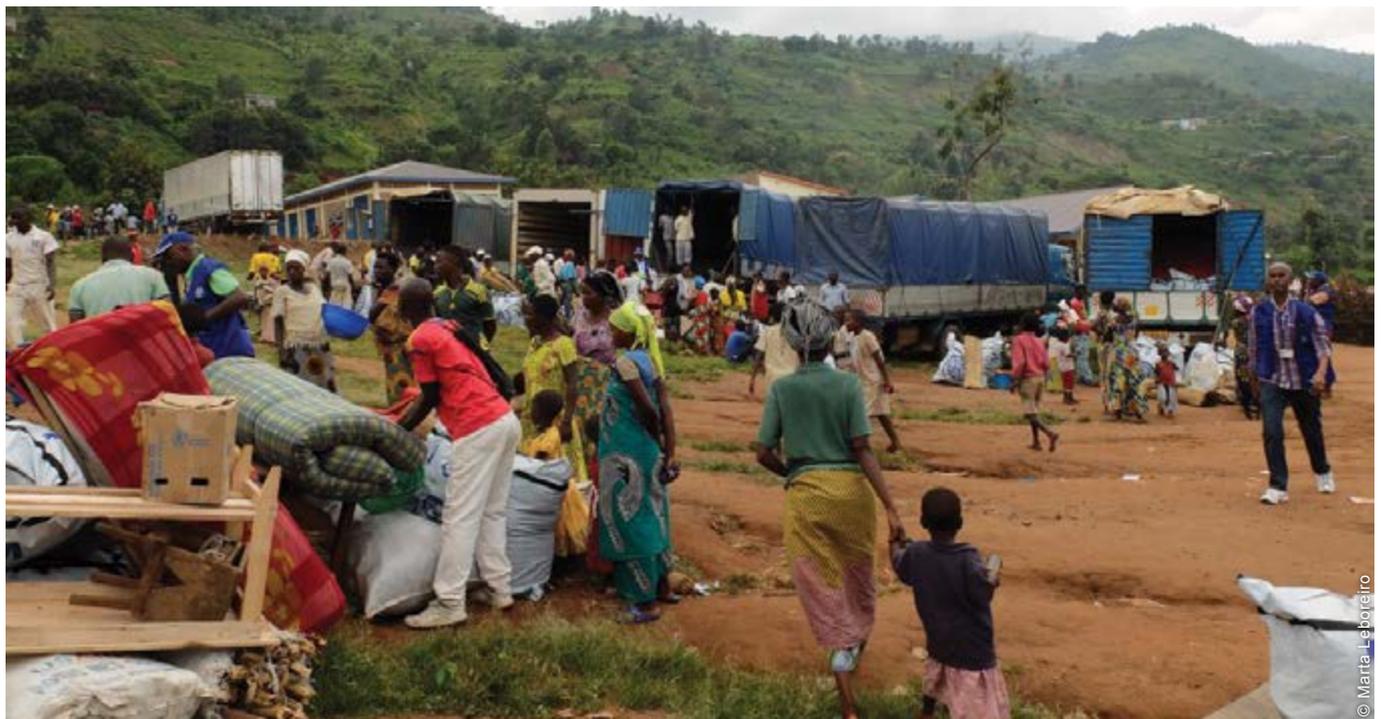
To facilitate the decommissioning process, the organization provided transport assistance and a cash-for-work grant for the dismantling and cleaning of tents and family plots in the camps.

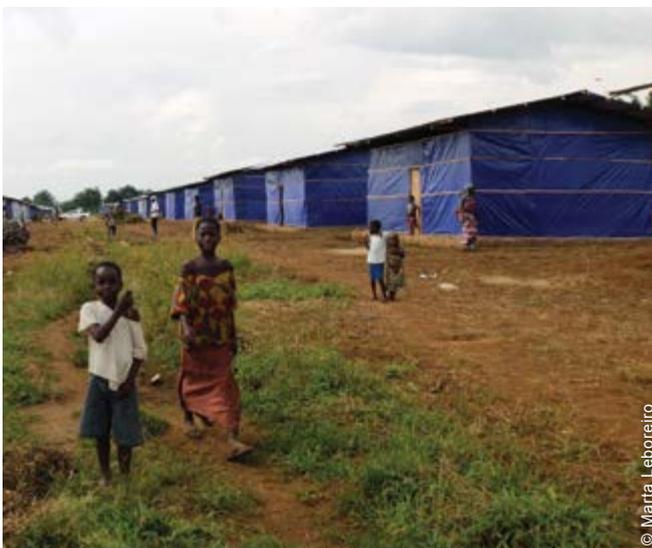
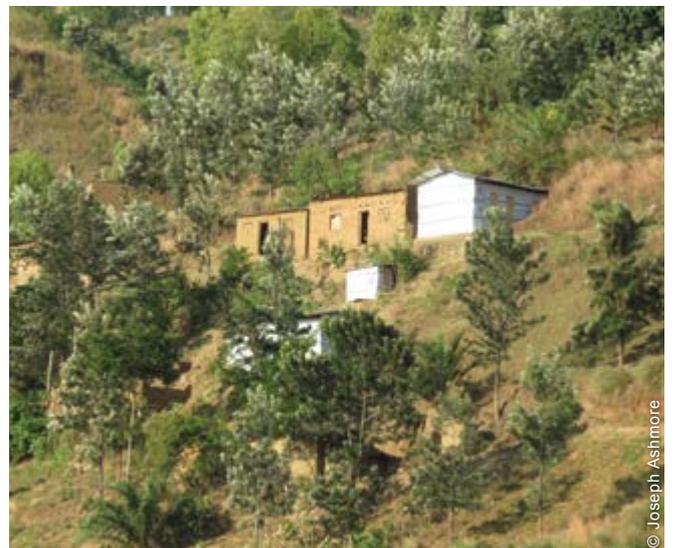
The project supported return by providing shelters on a resettlement site on government-issued land in Kigwena (above left). When land tenure and safety allowed it, shelters were built in the area of origin of the IDPs (above right, in the hills of Rumonge).

A. SEMI-PERMANENT SHELTERS IN RESETTLEMENT SITE. Those in Cashi and Gitaza who did not own land were relocated to the government-issued land of Kigwena, where 174 improved semi-permanent shelters were built. These included latrines and kitchens (including 40 for the most vulnerable among the host community). Due to budget restrictions, the shelters were built using corrugated iron sheets on the roof and temporary walls made of tarpaulins. The host community actively participated in the construction, supported through a cash-for-work programme.

B. SEMI-PERMANENT SHELTER IN AREA OF ORIGIN. 159 semi-permanent shelters were built in the areas of origin of the population living in Cashi and Gitaza camps, across seven different hilly locations. Due to timing and the complexity of transport to the isolated hills, some of which are located three hours away from a major road, the stone foundation was removed and households received cash to transport the materials (the equivalent of USD 2.50 per trip from the camp to the new land). Each household built its own latrine with materials provided and a cash grant for digging.

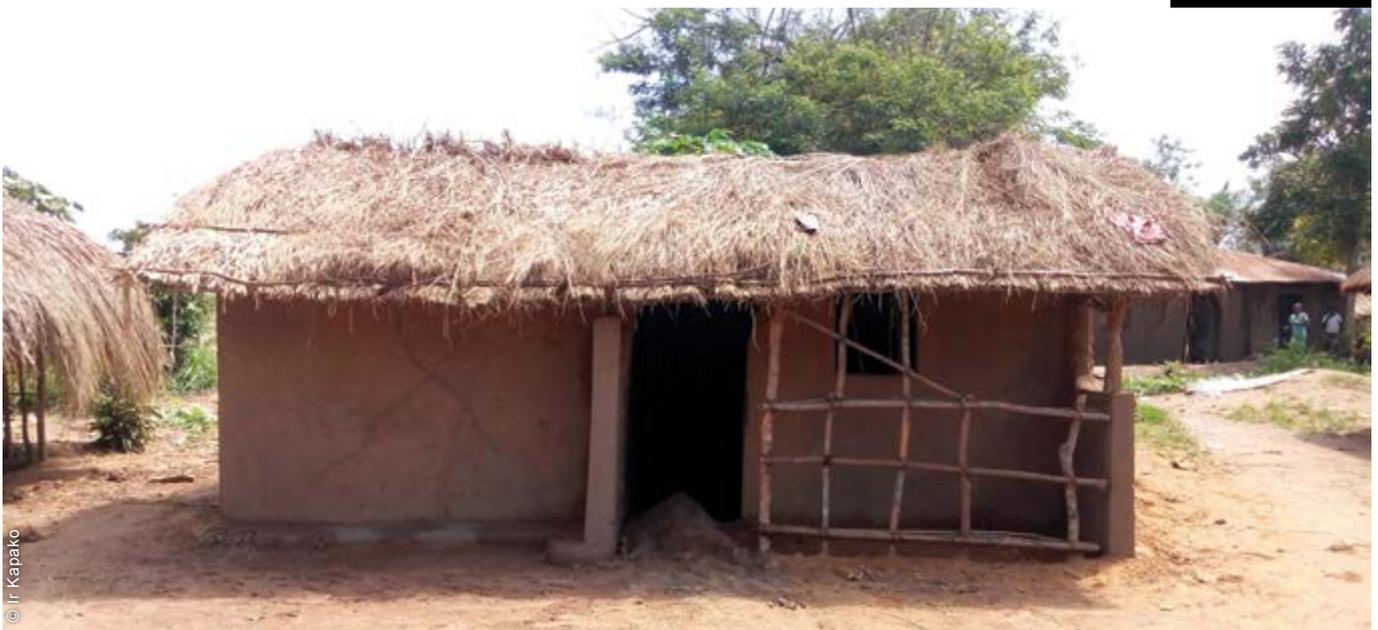
Shelters were cost-effective, as materials were locally available and labour was provided by the affected families themselves.

The shelter was designed based on local construction techniques and available materials, mainly a wattle and daub or mud-brick structure with thatched roof. On one hand, this allowed a smoother implementation, as target households had access to the local markets where the organization did not, and ensured that the cash was injected into the local economy. On the other, it also helped mitigate the risk of tensions with surrounding host communities, as the housing typology and size was very similar to the existing conditions in the area. The simple layout included a shaded veranda for cooking and storage, connected to a living area, and an additional sleeping space only accessible from the living room.

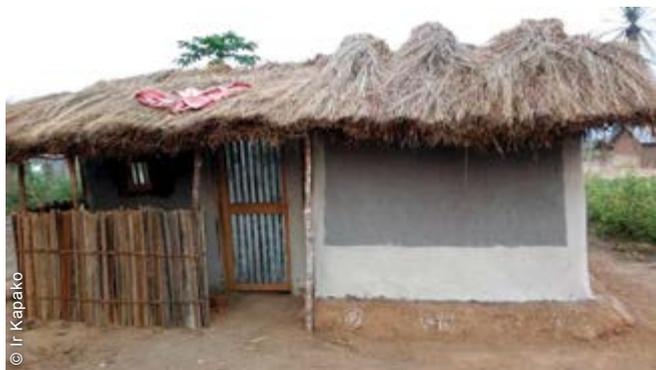
Communities actively participated in the design process. Thanks to their inputs, the shelters were expanded and a shaded veranda was added.

The addition of a covered veranda to the design had the advantage of reducing indoor cooking practices, which reduced health and fire hazards. More households in the area also started to apply the veranda to their shelters.

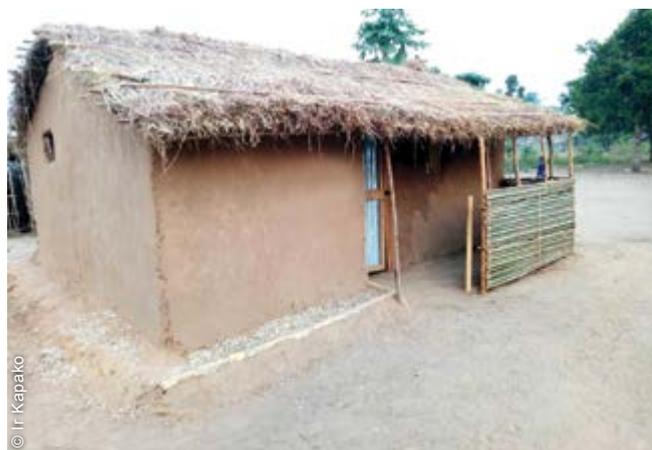
Other members in the communities were observed replicating some of the features and techniques proposed in this project, such as the outdoor veranda for cooking.

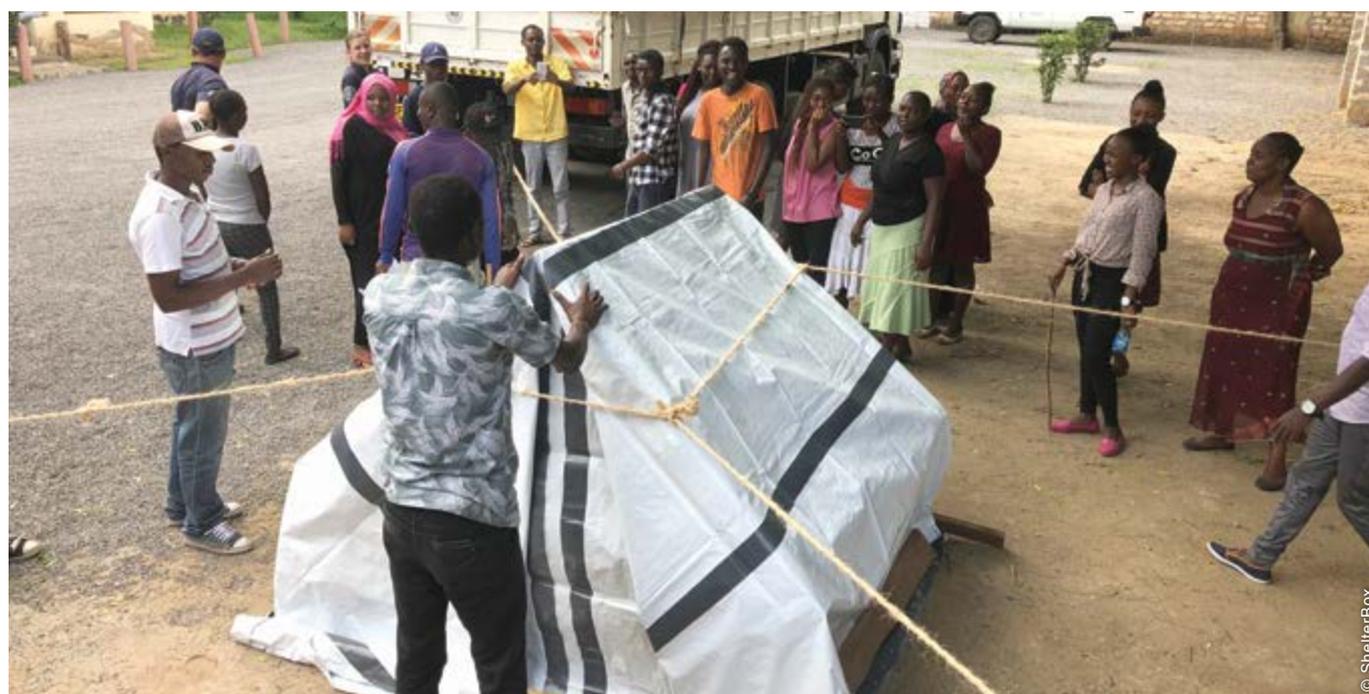
Most households confirmed that the training was useful and nearly half were observed using the appropriate techniques in their shelters. However, some families could not use the kits properly due to a lack of framing materials.

- **The failure to provide framing materials restricted the use of the shelter kits** in areas where timber was not available at local markets, or household finances did not allow additional purchase. This led to concerns that the response would exacerbate unsustainable deforestation.

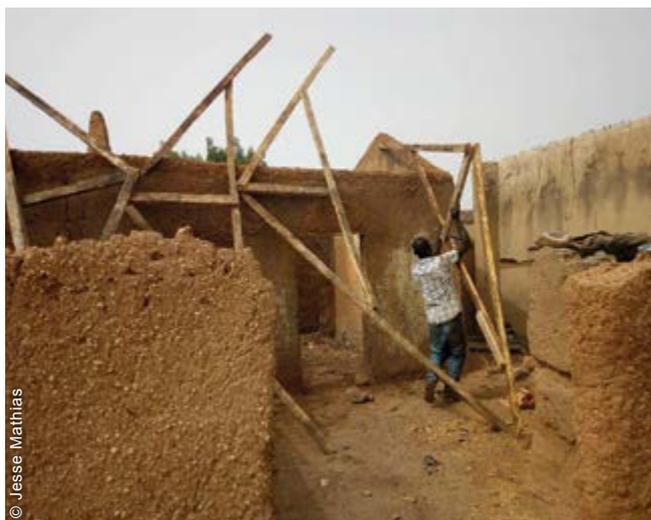
The project rehabilitated damaged houses in return areas by providing materials and technical assistance.

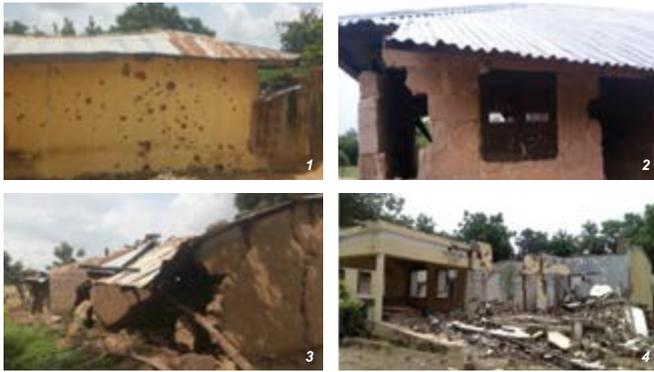
Damage was categorized in four groups. 1) Bullet holes on the external walls but not penetrated inside; hairline cracks in very few walls; fall of small pieces of plaster only. 2) Doors and/or windows need to be replaced, damage to brickwork 10%. 3) Failure of structural elements, damage to walls 25%. 4) Completely damaged with bullet holes, serious failure of walls; partial structure failure of roof and floor.

The selection of beneficiaries in the LGAs was conducted in accordance to the level of damage to the houses (with categories 1–4, from light to heavy damage). Female-headed households, the elderly, persons with disabilities and mental illness were prioritized. The criteria for selection were communicated to the community.

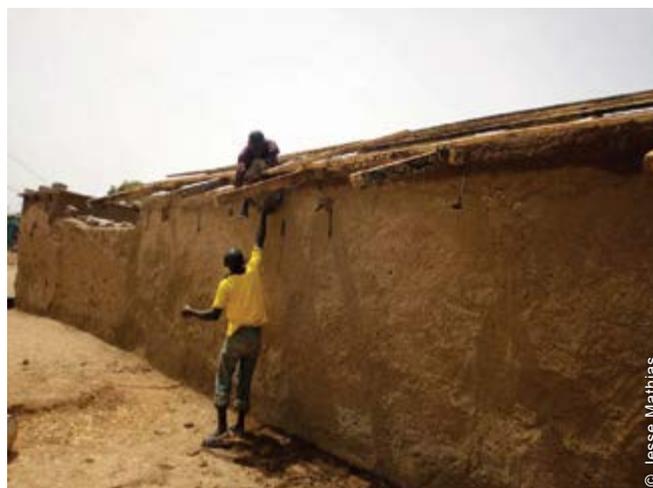
Families were able to repair their entire house, in some cases even expanding the original size. This also supported family reunification.

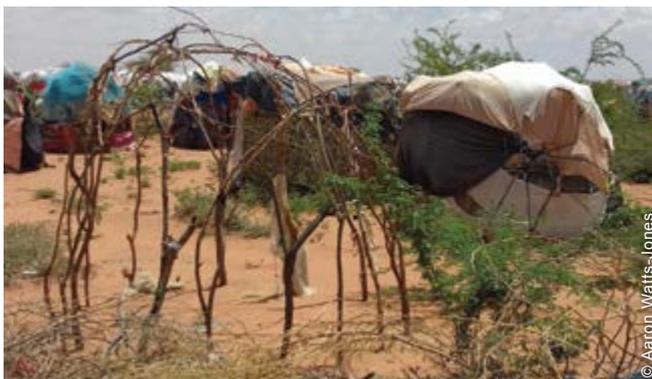
Tarpaulins were well received as they were versatile and could be used for a variety of purposes. However, the tools and pegs provided were barely used, as these were not considered appropriate nor were familiar to the displaced populations. Subsequent projects replaced the tools with rope.

- The least useful items were found to be pegs (2%). Most of the beneficiaries stated that they did not use these at all.
- Fifty-eight per cent of respondents said that the toolkit facilitated construction and repair work. Out of the 42 per cent who reported it did not, some stated that they did not know what to use it for and did not have the necessary skills to use the tools. This suggested that the toolkit may not have been entirely culturally appropriate.

- **Not all of the aid was culturally appropriate** and, at times, was superfluous (e.g. handsaw and pegs), thereby reducing the effectiveness of the project. Better, coordinated shelter assessments would have ensured a more defined kit content. The PDM helped adapting it in subsequent project, where the toolkit was replaced by rope.

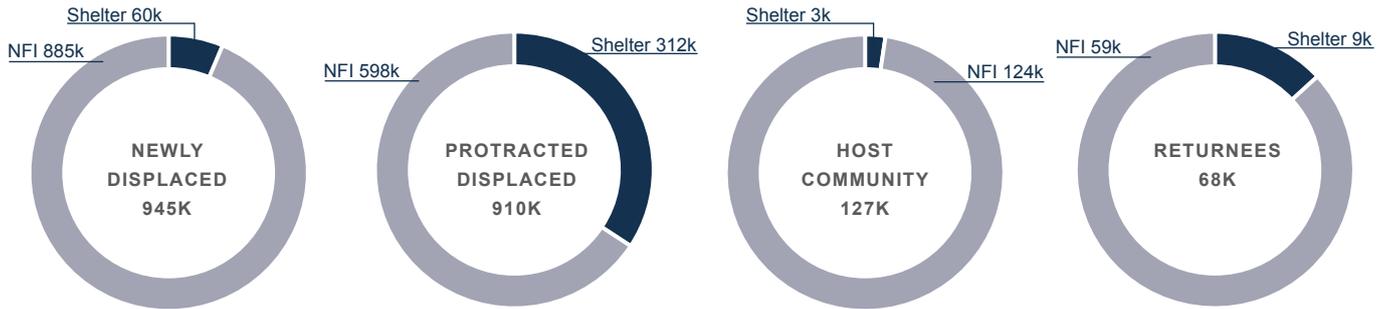
SHELTER-NFI DELIVERY BASED ON POPULATION TYPE (2017–2018)

The chart shows that the majority of interventions are distributions of NFIs, across population types and locations. Shelter assistance is provided mainly for people in protracted displacement. Figures represent individual beneficiaries reached (source: South Sudan Shelter-NFI Cluster Dashboard).

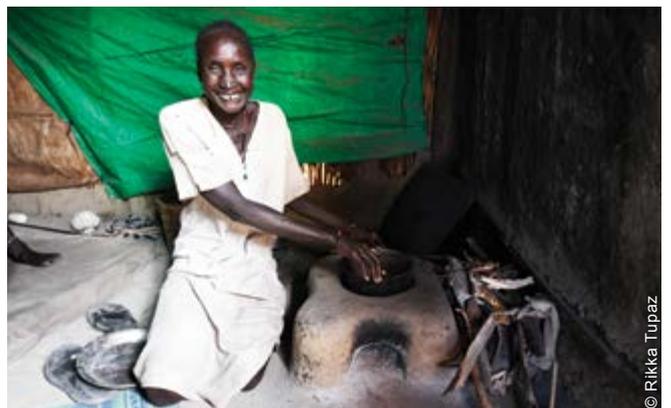
The project promoted local ownership by providing women with training to construct fuel-efficient stoves with local materials, which were accessed through a voucher system.

STOVE DESIGN AND SELECTION. The organization identified a stove model based on the results of the research study on fuel-efficient stoves and with careful consideration to local cooking practices and community preferences. The stove was built from locally available materials (mud and cow dung) and had a user-friendly design developed by the affected population themselves. It also reduced firewood consumption and improved users’ health through reducing smoke. A total of seven stoves, including the selected community-made design, together with imported and other local rudimentary stoves, were tested with a minimum of 15 families. The models were rotated

SKILLS TRAINING. The organization trained ten construction assistants in each block within the site, who themselves then trained 1,280 participants (98% women). The training of trainers lasted for one day and participants were compensated with a grant of SSP 150 (USD 1.1) upon successful completion. After this training, the construction assistants were able to provide support, repair or even build the stove. This represented a potential source of livelihood for the future.

PROCUREMENT AND VOUCHER DISTRIBUTION. The construction of the stove required 5kg of mud and 5kg of cow dung. Beneficiaries were responsible for the procurement of mud that could be found near the site. The community leadership selected local traders outside of the site to procure, transport and distribute the cow dung. The delivery of materials to beneficiaries was organized through a voucher scheme consisting of the following steps:

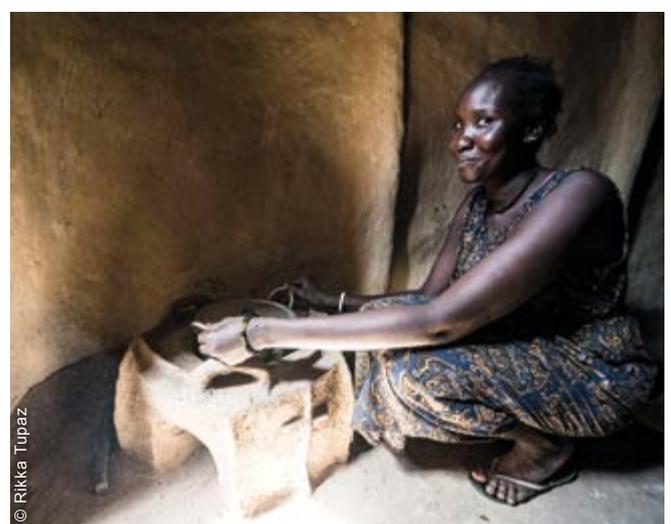
The project replaced inefficient three-stone stoves used in the camp (left) with fuel-efficient stoves made with local materials (right) through an people-driven process.

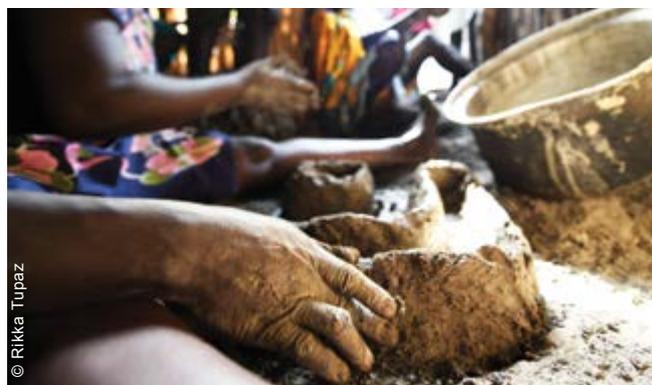
Stoves were made of local materials and according to traditional cooking practices. Women participated in the design of the stoves and were trained on how to construct them.

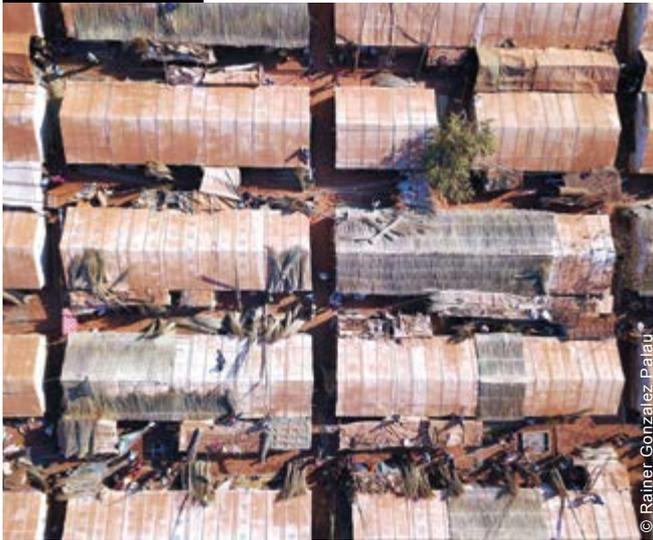
One of the upgrades consisted of adding a layer of dry elephant grass to rooftops to increase protection from the elements, improve ventilation and lower inside temperatures.

The upgrades consisted of adding a layer of dry elephant grass – found naturally in surrounding areas – to rooftops to increase protection from the elements, improve ventilation and lower inside temperatures. Further, bamboo-thatched walls and doors were installed around the shelter exterior, increasing privacy and further extending the durability of shelters.

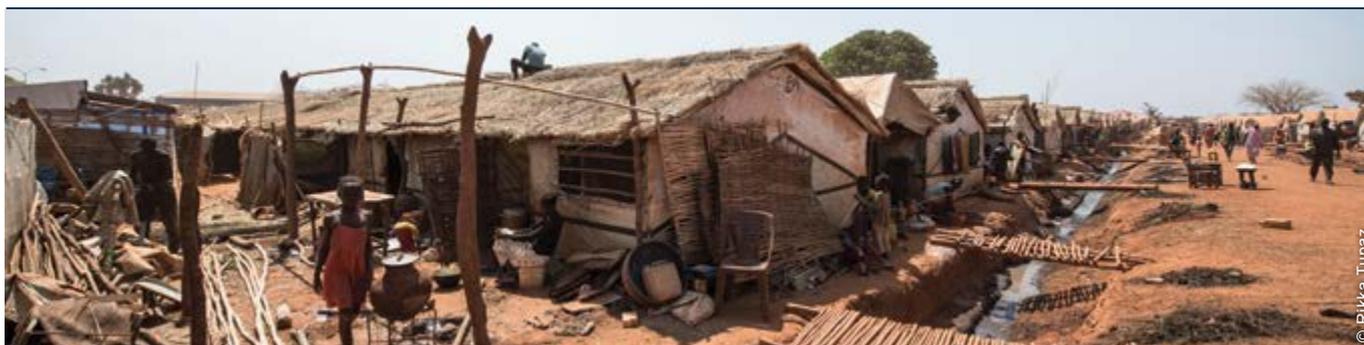
People on the site lived in communal shelters. The project upgraded the walls and roofs to extend their lifespan by protecting the plastic sheets.

Due to the extreme density of the site, IDPs occupied communal shelters hosting five households each, as per the design approved by the Shelter-NFI Cluster. The shelters were covered in plastic sheeting and organized in blocks, further grouped in three zones.

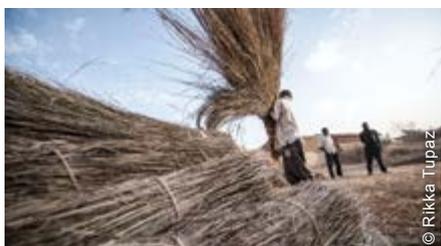
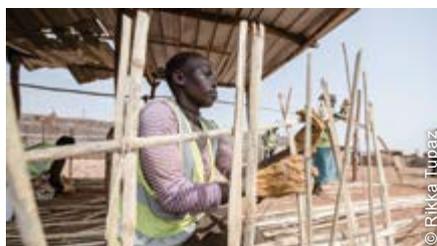
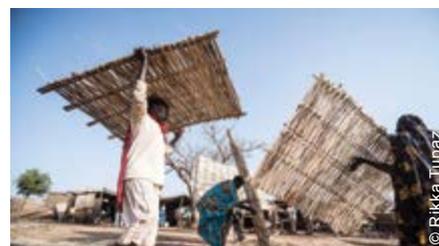
The project engaged local traders and trained beneficiaries on the upgrades, which included the addition of grass to rooftops and bamboo-thatched walls.

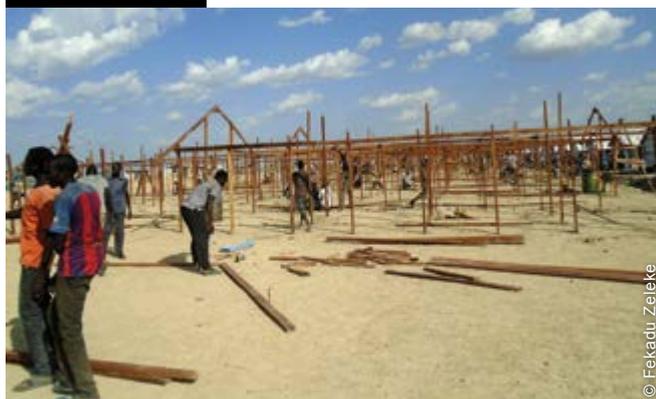
New shelters were built by local community members after ground levelling.

The shelters were made of timber and plastic sheeting for walling and roofing. Almost all materials were sourced outside Malakal, due to the unavailability in the local market and to protect the already dilapidated physical environment from further deterioration.

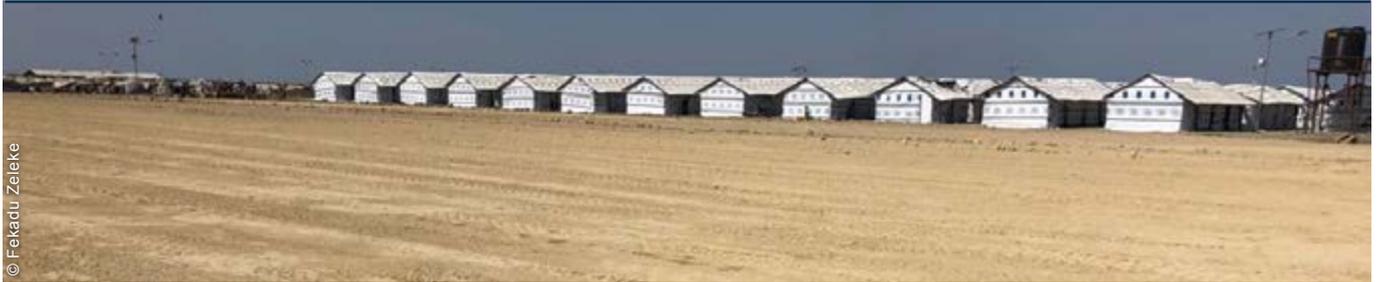
Priority activities in the rehabilitation included backfilling, ground levelling, reconstruction of drainage and rehabilitation of secondary roads, as well as reorganization of the space to improve access to services.

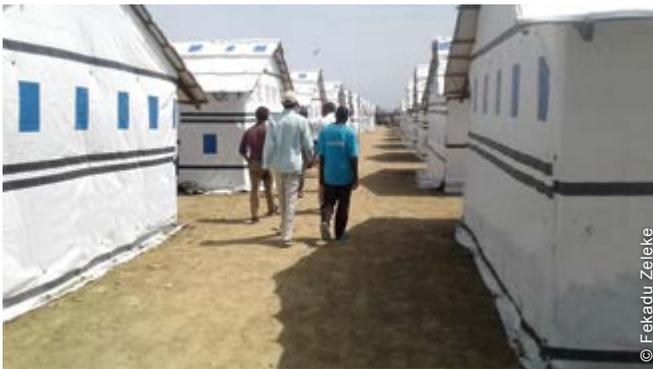
The new shelters were taller and larger to provide better ventilation and privacy.

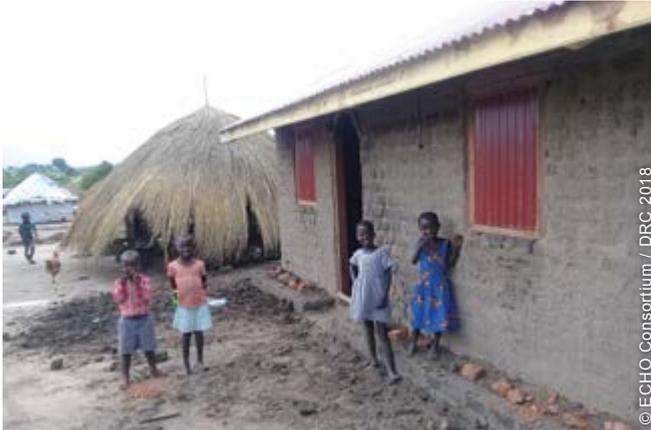
In Rhino the organization built larger, two-room shelters with CGI roofing.

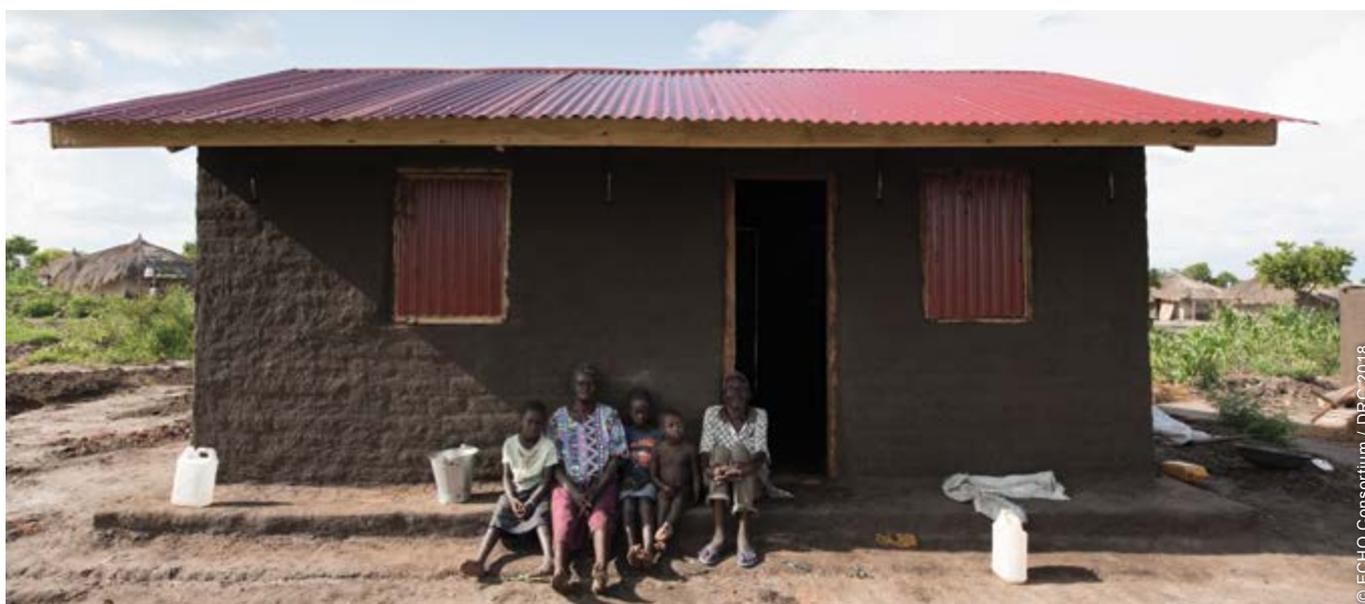
Shelters were built with locally available materials through the engagement of local youth groups who were divided in different teams based on their skills.

The shelter and latrine designs were adjusted depending on the nature of the soil and the water table. Foundations were either made of burnt bricks or reinforced concrete, and walls were made of unburnt bricks.

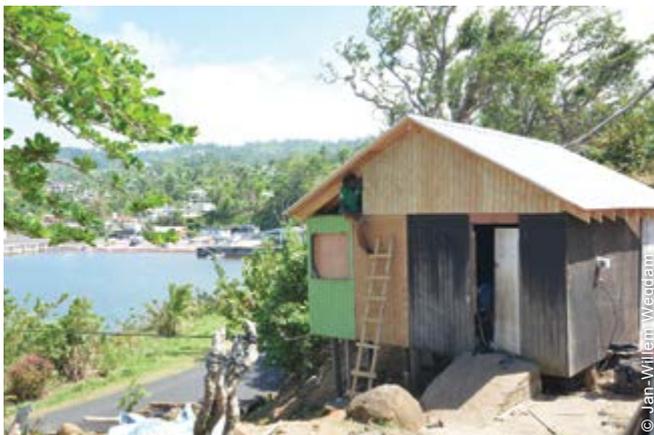
The project repaired 670 roofs in compliance with an improved building code after the hurricane.

ROOF REPAIRS. Roof repairs were provided to 670 households. **An underestimation of the structural damage** in initial assessments, combined with the emphasis on the building code and a shortage of building materials in the region, led to a high increase in the cost of repairs, forcing a reduction in the number of beneficiaries. **For 25 per cent of the targets, “interim solutions” were provided** following a widely adopted approach by the Sector, which highlighted different options for assistance depending on the structural conditions (code compliant or non-compliant) and the safety of the location. For non-compliant (but repairable) houses, the organization implemented the repairs instructing households to further strengthen their structure according to the building code.

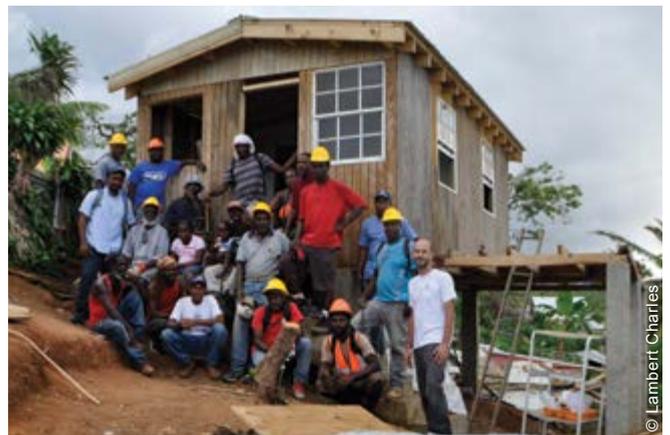
For vulnerable households with a completely destroyed house, core houses were built according to a locally approved studio design. Due to its cost, targets had to be adjusted.

CORE HOUSES. Given the small average family size in Dominica, the organization initially proposed to build 225 12m² timber transitional shelters. However, these did not meet the Dominica building code, which prescribed a minimum floor space of 18.5m² including a kitchen, bathroom and connection to sewage or septic tank. **The design had to be adapted into a larger core house** with an already approved studio layout and optimized materials. The donors agreed to a reduction to 80 beneficiaries.

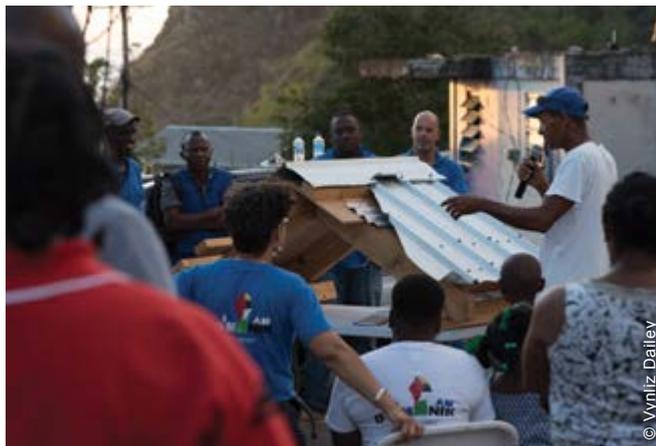
A model was used to explain safe roof repair interventions.

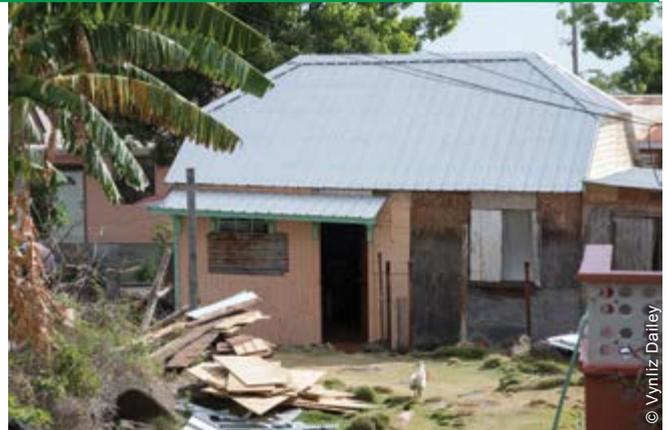
Even though roofs were repaired to code, structural improvements were not considered, nor were water, sanitation and livelihood components.

- **The project scope and budget did not include structural reinforcements** needed by many of the damaged houses to support a code-compliant roof.

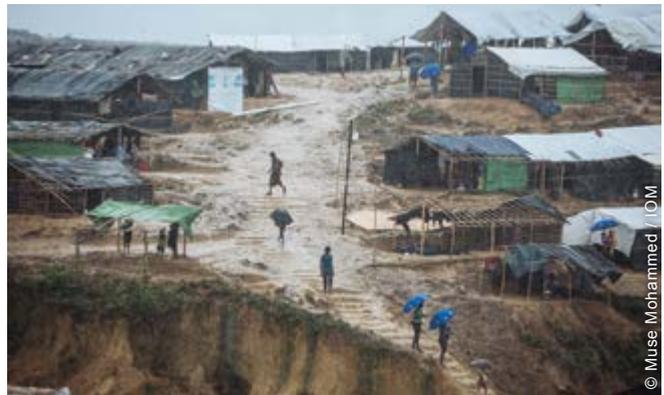
Access in and around the site was extremely challenging. When it rained, steps became impassable and perilous. Improved access became a priority in early 2018, in preparation for the monsoon rains.

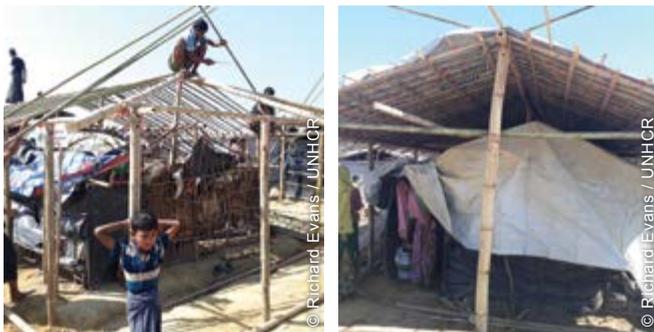
Refugees often used upgrade materials to build over old makeshift shelters.

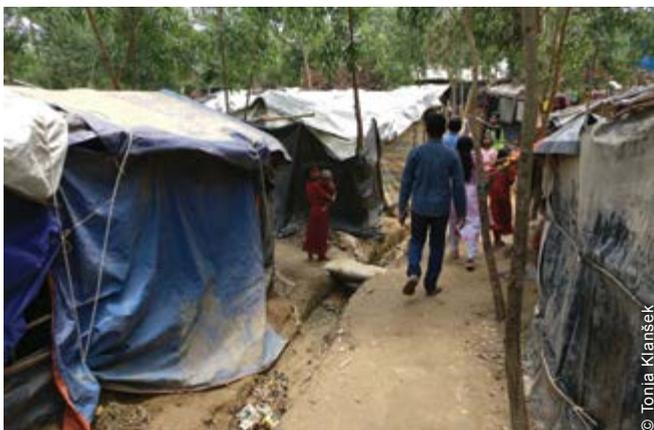
Makeshift shelters before the implementation of the upgrade phase of the shelter response were small, often fragile and highly vulnerable to weather hazards.

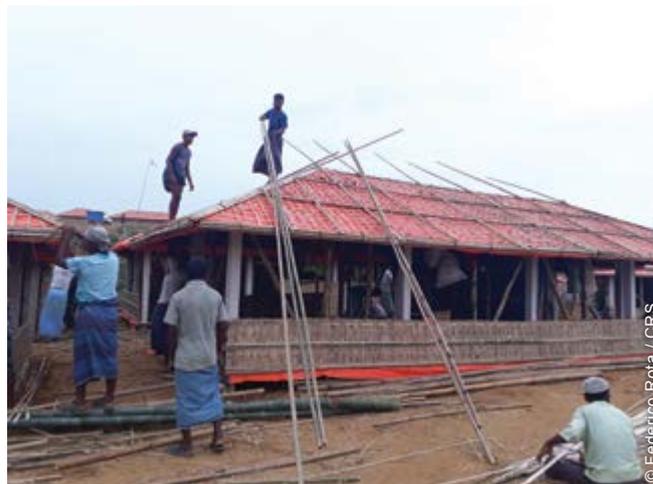
In phase 3, the Shelter Sector started to implement more durable solutions, such as Mid-Term Shelters.

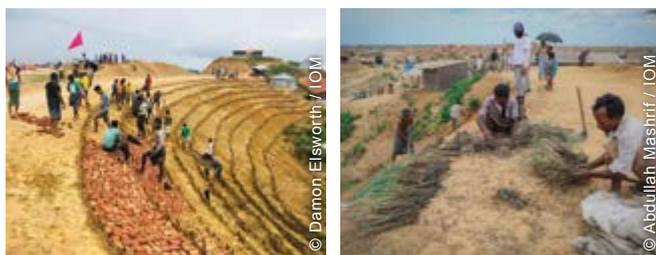
Site improvements were mainly conducted through cash for work and included slope protection by terracing (above-left) and vetiver plantation (above-right).

The site development and improvement strategy focused on small-scale site improvements, site macro-planning, and infrastructure and engineering works, aiming to improve access and living conditions in refugee sites and adjacent host communities, and reduce vulnerability to natural hazards.

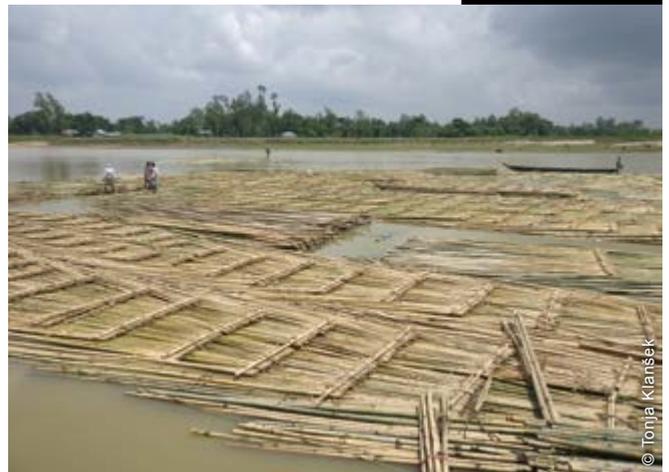
Millions of pieces of bamboo were needed for the shelter response, as well as the construction of community facilities, bridges and other site improvements. Bamboo was mainly transported by river from the Chittagong Hill Tracts area.

After the emergency phase, the focus was on strengthening and increasing the durability of existing shelters, which were built with untreated bamboo in direct contact with the ground, creating the perfect conditions for pests and rot, which will result in failure in heavy winds and rains.

By the end of 2018, significant steps were taken to address these issues. A technical note and report were developed on the durability and treatment of bamboo in Cox's Bazar, technical specifications for bamboo treatment were agreed, and Sector partners achieved a better understanding of the whole bamboo supply chain and key recommendations for sourcing, procurement, handling, treatment and design.¹¹

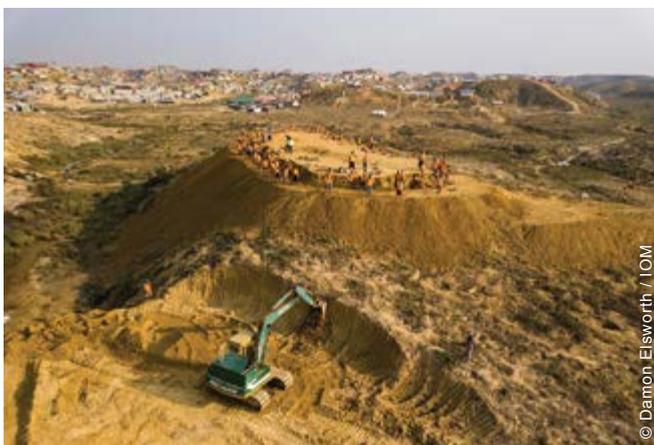
The Site Management Engineering Project was instrumental in conducting large earthworks to modify the challenging landscape.

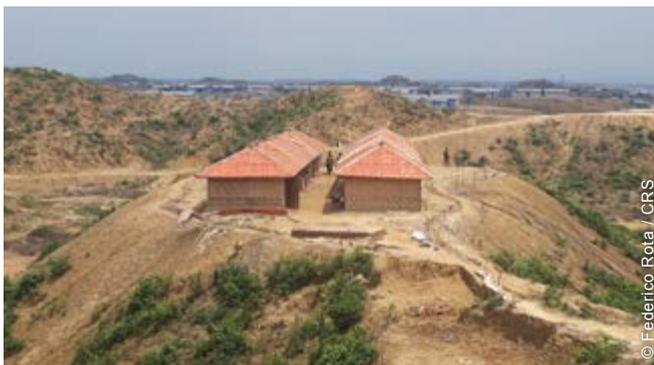
In the third phase of the response, Mid-Term Shelters were built on plots already prepared by site development partners.

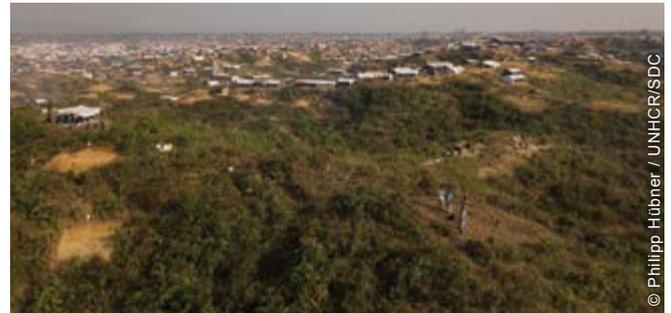
In the initial phase of site planning in the field, drones were used to identify prime land for communal facilities, that was demarcated by teams on the ground.

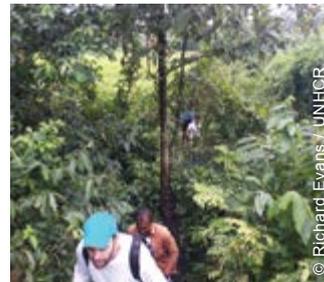
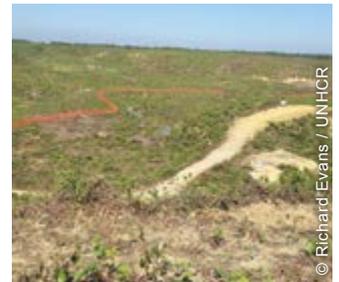
Access to the site was challenging and agencies fenced the west side of the zone to prevent uncontrolled expansion towards the natural reserve area.

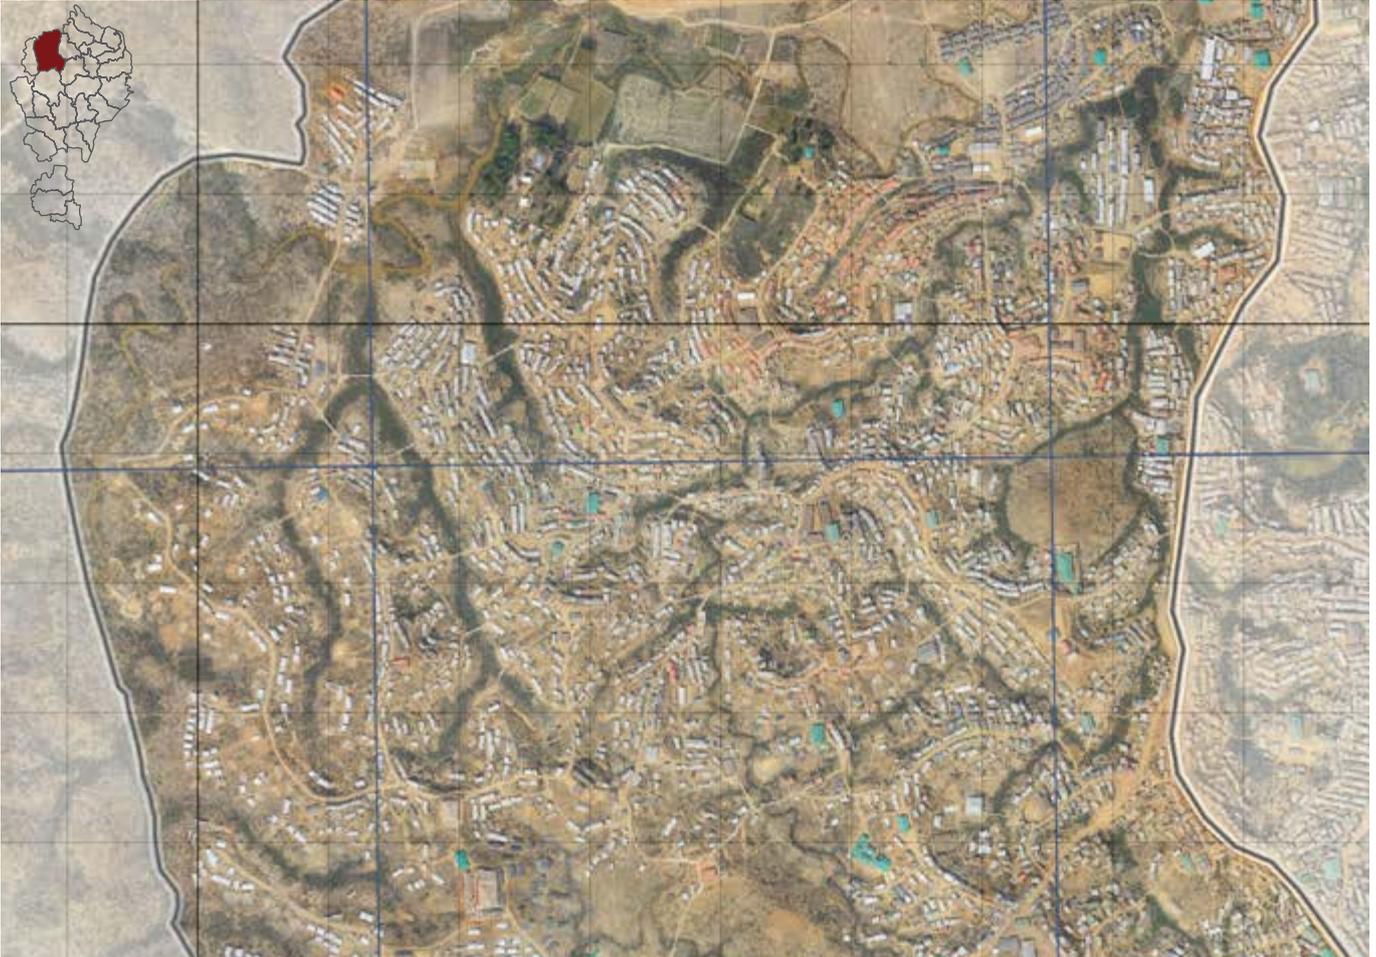
Drone image of zone OO after refugees settled, in February 2018. Densities were lower here than in other parts of the site, and services were relatively well distributed. However, this also meant that assistance was not evenly spread throughout the site, as other areas remained very dense and lacked services (Source: NPM, 14 Feb 2018).

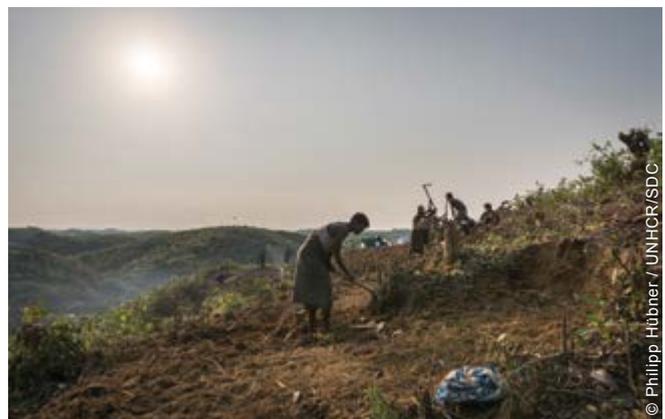
Without an agreed site plan or camp management structure in place, new arrivals started to level ground for shelter and self-settle.

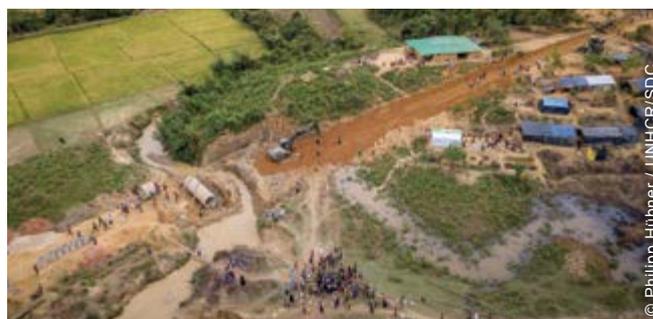
Major infrastructure (such as the Army road and culverts) was needed to convert a forest land into a liveable settlement.

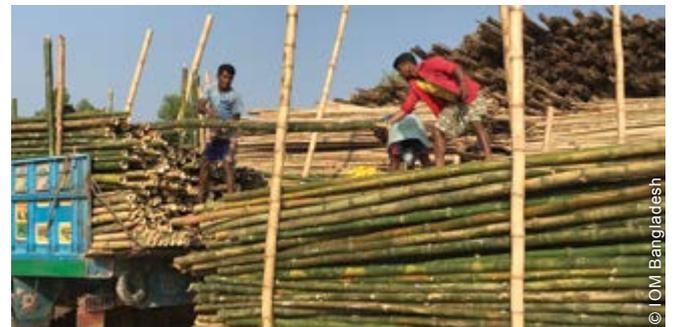
The procurement and logistics for the bamboo required for 100,000 kits needed a large dedicated team and the application of expedited procedures. Because of time constraints, bamboo was untreated and often harvested hurriedly.

Bamboo procurement was particularly challenging. A specialist was deployed to address bamboo supply chain issues and travelled to assess several suppliers with confirmed stocks.

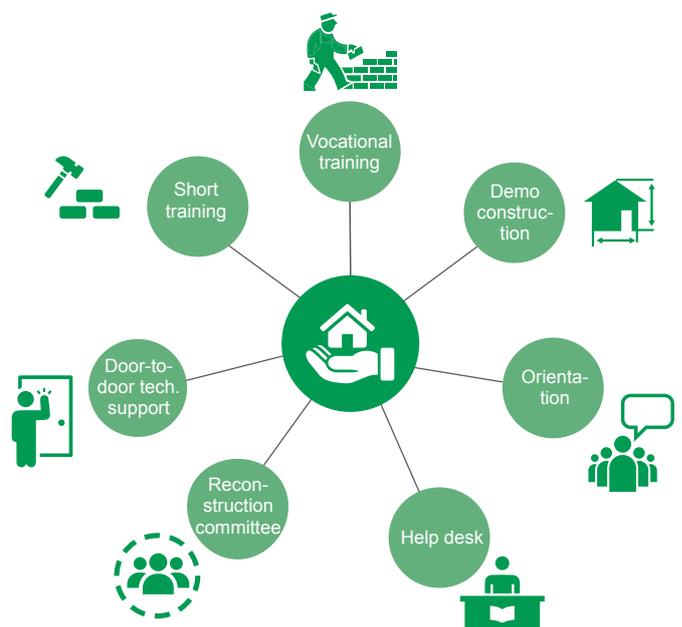
CORE SOCIO-TECHNICAL ASSISTANCE PACKAGE IN NEPAL

Basic STA package in Nepal. STA is not a one-off activity (Diagram: HRRP).

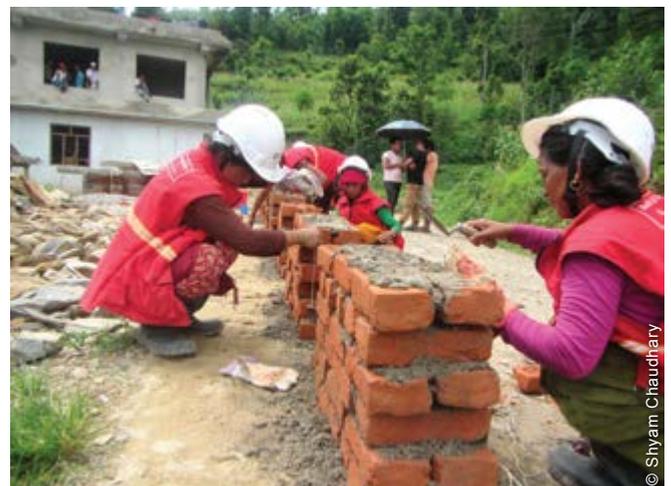
Vocational trainings included practical sessions on seismic resistant construction techniques. 38 per cent of participants were women.

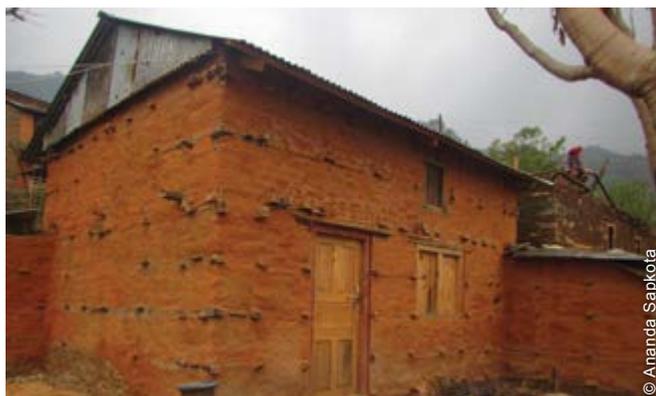
Designs were flexible and allowed the use of local materials without compromising on compliance with the building code.

AVAILABILITY OF MATERIALS. Due to increased demand caused by the response activities and the difficulties for international imports via the land border between India and Nepal, materials such as cement, reinforcement bar and CGI sheets were scarcely available and very costly. With this in mind, the house designs were flexible and allowed a variety of options to use local materials.
