SHELTER PROJECTS

2017-2018

CASE STUDIES OF HUMANITARIAN SHELTER AND SETTLEMENT RESPONSES

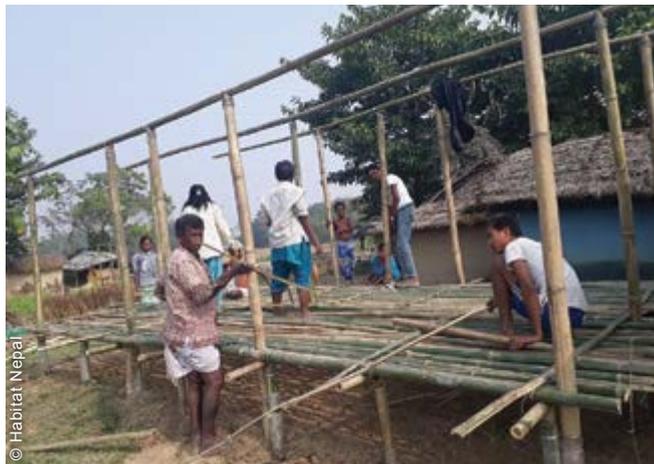
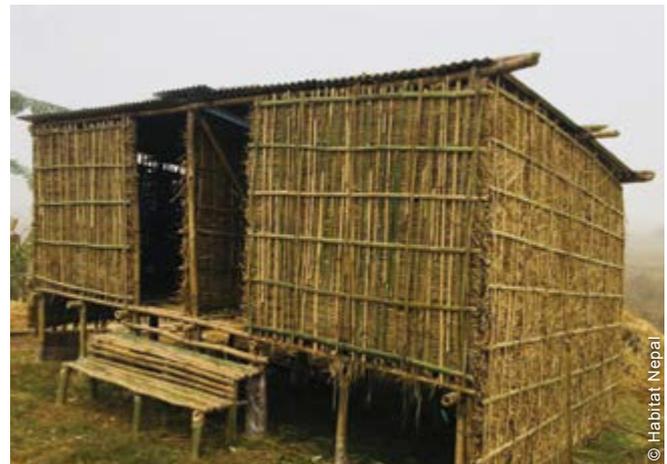
The project provided emergency shelters for flood-affected populations using local materials, and was implemented by local organizations who trained community members on bamboo construction techniques.

The main frame of the shelter was made of untreated bamboo. Treatment was not used due to the temporary nature of the shelters and the decision to prioritize the scale and timeliness of the response. The walls were made of tarpaulins that could be later replaced, while the roofing was made of corrugated galvanized iron (CGI) sheets.

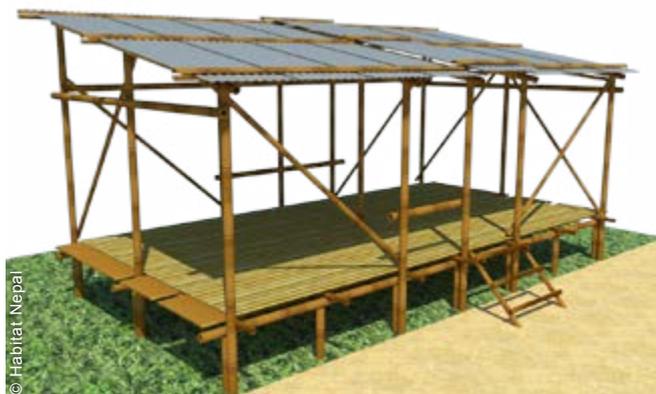
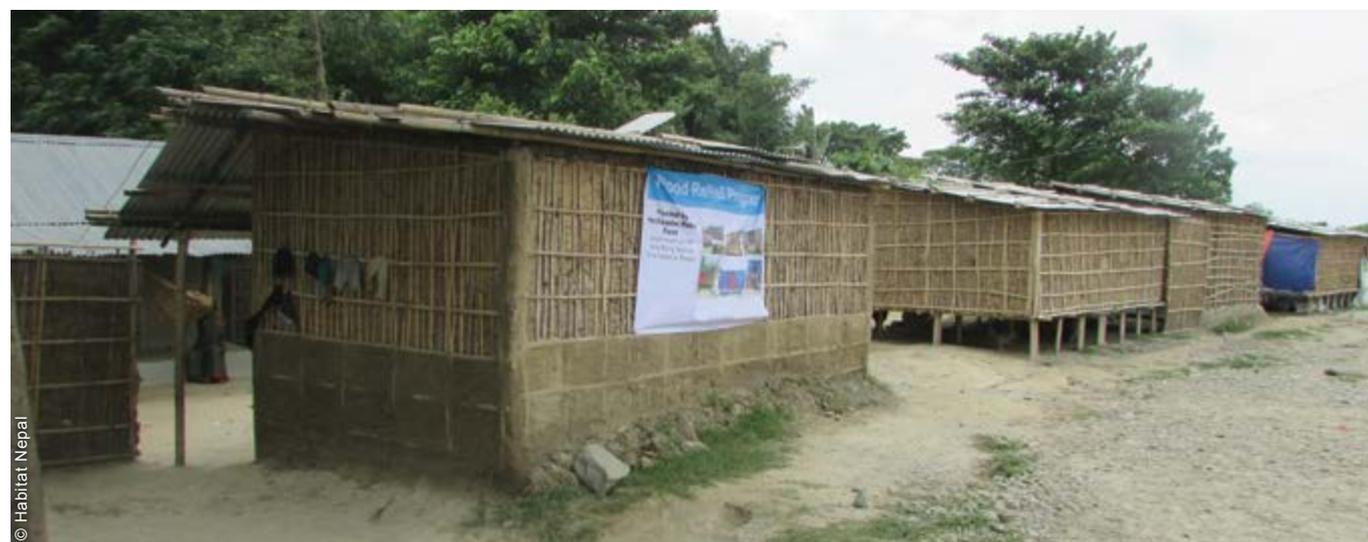
Shelters included mitigation features, such as raised floors, bracing and secure connections, and allowed for some adaptations, such as the upgrade of floors and walls.

- **Raised floor** to reduce the effect of seasonal floods. However, some families claimed this was not needed when shelters were built in areas not prone to flooding. The design was adapted following this recommendation.

- **The central CGI sheets were raised** by an extra layer of purlins to allow the heat to escape from the gap created at the top. The high ceiling was also aimed at providing better ventilation.

- **Bamboo bracings** were used to strengthen the frame by making it a single structural unit.
- **Connections** were done with lashings.
- **Anchorage** was used to increase stability.

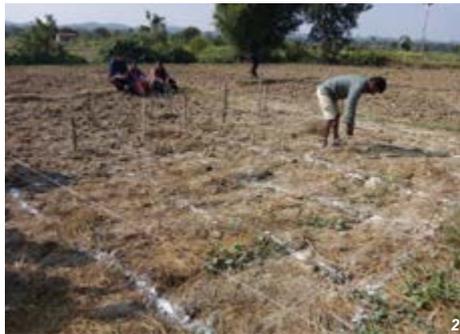
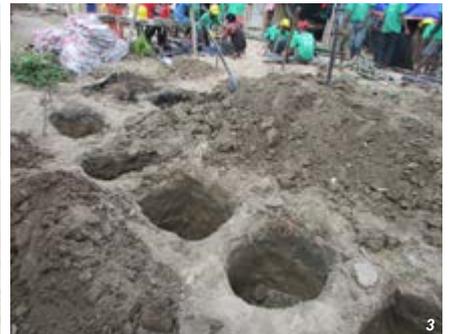
Left (1): Draw lines for foundation according to the dimensions and place the stakes in the ground. Check whether the stakes are at right angle using the 3-4-5 method. Centre and Right (2-3): Dig 21 post holes of 2' x 2' in the ground. (Photo credits: Habitat Nepal).

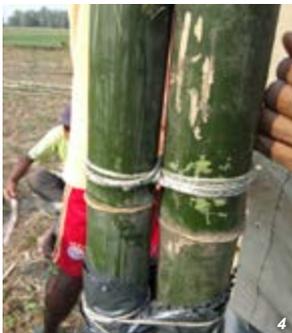
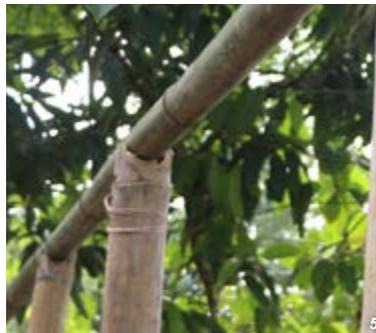
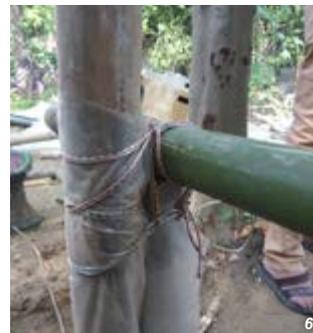
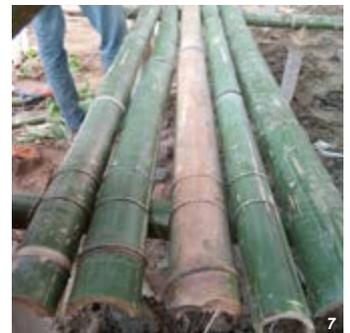
Left (4-5): Cut the required length of floor and roof posts with saw, tie them together and wrap them with polythene sheet. Cut the upper ends of the posts with a fish-mouth cut. Right (6-7): Place and tie floor beams to the bamboo floor post with rope. Place the next set of beams on top, perpendicular to the beam below. Place split bamboo joists above the floor beams. (Photo credits: Habitat Nepal).

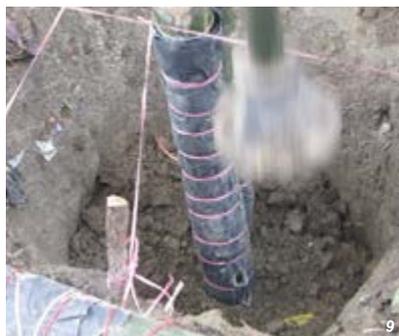
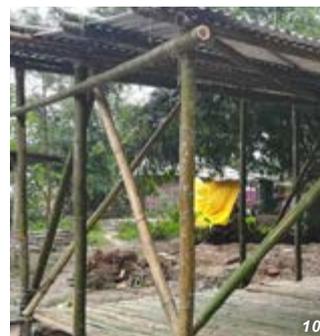
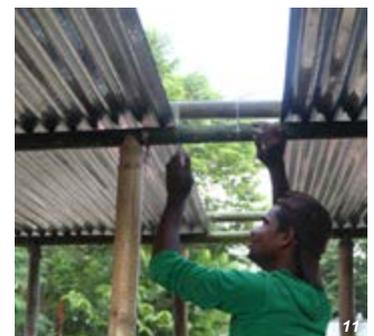
Left (8-9): Tie bamboo posts to the anchorage and place it inside the post hole. Then fill the hole with debris and tamp using wooden tamper. Right (10): Tie diagonal bracings of required dimensions to the roof post. Then tie the horizontal bracing at lintel level. Place the roof beams on top of the bamboo post and tie with rope. Place the cross bracings at roof level and then tie to the beams with rope. Right (11): Place bamboo purlins on top of the roof beam and tie with rope. Arrange 8 CGI sheets over them leaving one sheet width vacant in the middle. Tie 2 layers of purlins together to hold the CGI sheets in place. Place the remaining CGI sheet over the void and place 3' length purlins on top of each purlins below to hold the sheet down. This provides air movement inside the shelter through the roof. (Photo credits: Habitat Nepal).

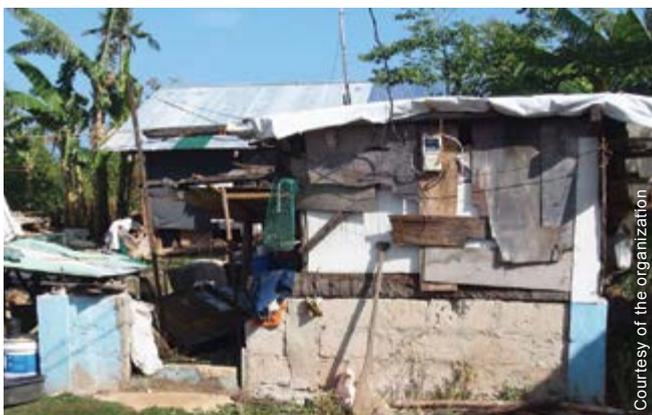
A year and a half after the typhoon, many houses were in very poor structural conditions. For this reason, repair and retrofitting assistance was not an option, although this would have reached more people because of the lower costs.

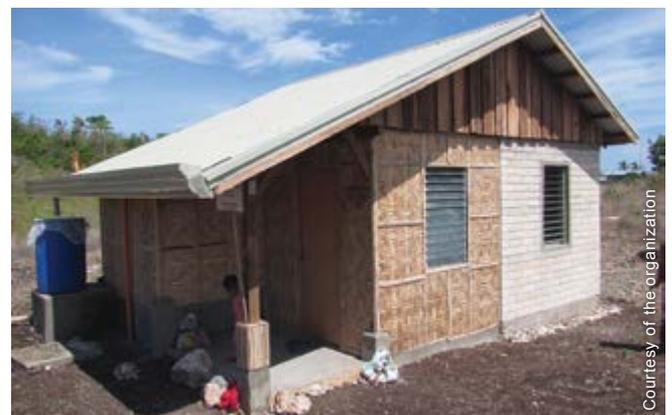
The project provided core houses with light-weight extensions, based on a common rural design. The houses included a gutter and a water tank for rainwater collection.

The design was developed from a common rural house – which usually includes a main private room and an adjoining room used as communal space – and was flexible to allow people to make extensions or adjustments according to their needs (e.g. the design and position of the windows/doors/porch). In compliance with national regulations on accessibility, adjustments in construction were provided when a family member had a physical disability.

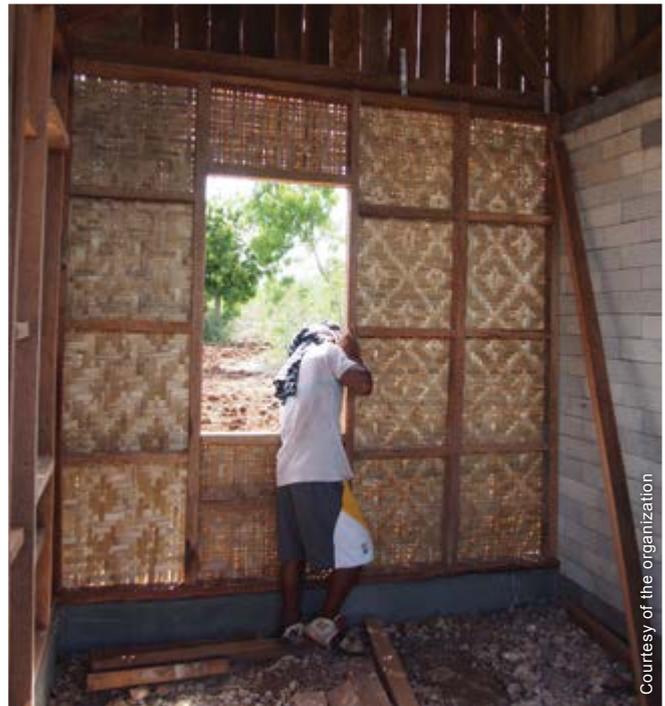
The adjoining room was made with a structure in coco lumber protected with a termite treatment, and an amakan walling. This could be replaced or re-design, so some families could built extensions for small kitchens and dining areas.

The adjoining room was made of lightweight materials with a coco-lumber structure and amakan walling. Termite treatment and protection of the coco lumber were critical to ensure durability. This part was also designed to be typhoon- and earthquake-resistant, but was expected to last less than 10 years. The coco lumber and walling could be easily replaced or adapted. In fact, many families changed some of the design or built extensions for small kitchens and dining areas.

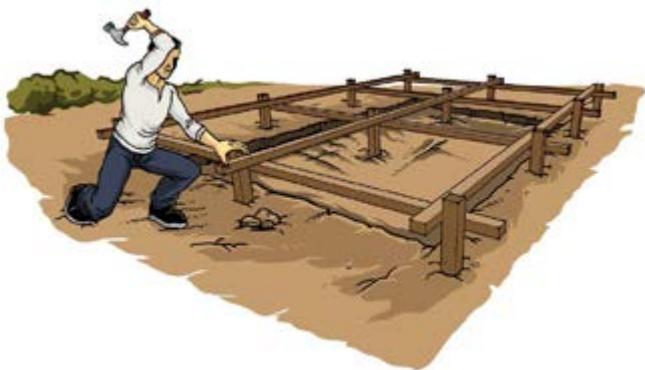
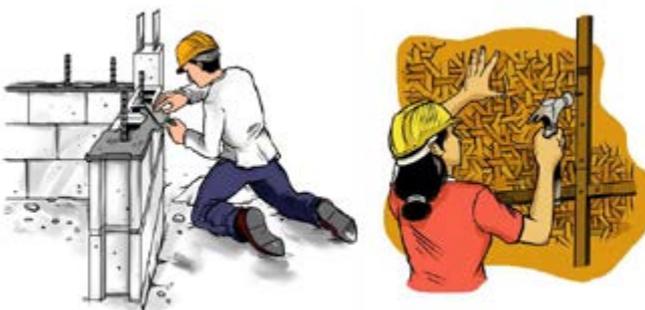
A “Beneficiary Guide and Construction Handbook” with 3D drawings was used to show the households how to build their new house.

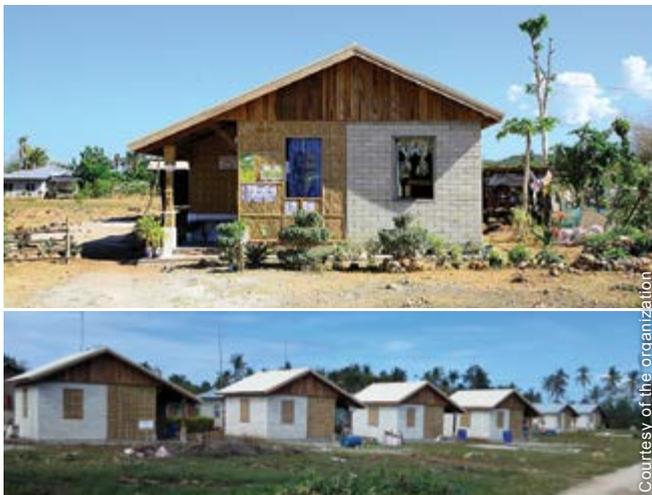
Core houses were built to resist typhoons and earthquakes and have an expected lifespan of 20 years for the core and 10 for the extension.

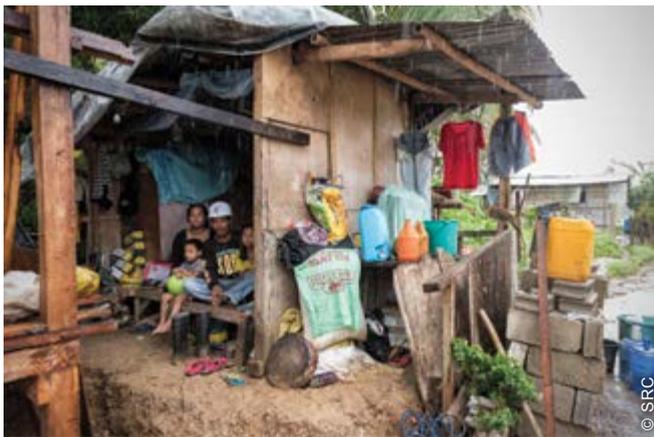
Most houses built in lightweight materials failed during the typhoon and were quickly repaired to be re-inhabited by the affected households.

Typhoon Haiyan affected most of the population in Ormoc. Most houses were constructed with light materials (i.e. timber and woven split bamboo) and the structures did not incorporate adequate bracing or other disaster-resistant construction techniques, with roofs of thatch or light corrugated galvanized iron sheets (CGIs). Houses built with concrete and masonry fared better, but most of the rest suffered varying degrees of damage. Over half of the houses were partially repaired quickly, to make them habitable (e.g. damaged roofs were covered with tarpaulins), but remained susceptible to future storms.

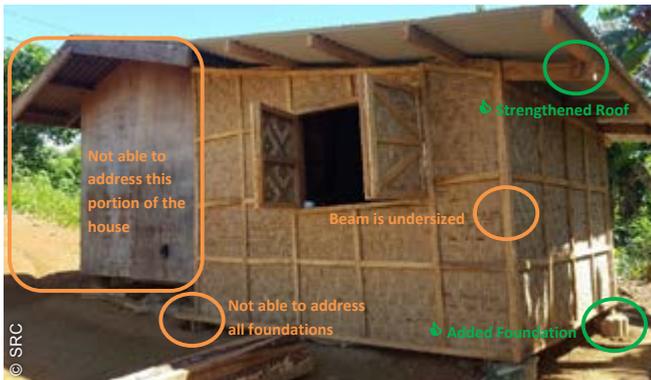
A partner NGO, which specialized in disaster-resistant design, developed guidelines with three steps for all components of a house to be repaired.

The partner evaluated all the houses repaired through the project, confirming that all had been strengthened after the intervention.

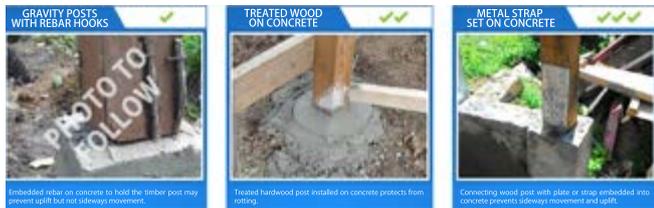
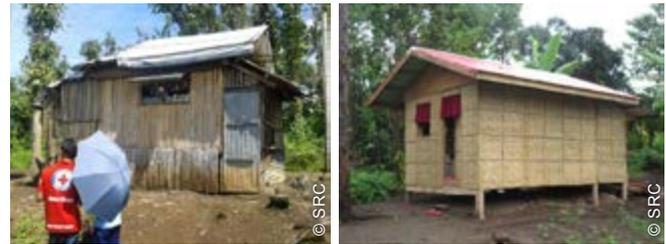
This picture shows a house before and after the intervention. All targeted shelters were structurally strengthened, with a high involvement of the affected people.

According to the final report, **all houses were structurally strengthened**, with an estimated 60 per cent considered to be fully reinforced, while the remaining 40 per cent required further improvements. This was observed in larger houses, where the funds distributed were stretched more, or in houses which were partially timber and partially masonry, requiring more expensive connection techniques. However, through the orientation sessions and information materials, those households were also given knowledge about how to address these issues and how to continue strengthening their home.

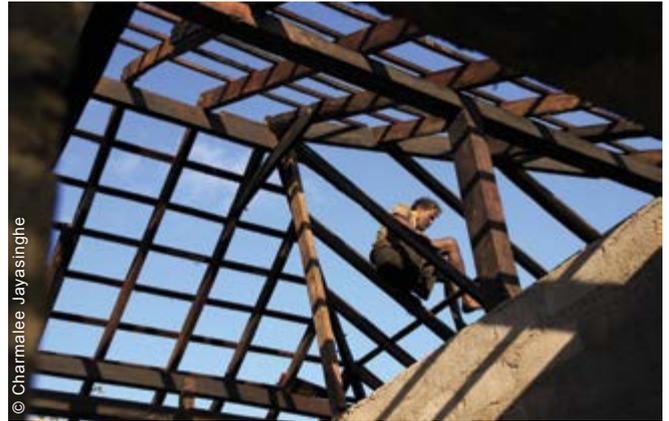
Roof work in progress in Vavuniya district. DRR features were included in roofs, foundations and walls. The gradient was increased to enable better run-off.

- Raised foundations to protect from flooding;
- Specially reinforced foundations for structurally poor soils, such as expansive soils.
- Increased external wall thickness (150 mm) combined with a reinforced concrete ring beam at lintel level, to improve structural stability during strong winds and floods;
- Increased roof gradient (25 degrees), anchoring of roof to the ring beam and mortar restraining bands over roof tiles.

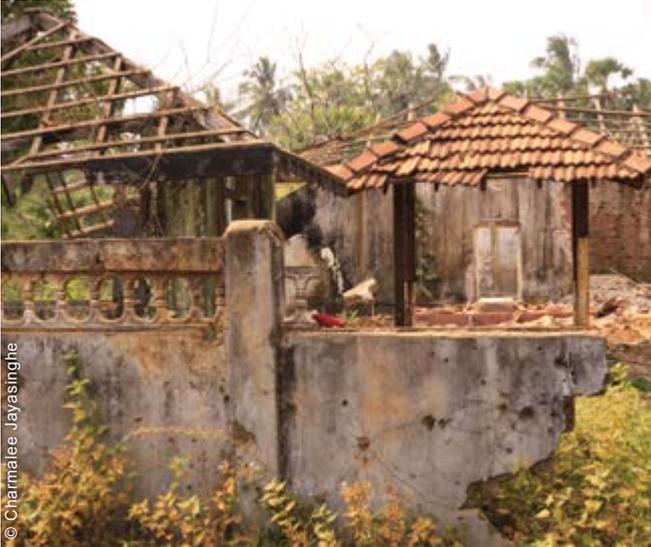
Damaged house in Mullaitivu district. One of the issues to solve in the reconstruction was land tenure, as many families had lost their titles during the conflict.

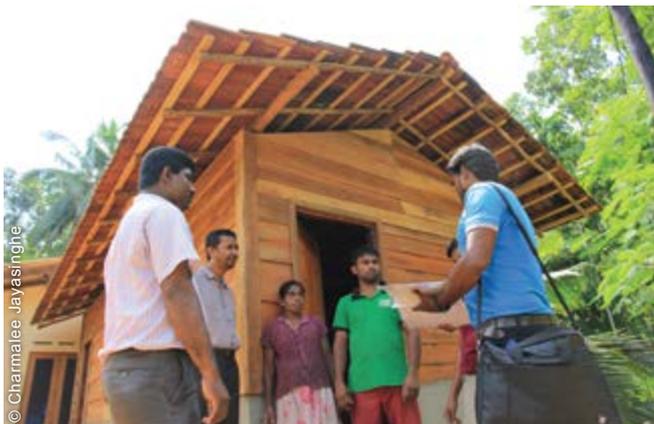
For very vulnerable households with a completely destroyed home, cash grants were given to build a transitional shelter.

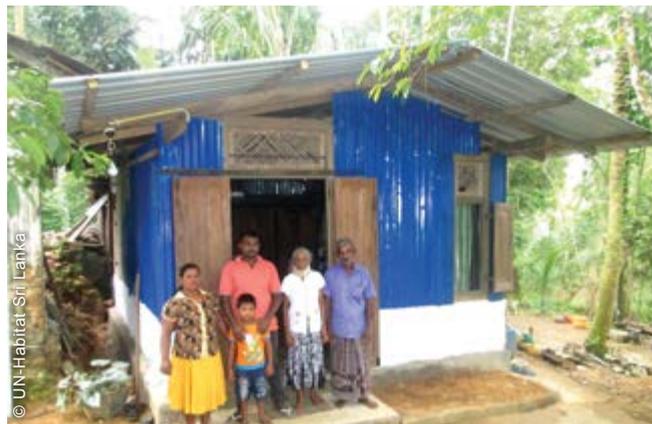
In some cases, transitional shelters were also built using salvaged materials.

Reclaimed materials were used to reduce costs by decreasing the procurement of new materials and limit the environmental impact of the disaster by recycling debris. Affected households recovered roof tiles and timbers, doors and windows damaged by the disaster, stored them on site and reused them both for repairs and new construction. The debris available on site (such as bricks and concrete rubble) were sorted, cleaned and reused as aggregates into foundations and as floor concreting.

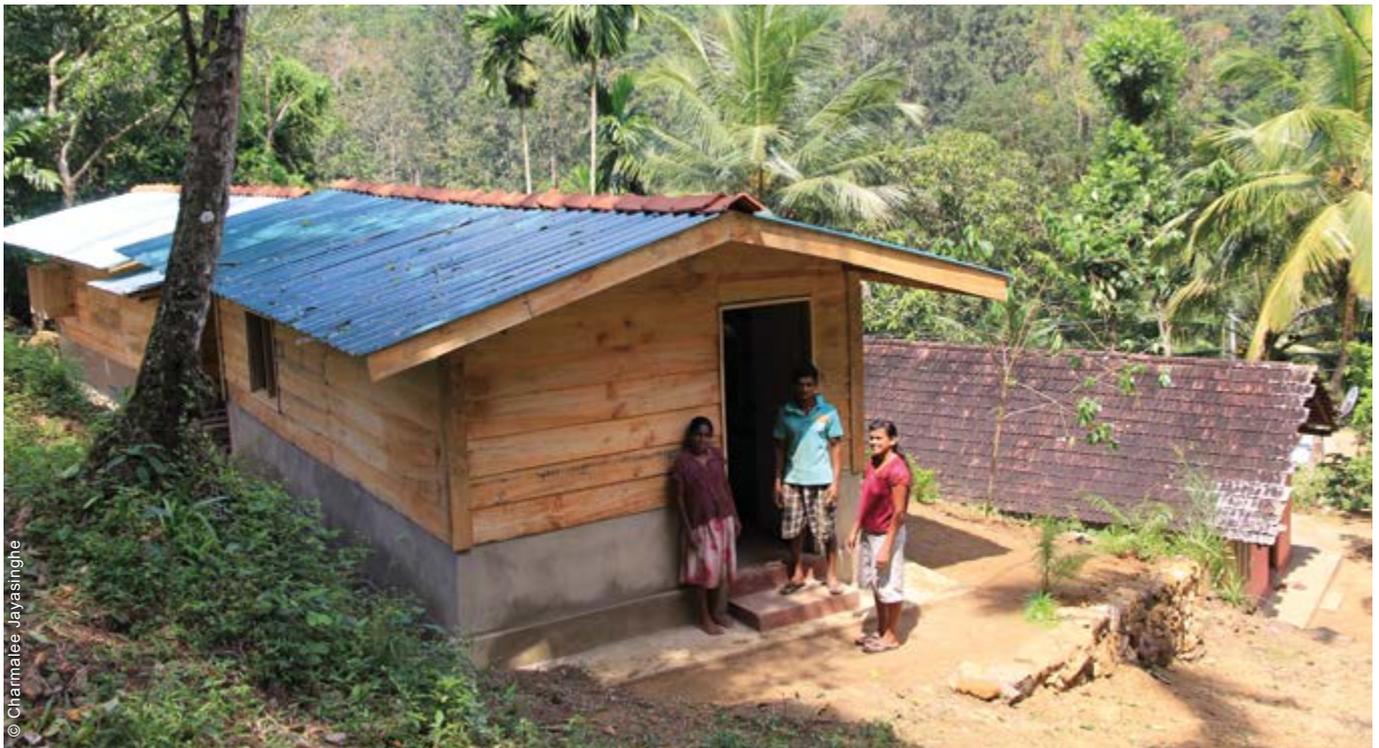
Along with distributing NFIs and shelter repair grants, the project supported 89 households in building transitional shelters via transferring funds to their bank accounts.

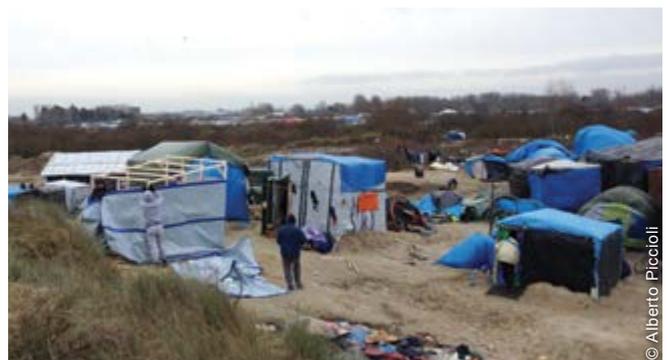
The organization started using a shelter design at the end of September 2015. Frames were prefabricated off site and built by volunteers only for the most vulnerable.

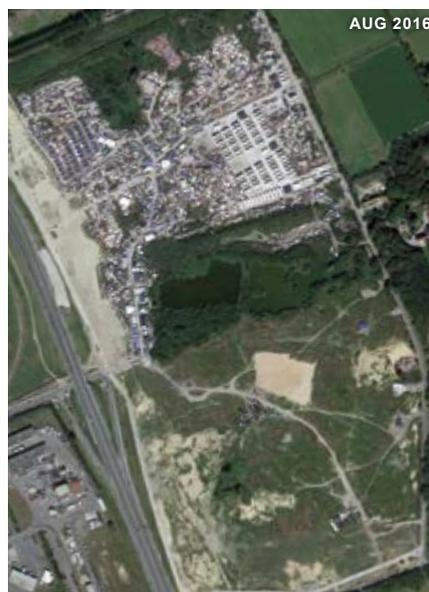
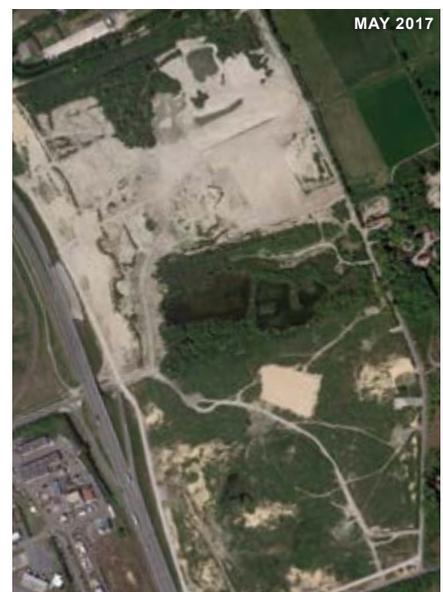
Camp evolution. Left: the authorities of Calais designated a former asbestos dump to be opened after the large influx of displaced populations into the north of France. Center: after the creation of the “buffer zone” around the perimeter and the destruction of the southern half. Right: after the camp was dismantled.

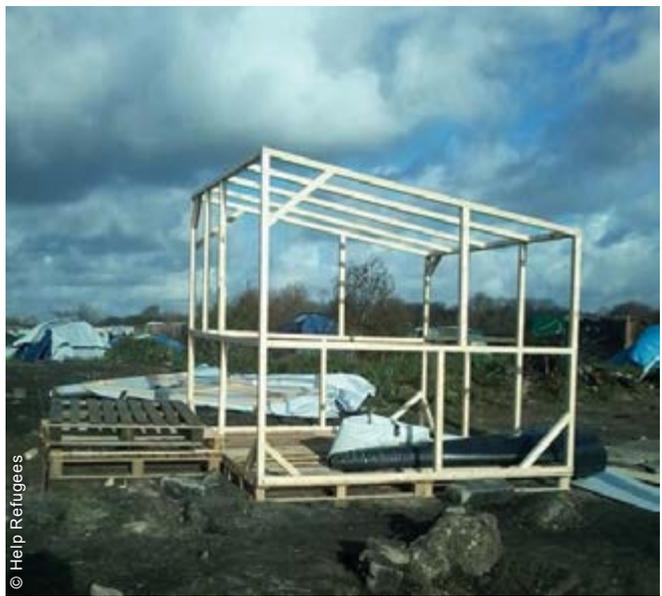
The organization started using a shelter design at the end of September 2015. Frames were prefabricated off site and, for the most vulnerables, shelters were set up by volunteers.

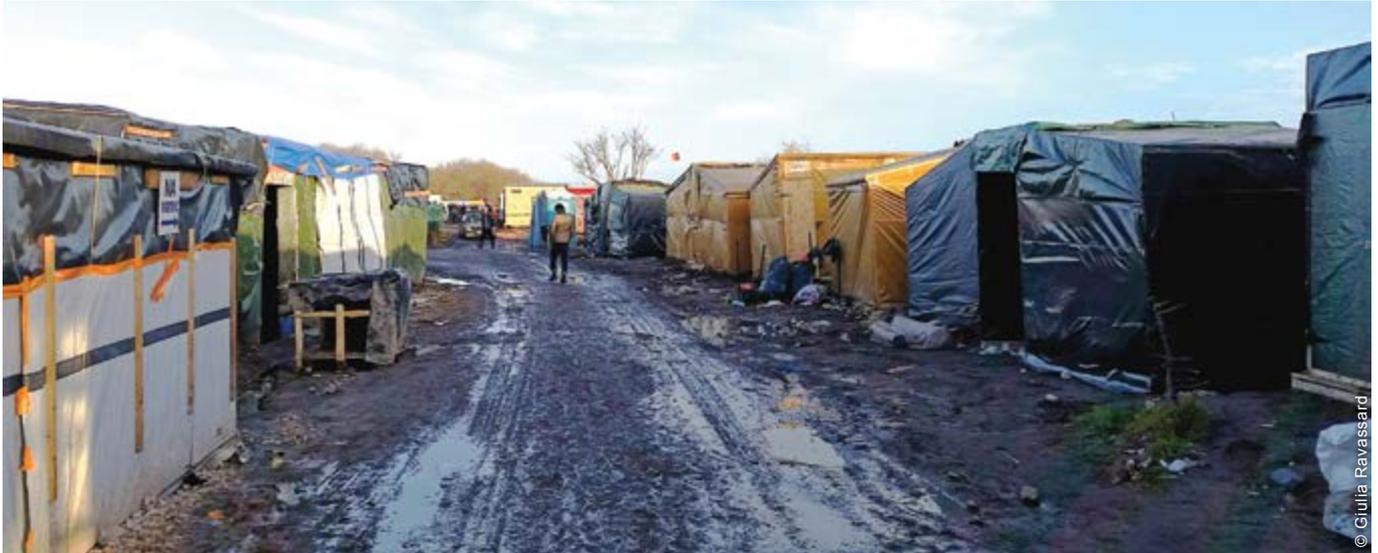
There were different kinds of shelters in the camp. New arrivals mainly slept in flimsy tents. By the end of 2015, the most vulnerable had received a timber-frame shelter.

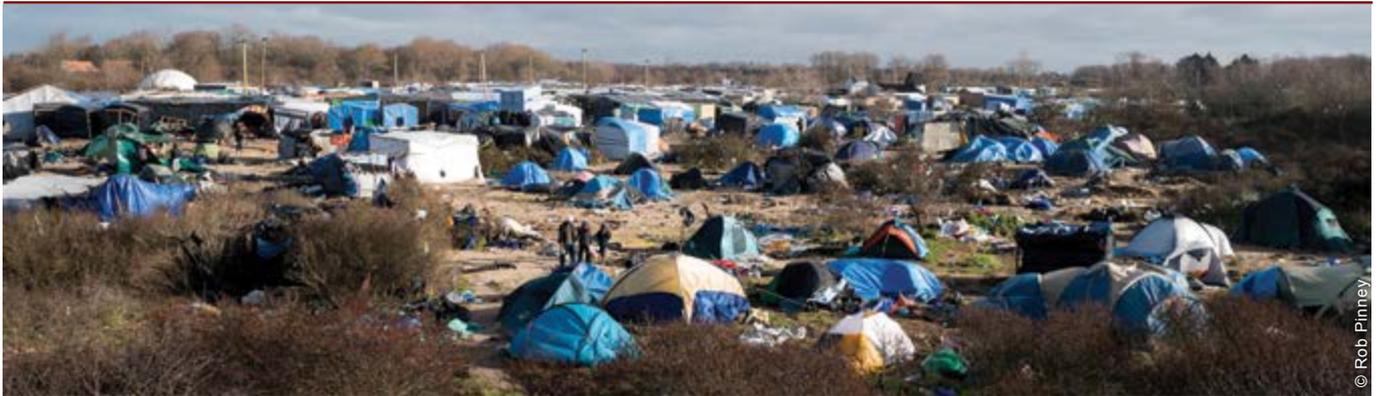
Little to no site planning was done in the camp. Refugees and migrants gathered based on nationalities. Overcrowding was a serious issue, as well as fire hazards.

There was little planning on the placement of shelters in the camp. Upon arrival, residents organized their tents into groups – mainly by nationality or age – and when it was their turn for a shelter, the tent would be replaced in the same place. When the southern half of the camp was bulldozed, as many shelters as possible were moved into the northern part. Here some planning was carried out, for example to secure empty areas for a specific group ahead of time. However, in the end much of this was undone as there was not enough space to accommodate all the people that had to move. Countless shelters were destroyed and those that remained were squashed together, further increasing fire and health risks. Generally, throughout the site there was not enough space to create any firebreaks, nor willingness from the residents to abide by fire risk mitigation measures, either.

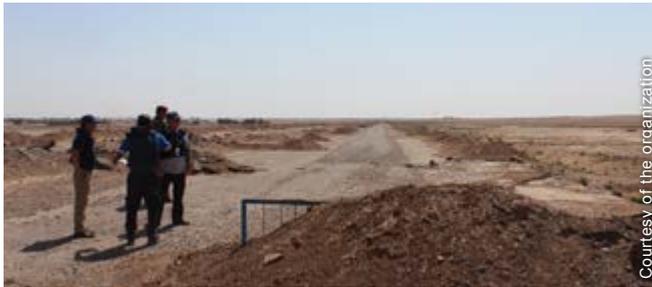
Before mine clearance was completed, sites were only accessible from the perimeter. Planning was done remotely, by observation and thanks to satellite images.

+ **Remote site planning.** In the initial planning stage, the site could not be accessed and so topographic analysis and measurement of site boundaries were done by a mix of observation from the perimeter and analysis of satellite imagery. Plans were then adjusted during the implementation phase. Such remote planning worked well thanks to the high-resolution satellite images acquired from authorized agencies.

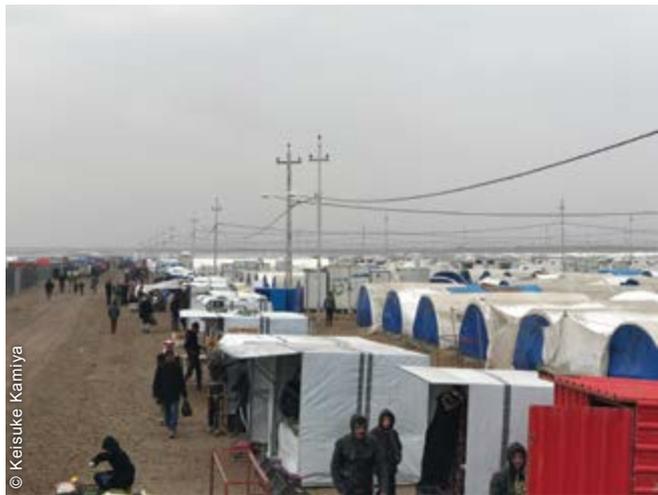
In less than six months, capacity for 17,500 households was established in two sites. The main roads were used for small shops and storage of materials.

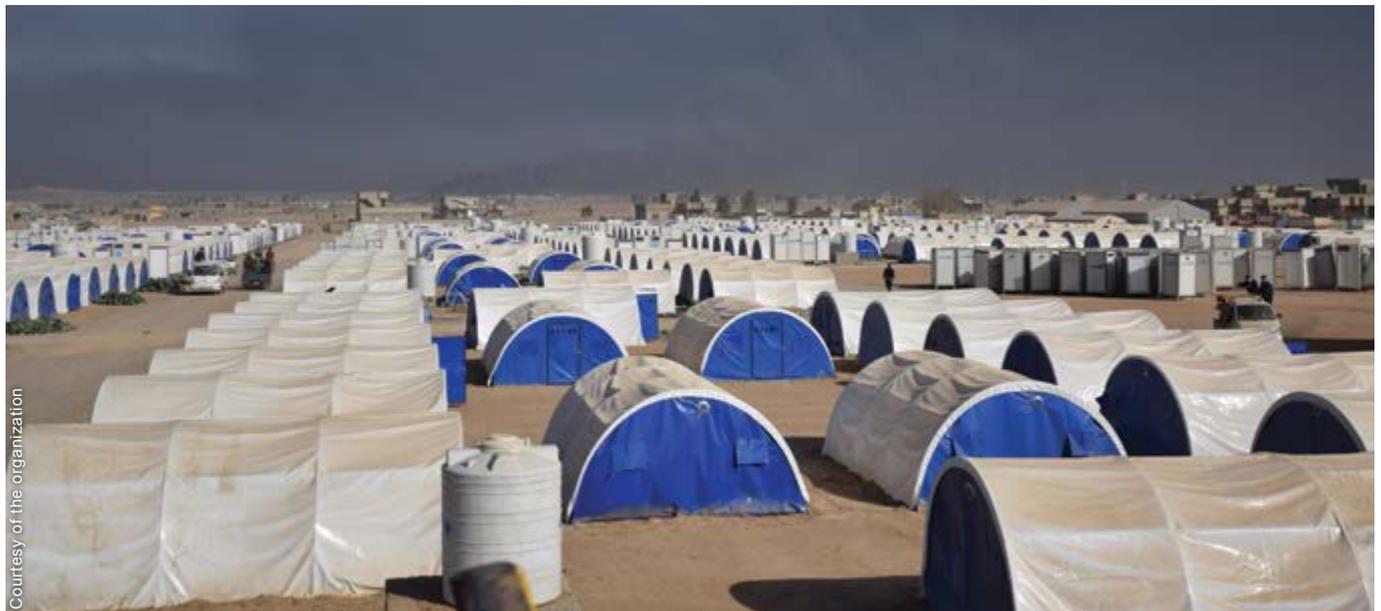
Government standard tents of 6x4m were installed in clustered blocks of 20 each. Space for extensions was minimal but, after families had moved in, upgrades were conducted to the floor and electricity was installed. Partners could then build service facilities in specific blocks pre-allocated in the site plan.

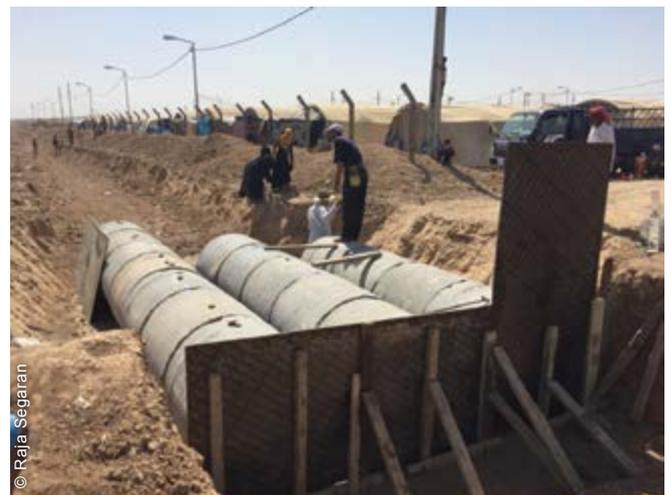
One site was vulnerable to heavy rains and suffered minor flooding during winter. In 2018, storm-water drainage channels and culverts were upgraded.

Storm-water drainage was later expanded in early 2018, after five new sites were built around the main Qayyarah Airstrip site. This consisted in wide earthen channels with protective berms and large concrete culverts.

In late 2018, minor flooding occurred due to the blocking of culverts by informal settlements outside the site.

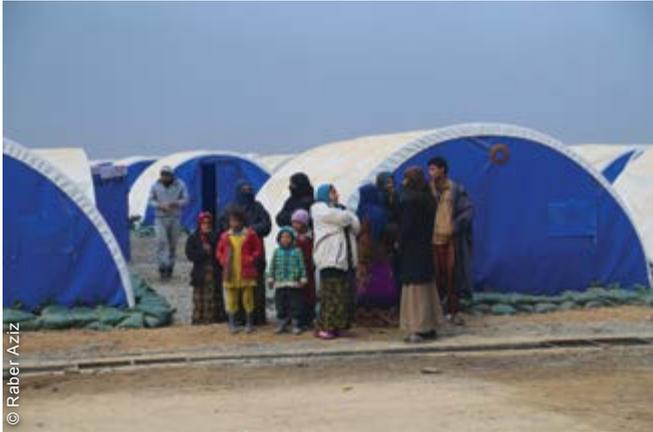
Using a rapid settlement approach, families were accommodated before all facilities and infrastructure were installed. Gravel was added in the shelter areas and roads excavated 20cm lower than the blocks, to prevent flooding.

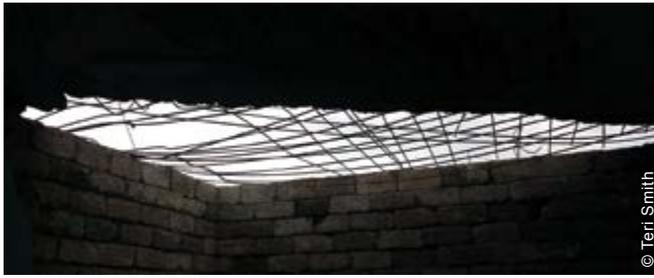
The project rehabilitated houses through a voucher scheme. Repairs included roofs and walls.

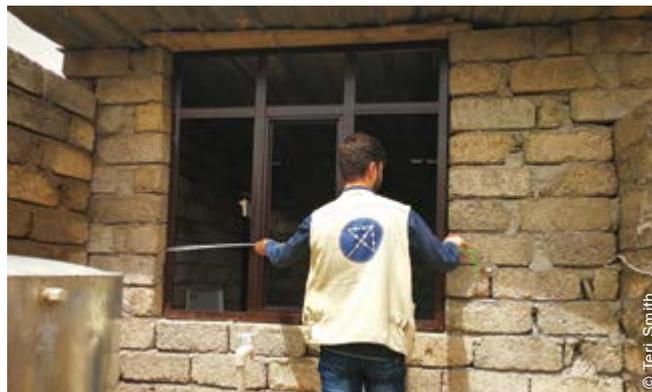
Engineers conducted structural assessments and developed individual BoQs.

Project engineers conducted structural assessments of houses to ensure people were not inhabiting unsafe structures and to create individualized Bills of Quantities (BoQs), taking into consideration households’ unique needs and the different types and levels of damage.

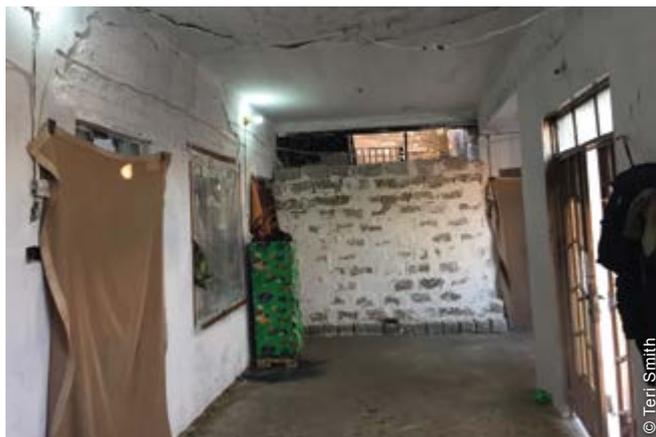
Families in conflict-affected areas also conducted repairs themselves. The image shows a self-built rehabilitation in another location.

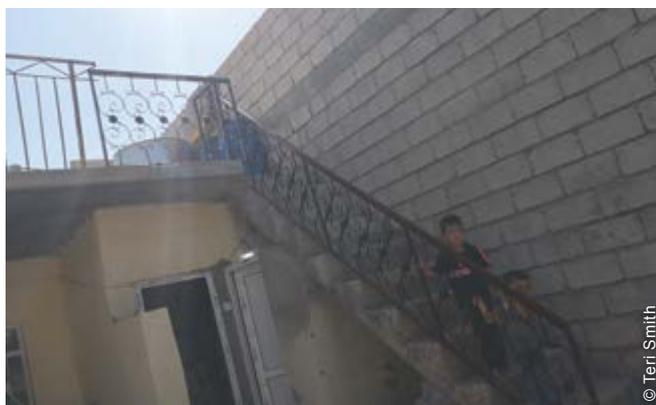
The project repaired walls and stairs, and added handrails for safety.

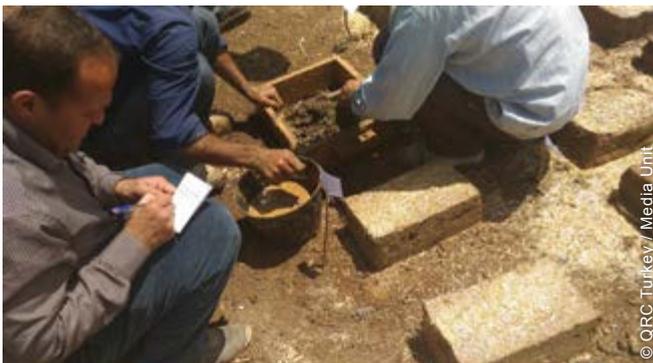
A ToT was also conducted in Syria for the local partner staff. It consisted of a class-based module and practical tests in the field, such as testing bricks made with different mixtures and analysing different samples of soil.

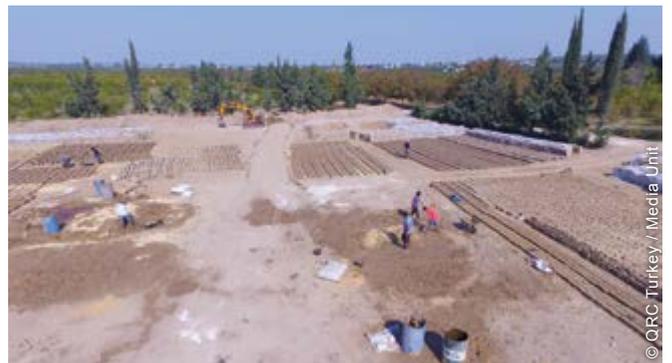
Adobe brick production required very large spaces and could only be conducted during the dry season. This caused some implementation challenges.

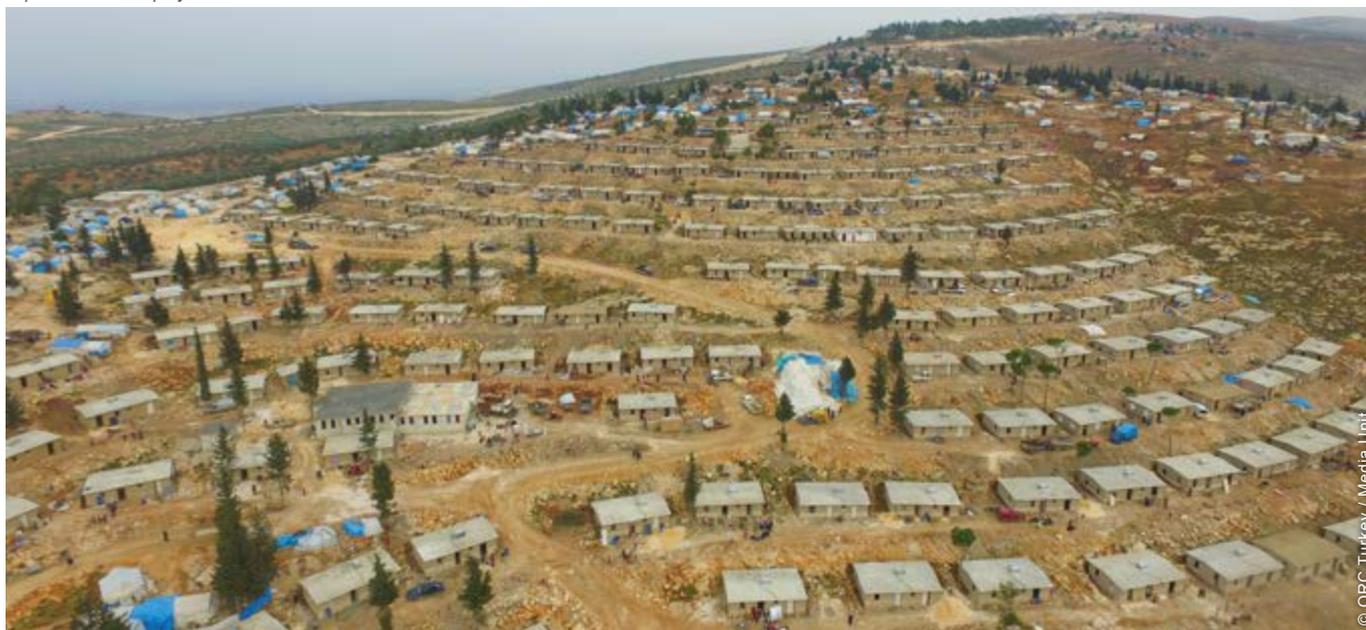
The project was implemented in five different locations close to the Turkish border in Syria. Soil for bricks was sourced in abandoned hills and holes refilled after extraction.

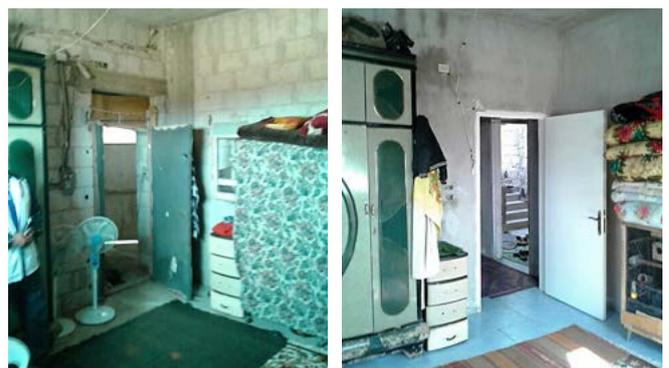
Rehabilitation works were conducted using local labour and materials.

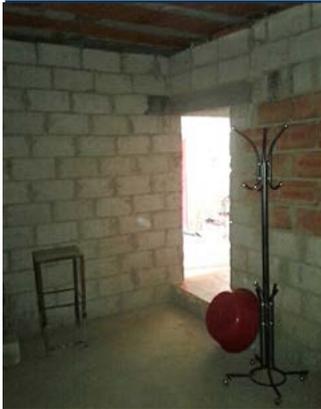
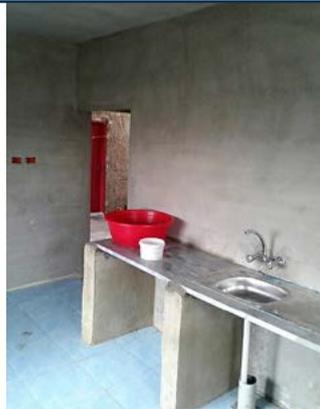
The project considered the needs of persons with disabilities.

Where required, works included rehabilitation of household-level water and sanitation systems.

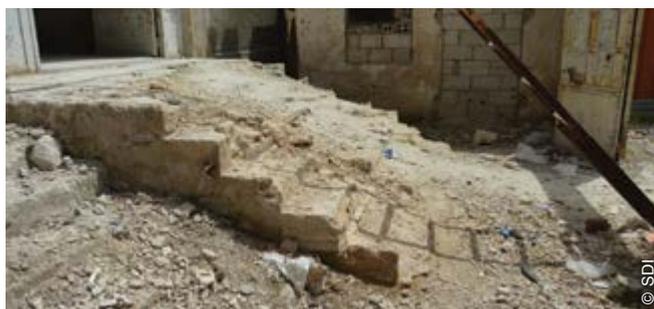
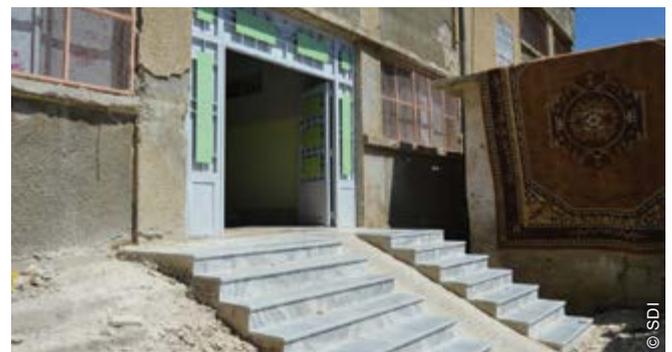
Before (above) and after (right) rehabilitation works in one collective centre.

The project rehabilitated five collective centres in southern Syria, including four schools and a public housing complex. Conditions in the centres prior to rehabilitation posed physical safety and protection risks to the residents. The rehabilitation works included climate protection, securing partitions, water, sanitation and cooking facilities, according to standards developed collectively by shelter actors in southern Syria.

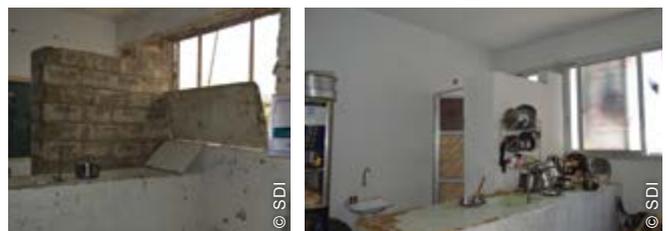
Rehabilitation works included furnishing and upgrade of common kitchens.

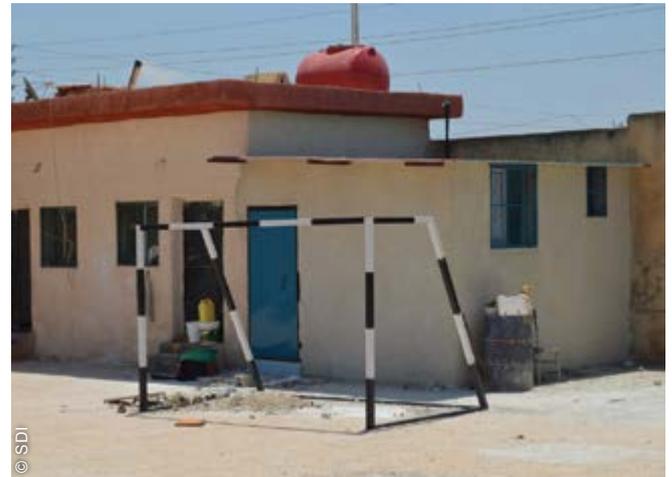
Doors and windows were repaired or replaced to increase security and privacy.

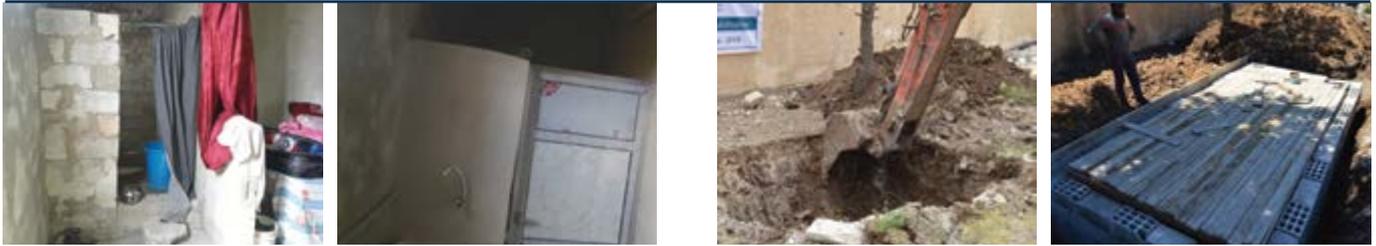
Works included the rehabilitation of water and sanitation facilities (left) and the construction of cesspools and wastewater disposal systems (right). Photos: SDI.

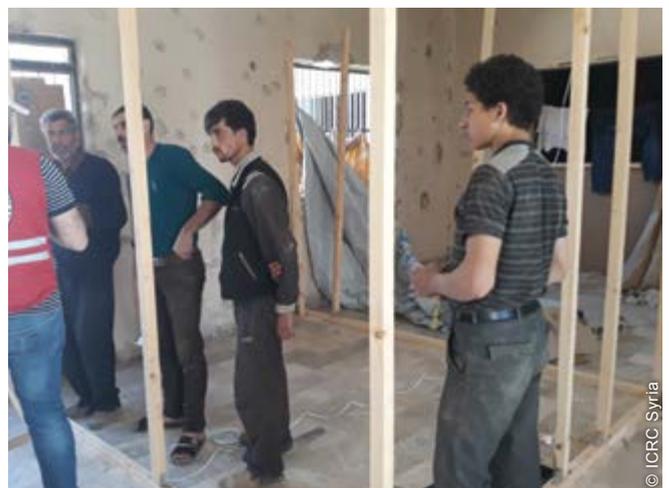
Shelter kits were used to build indoor partitions to increase privacy.

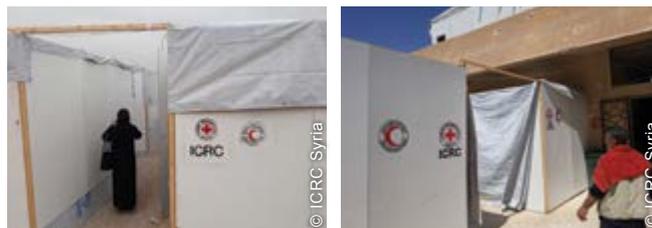
Shelters were also set up outdoors using the materials in the kits.

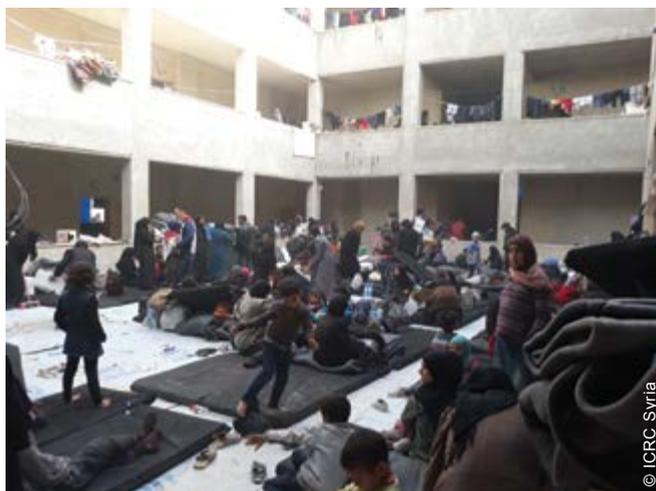
Buildings were upgraded through the set-up of rooms, installation of doors and windows, general repairs, rehabilitation or provision of water, as well as lighting.

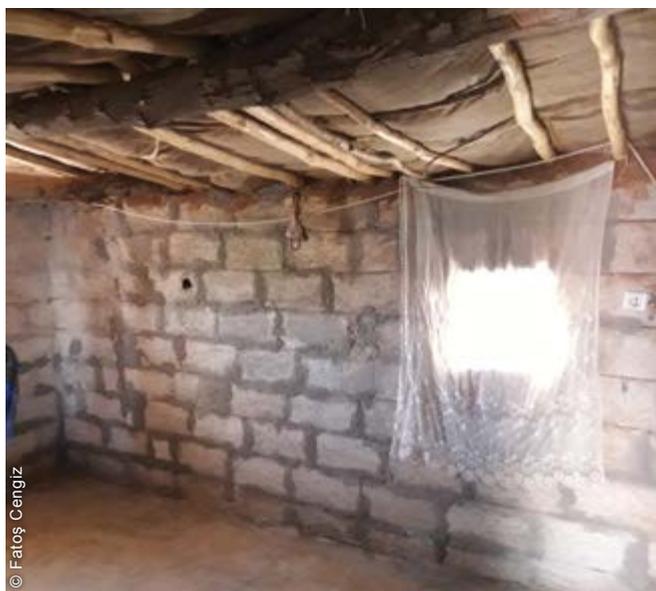
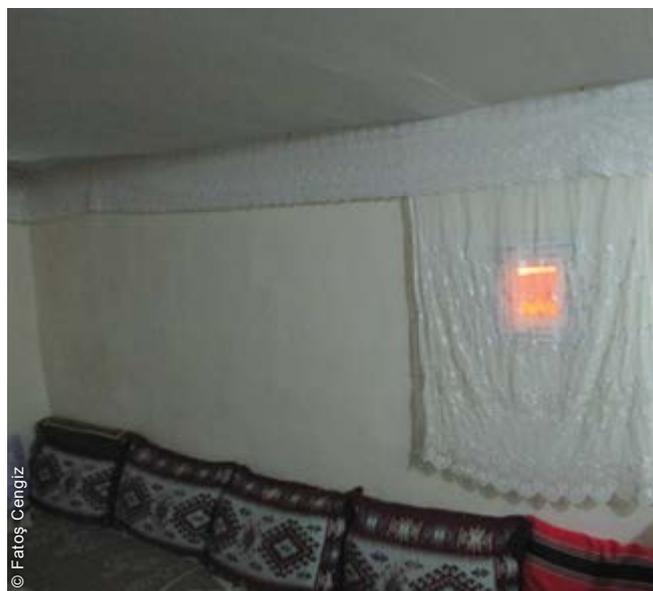
Repairs included roofing insulation, walls rehabilitation, electrical works, floor repairs, plumbing and replacement of doors and windows.

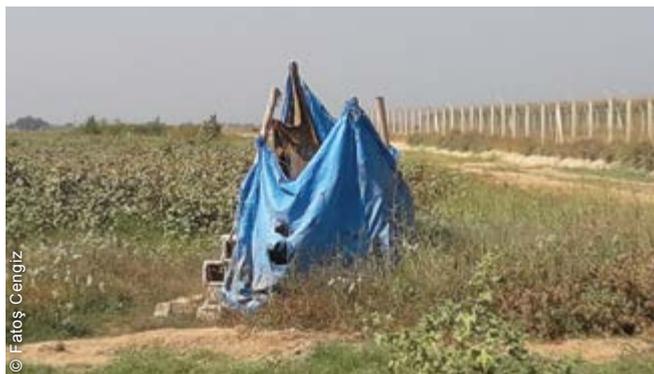
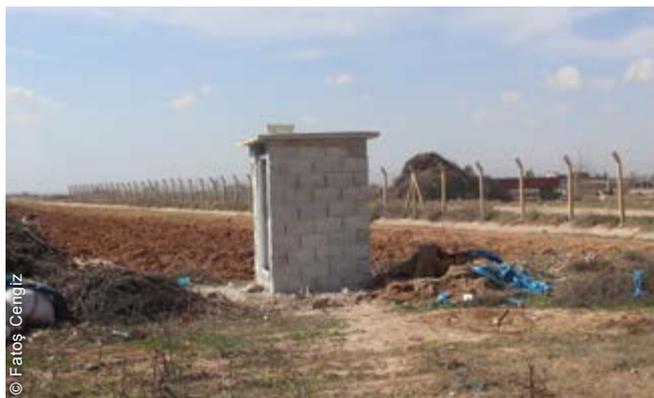
The project also provided rehabilitation of water supply and sanitation facilities.

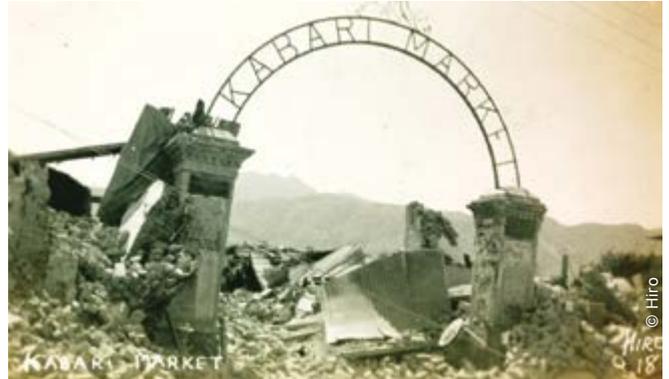
As the market had been destroyed, the municipal authorities constructed markets and shops on government land before reconstruction began, to restore a degree of normality.
