SHELTER PROJECTS

2017-2018

CASE STUDIES OF HUMANITARIAN SHELTER AND SETTLEMENT RESPONSES

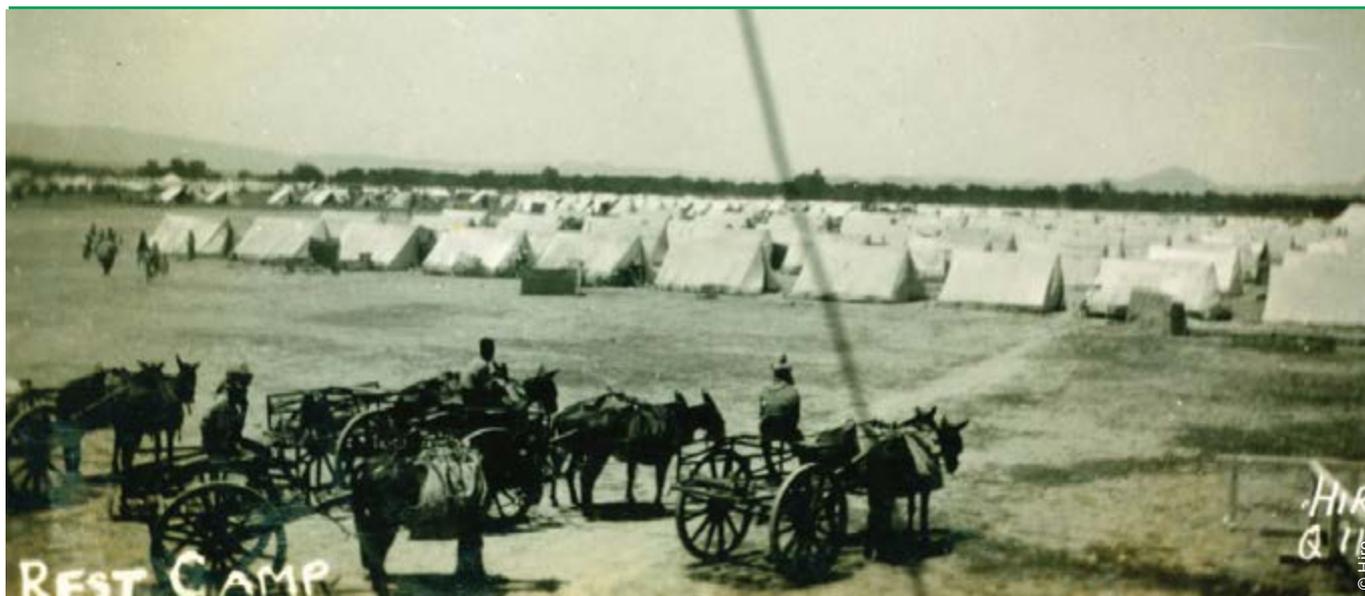
Camps were established as a measure to house homeless survivors. The largest hosted around 10,000 people in basic tents, often built by the people themselves. More durable tents were established to house the garrison.

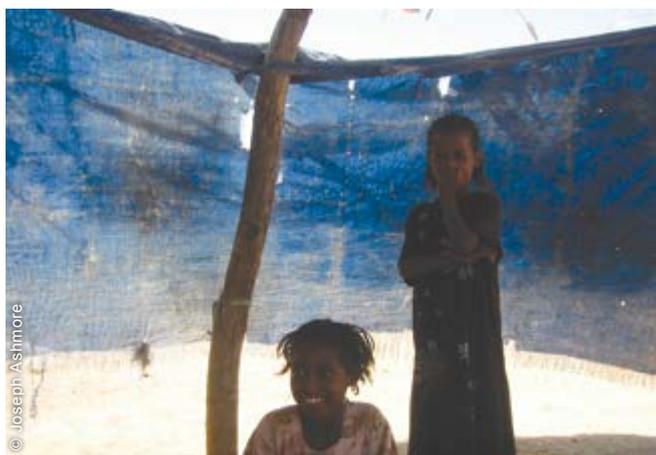
Poor-quality plastic sheeting in the field. This product can last just a few weeks when exposed to the elements.

Moving on from polythene film, agencies began to purchase the kind of cheap plastic sheets that can be found in a supermarket. These cost just USD 0.20 per square metre, but tear easily and the polyethylene is very sensitive to the ultraviolet rays in sunlight. As a result, they degrade very fast. After just a couple of weeks in the strong sun of South Sudan, the plastic turns into powder.

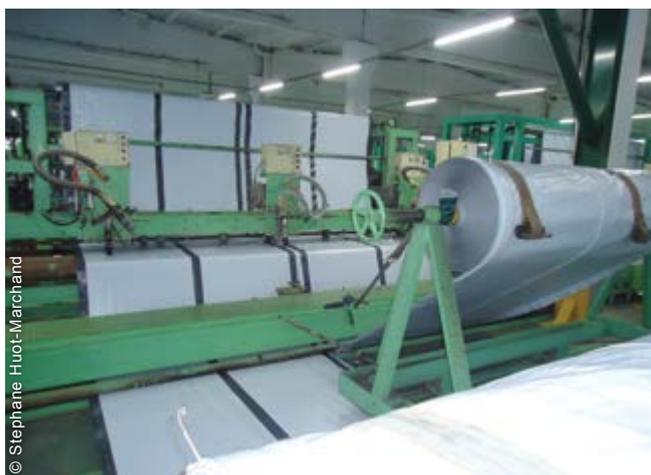
Suppliers started producing the new tarpaulin in the late 1990s. The use of reinforcement bands instead of eyelets allows for mechanization, increasing quality and speed of production.

- + **Technical solutions improved items' quality and workers' conditions.** For example, the use of reinforced bands with pre-punched holes in the tarpaulins, instead of eyelets, not only improves quality, tear resistance and is preferred by users, but also allows industrial processing, avoiding placing eyelets by hand in unacceptable working conditions.

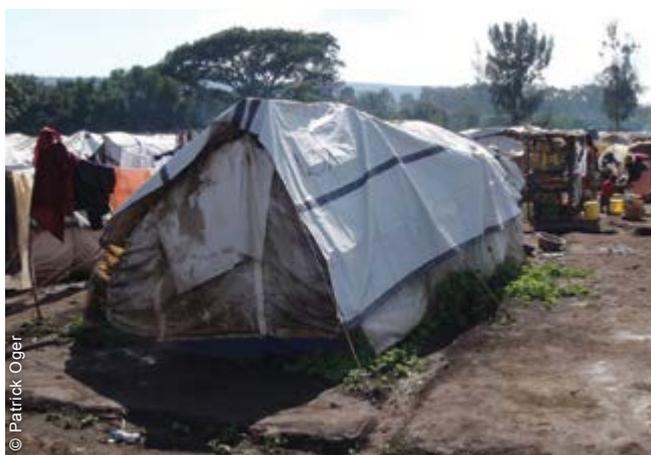
A good-quality tarpaulin can resist up to a year or longer. It can be used for multiple purposes, such as covering older plastic sheets to provide waterproofing.

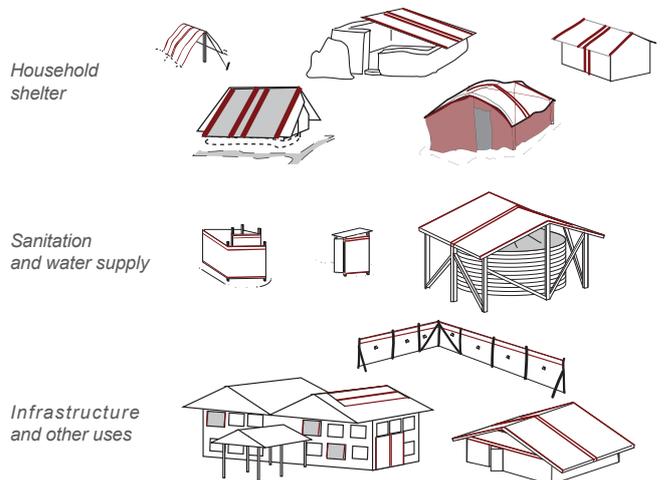
Tarpaulins can be extremely versatile. Guidelines on their procurement, use and testing are available at <http://www.plastic-sheeting.org/>.

Whilst agencies recognize that plastic sheeting is far from ideal and is only one component in shelter solutions in emergencies, it remains the most practical and cost-effective material in terms of logistics and functionality. It can also be used for multiple purposes other than shelter, including for construction of medical and educational facilities. Plastic sheeting is one of the most life-saving of humanitarian products, reaching millions of people every year. For those in need of emergency shelter, there is a huge difference between a good-quality tarpaulin with a prospected lifespan of a year or longer, and a poor-quality one with a lifetime of just a few weeks or months.

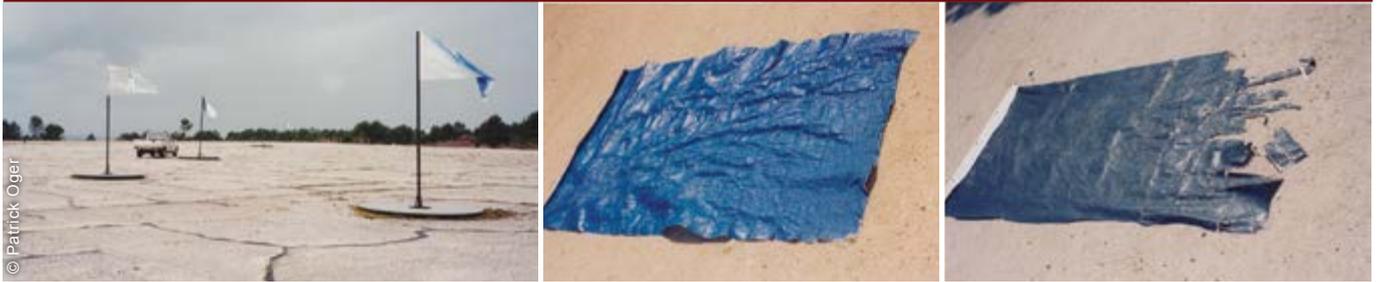
Flapping tests showed how poor-quality plastic sheets degrade and tear extremely quickly, especially when exposed to strong sunlight, as in most field applications.

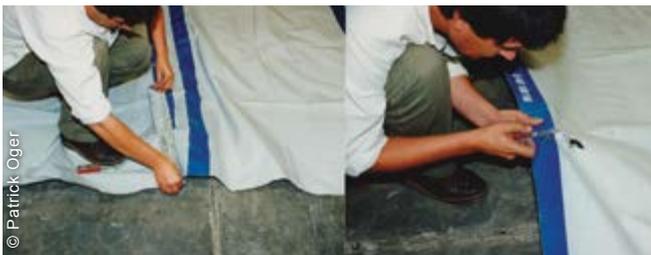
Peeling and scratching tests can be conducted in the field after basic training.

Quality control (QC) is implemented in multiple ways. Each line of the specification has corresponding tolerances and a grade to indicate whether shipments should be refused (a critical failure that compromises performance) or accepted (with or without penalties). Controls are made at factory door and in a network of agency managed QC centres in agency warehouses. The inspections are led by trained quality controllers and -- upon request -- with the help of external laboratories, in order to ensure compliance with the minimum requirements. If goods fail to match minimum requirements, financial penalties are imposed to suppliers and a corrective action plan is requested. A global network of 20 QC centres was established by four major agencies over the years using the same set-up. Agencies regularly meet and share findings.
