SHELTER PROJECTS

CENTRAL AND WEST AFRICA: 16 Case Studies

CASE STUDIES OF HUMANITARIAN SHELTER AND SETTLEMENT RELEVANT TO CENTRAL AND WEST AFRICA

Shelter Projects - Central and West Africa: 16 Case Studies

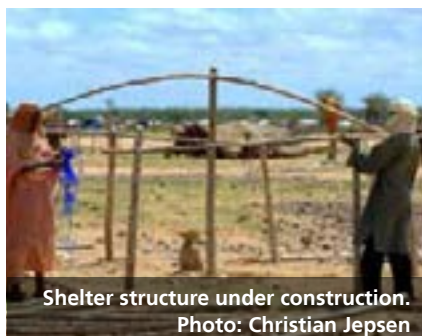
Shelter structure under construction.
Photo: Christian Jepsen

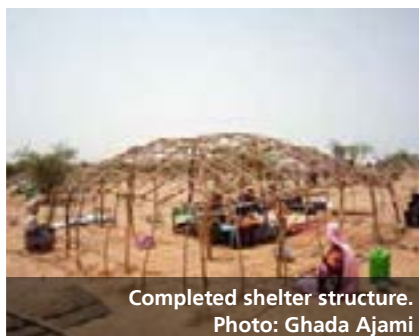
Completed shelter structure.
Photo: Ghada Ajami

Tuareg tents are suited to the environmental conditions: high wind loads, high temperatures and sand storms. The shelter contained no concrete so did not worsen water scarcity. The sides of the shelter were made from mats which could be re-positioned in order to change the location of the doors depending on the direction of the wind.

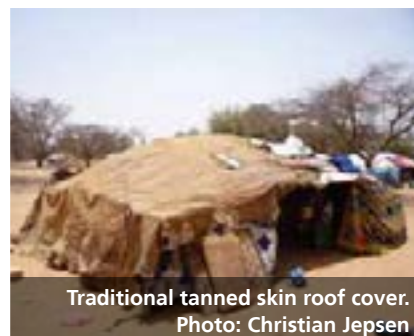
Traditional tanned skin roof cover.
Photo: Christian Jepsen

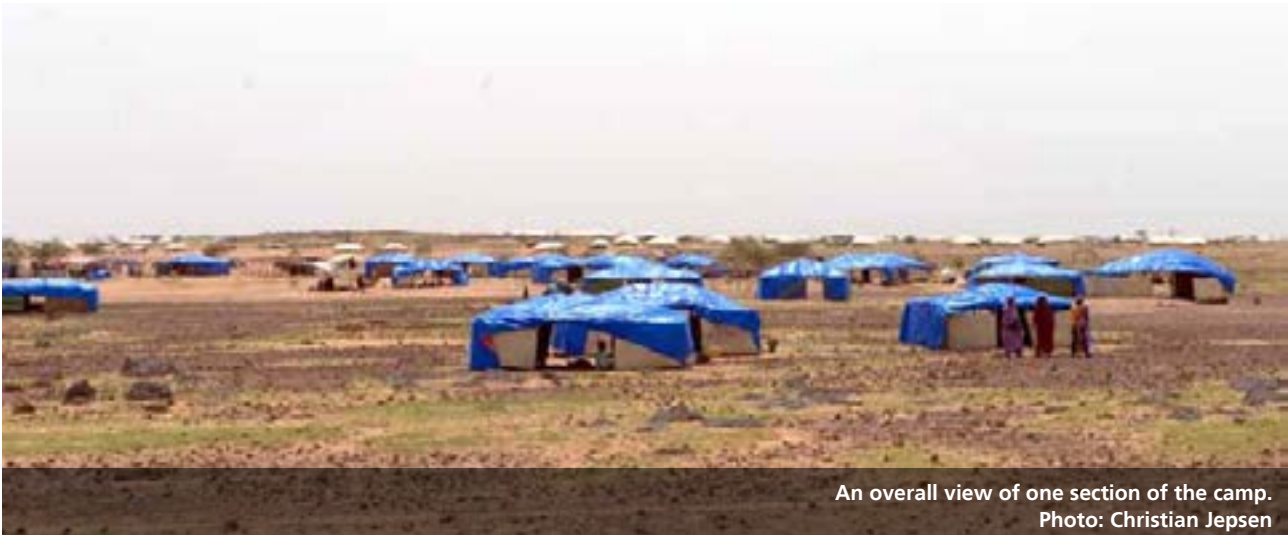
An overall view of one section of the camp.
Photo: Christian Jepsen

- Site planning at Férério camp had to adapt to the cultural norms and social structures of the camp population. A traditional grid layout was inappropriate and was rejected by the refugees who preferred to group their shelters according to tribal affiliations and space them in a way that reflected their usual, nomadic way of living.

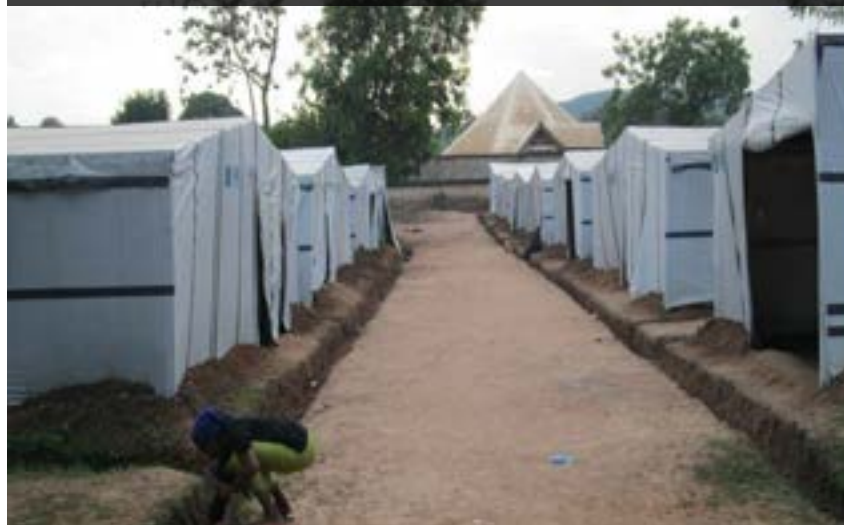
The project has a plan for returning the site to its former use, including filling in drainage channels.
Photo: ACTED

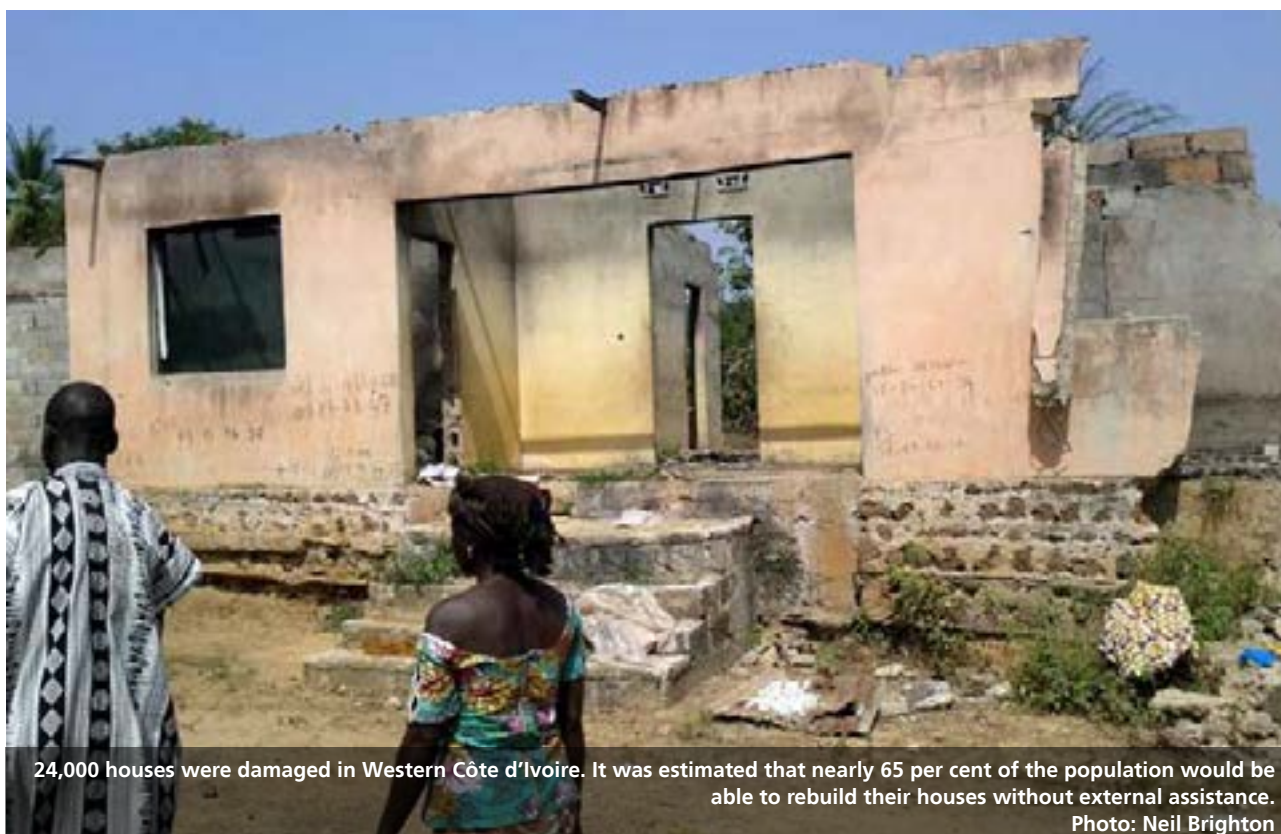
24,000 houses were damaged in Western Côte d'Ivoire. It was estimated that nearly 65 per cent of the population would be able to rebuild their houses without external assistance.

In Western Côte d'Ivoire, the vast majority of households lived in houses that are built with materials found locally and were either constructed from mud-bricks or wattle and daub. The roofs were thatched or covered in corrugated iron. Though the house walls were prone to erosion from rain and wind, and were relatively weak, they were built by the households themselves and contributed to a high self-recovery rate.

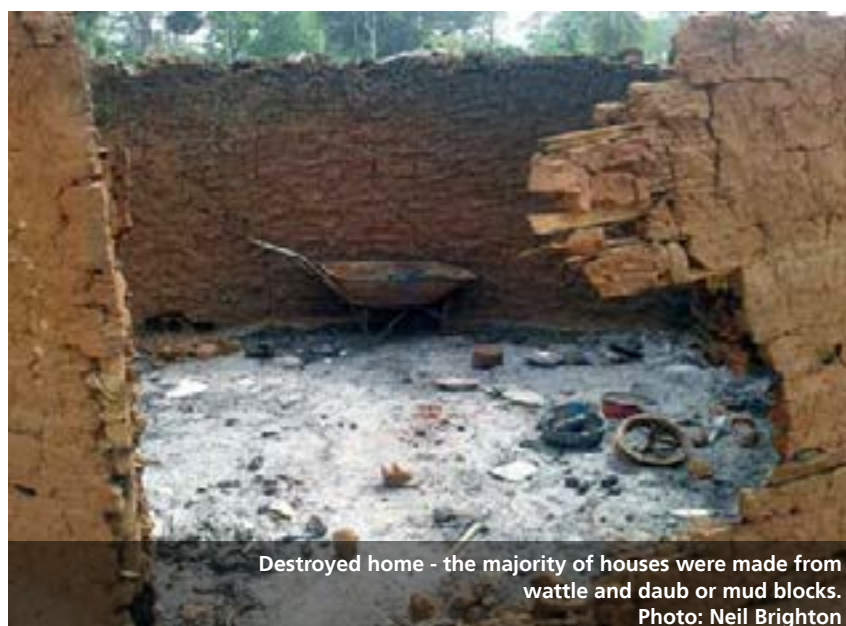
Destroyed home - the majority of houses were made from wattle and daub or mud blocks.

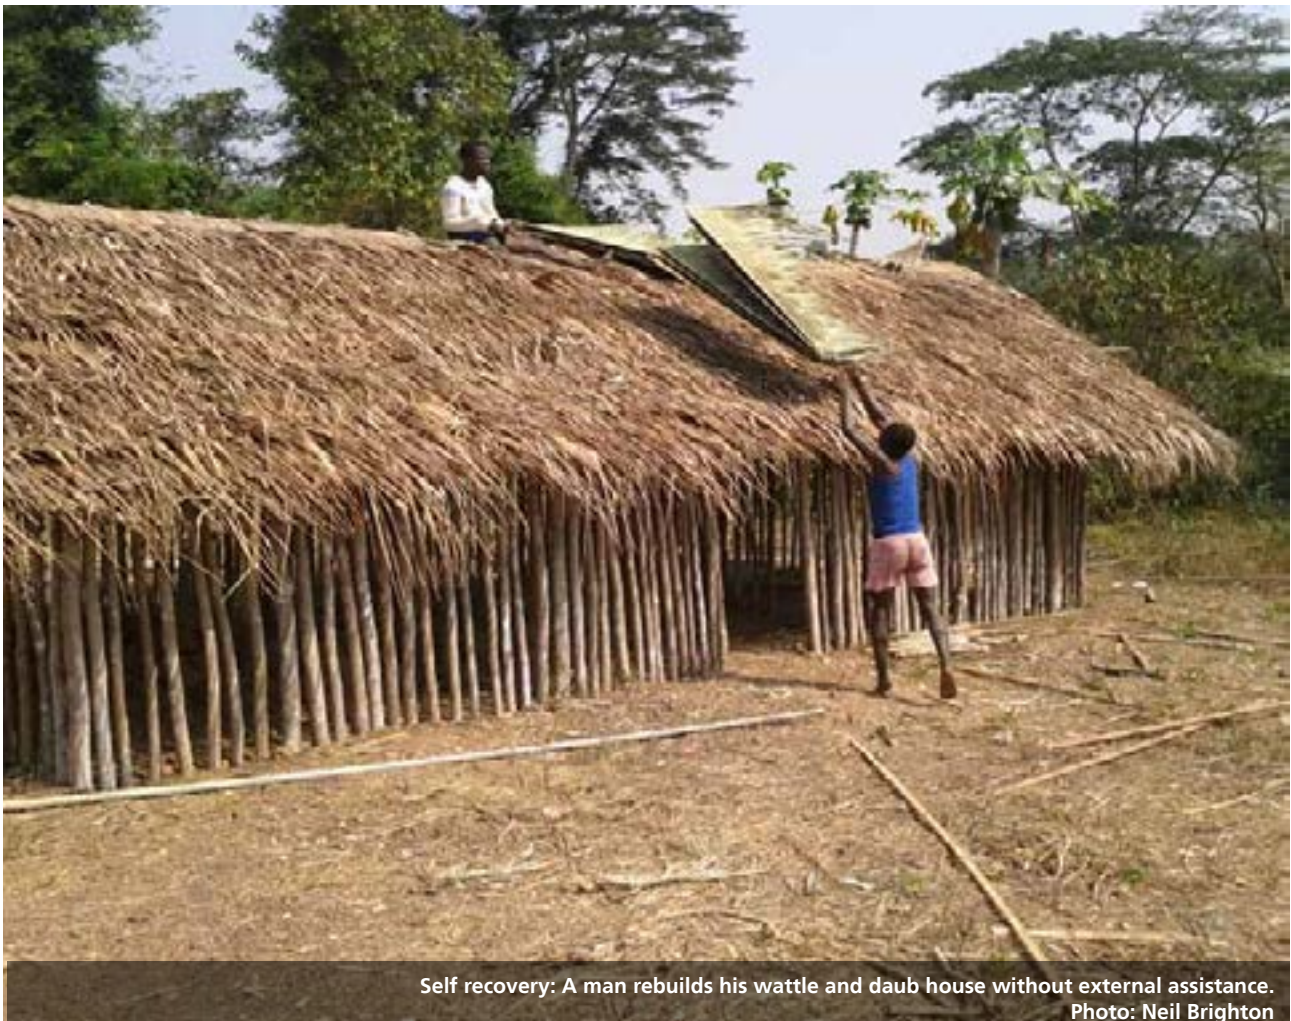
Self recovery: A man rebuilds his wattle and daub house without external assistance. Photo: Neil Brighton

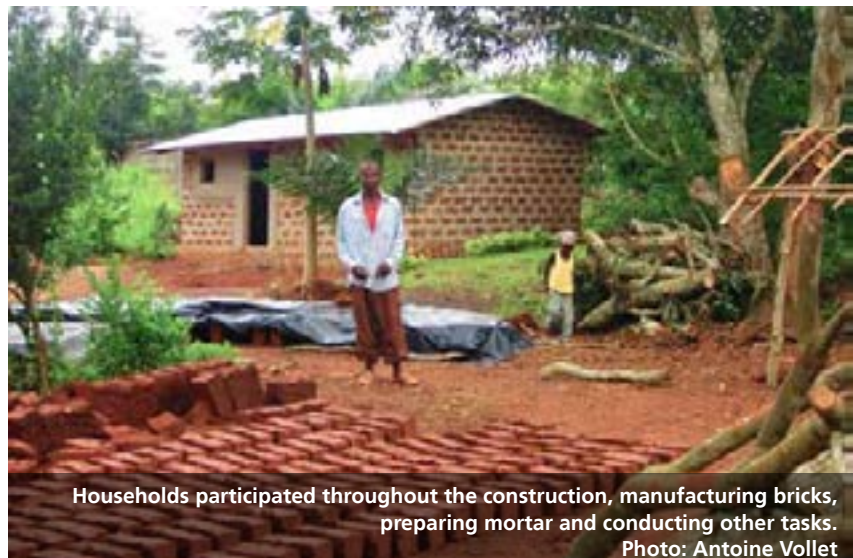
Households participated throughout the construction, manufacturing bricks, preparing mortar and conducting other tasks.

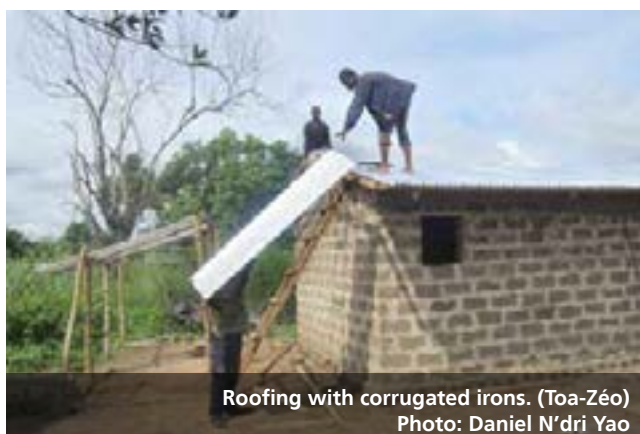
Roofing with corrugated irons. (Toa-Zéo)
Photo: Daniel N'dri Yao

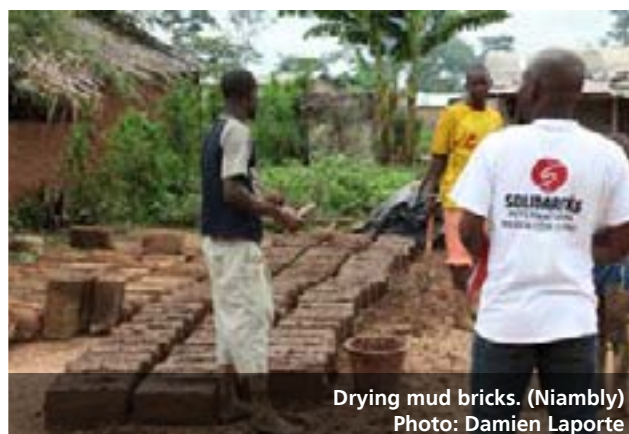
Drying mud bricks. (Niambly)
Photo: Damien Laporte

- In most communities, the population was not accustomed to working together and every step of the project required a meeting with all households.
- Rehabilitations often require technical skills and as a result are led by local masons and carpenters. To ensure participation, beneficiaries were asked to collectively produce mud-bricks.
- Some beneficiaries finished their houses earlier than the others.

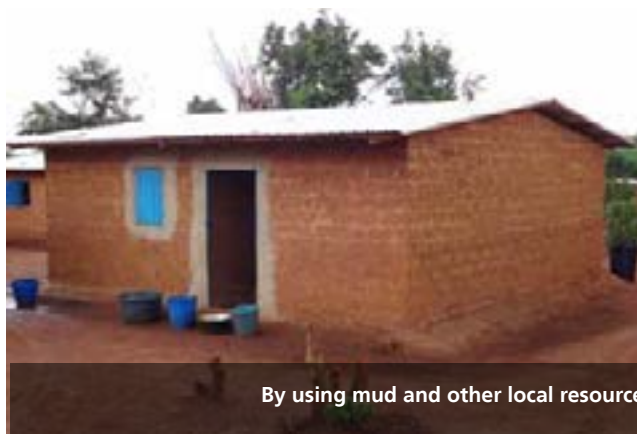
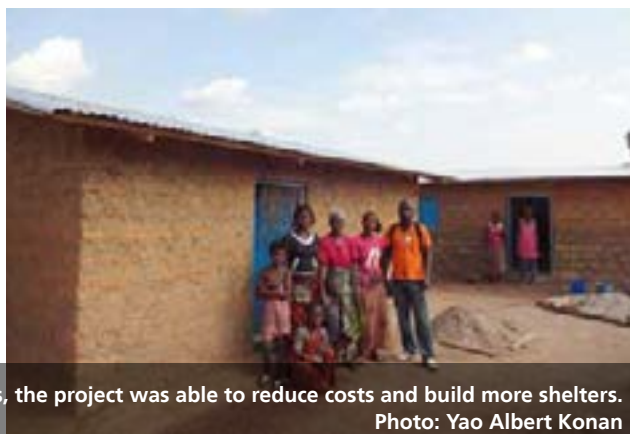
By using mud and other local resources, the project was able to reduce costs and build more shelters.

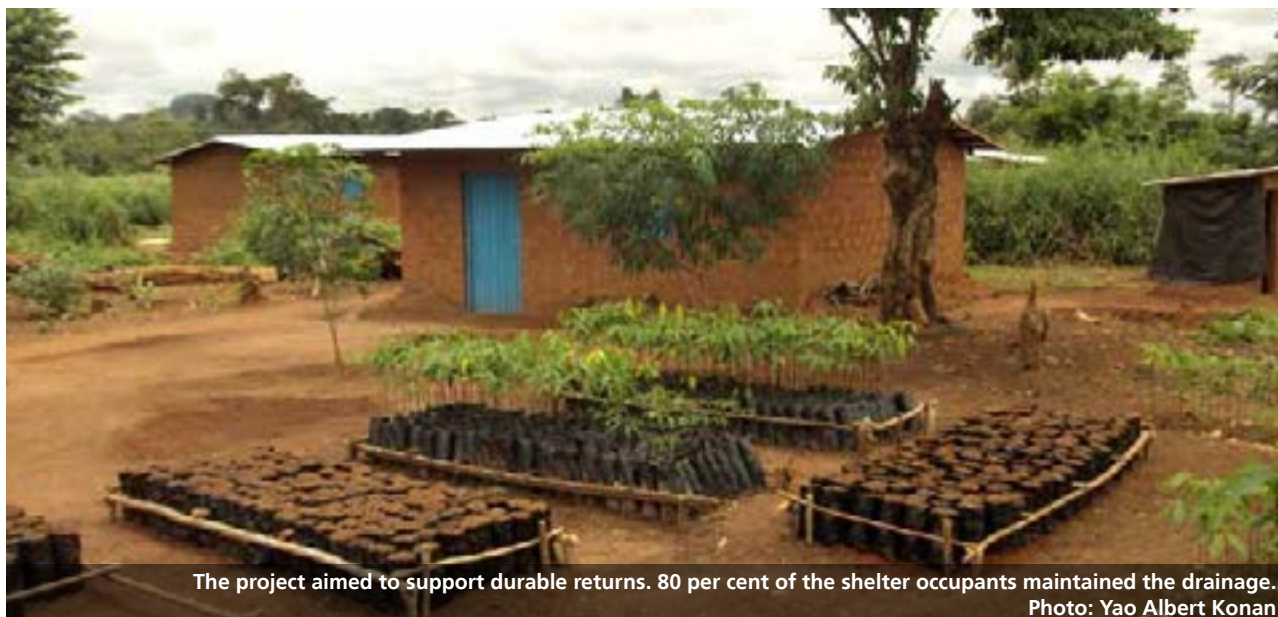
The project aimed to support durable returns. 80 per cent of the shelter occupants maintained the drainage.
Photo: Yao Albert Konan

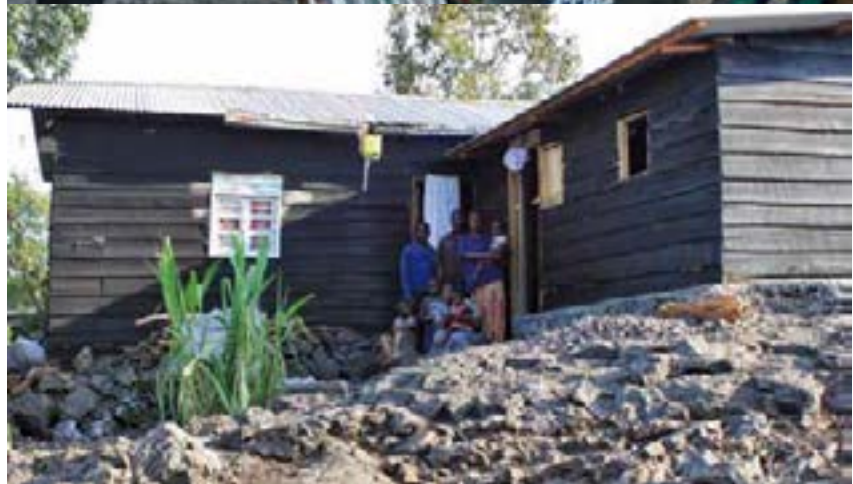
Materials distribution and construction for the host family support programme in urban environments in Goma
 Bottom: The building on the right is the extension built during the programme.
 Photos: Angela Rouse

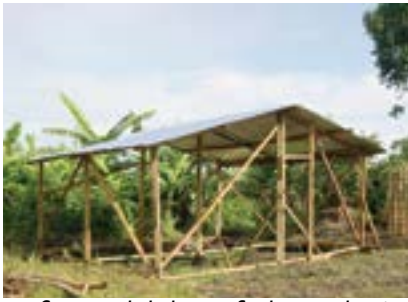
Structural skeleton of a house, showing cross-bracing

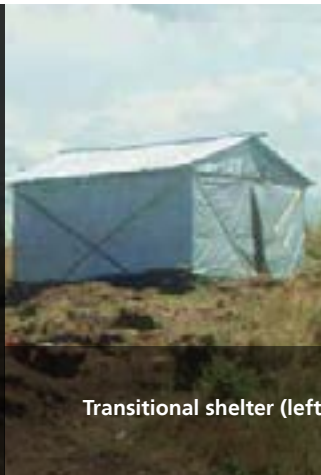
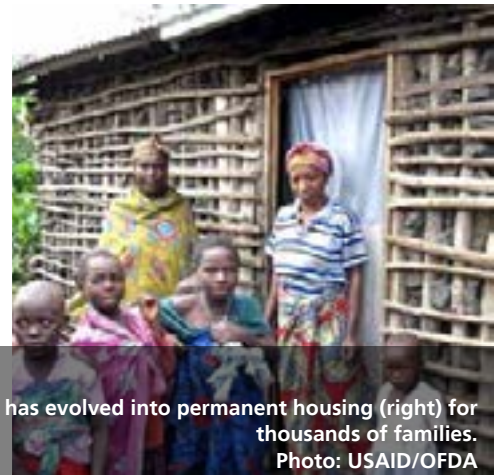
Transitional shelter (left) has evolved into permanent housing (right) for thousands of families. Photo: USAID/OFDA

✓ *Transitional shelter really can facilitate the transition to permanent housing.* As intended, nearly all of the original 5,000 “t-shelters” have been improved in some way as part of making it a permanent home. A site visit 2012 noted that most beneficiary families continue to live in their transformed transitional shelters. After ten years, some families are still making improvements leading to permanence, suggesting that the process of incremental housing development is both evident and likely to continue in the foreseeable future.

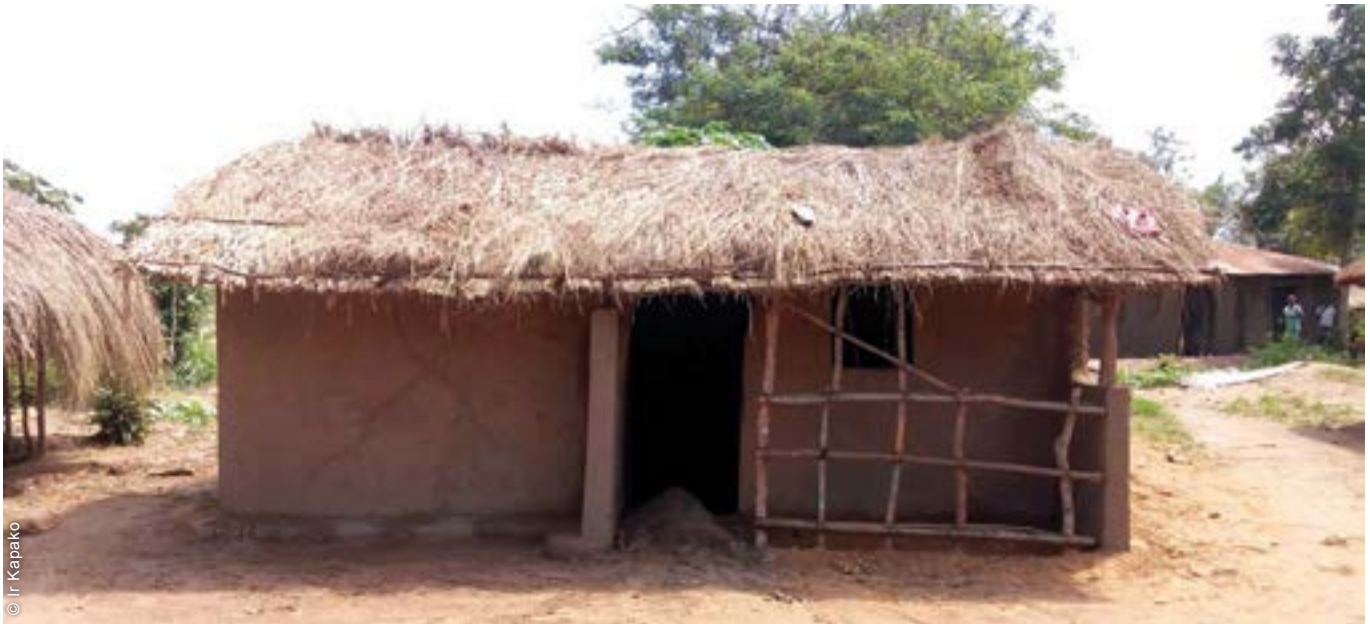
Shelters were cost-effective, as materials were locally available and labour was provided by the affected families themselves.

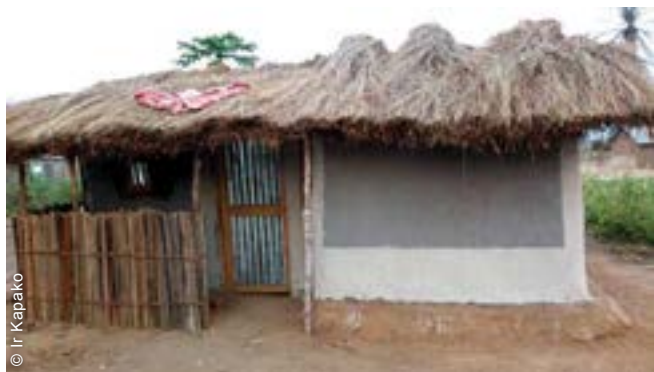
Communities actively participated in the design process. Thanks to their inputs, the shelters were expanded and a shaded veranda was added.

The addition of a covered veranda to the design had the advantage of reducing indoor cooking practices, which reduced health and fire hazards. More households in the area also started to apply the veranda to their shelters.

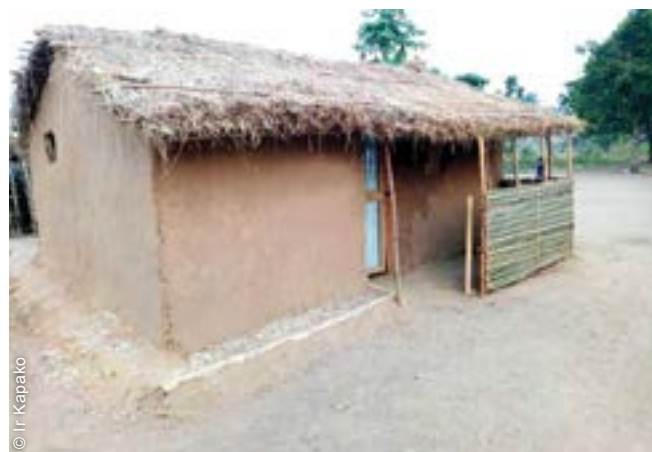
Other members in the communities were observed replicating some of the features and techniques proposed in this project, such as the outdoor veranda for cooking.

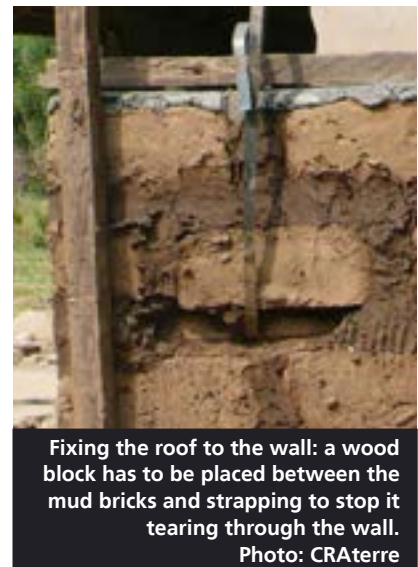
Fixing the roof to the wall: a wood block has to be placed between the mud bricks and strapping to stop it tearing through the wall.
Photo: CRAterre

The training was conducted by a team made up of the organisation's own shelter experts, the organisation's technical partner, and a university-based expert. The training focussed on improved roof-fixing methods, constructing a damp course, and bracing techniques.

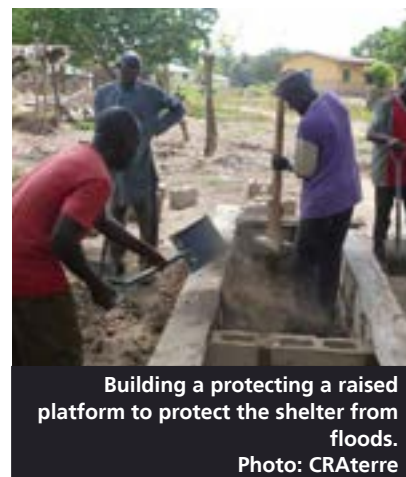
Building a protecting a raised platform to protect the shelter from floods.
Photo: CRAterre

Those communities employing a waterproof plinth (using Concrete Hollow Blocks) were educated about the capillarity characteristics of materials, and how this can be prevented using a damp proof course in the wall.

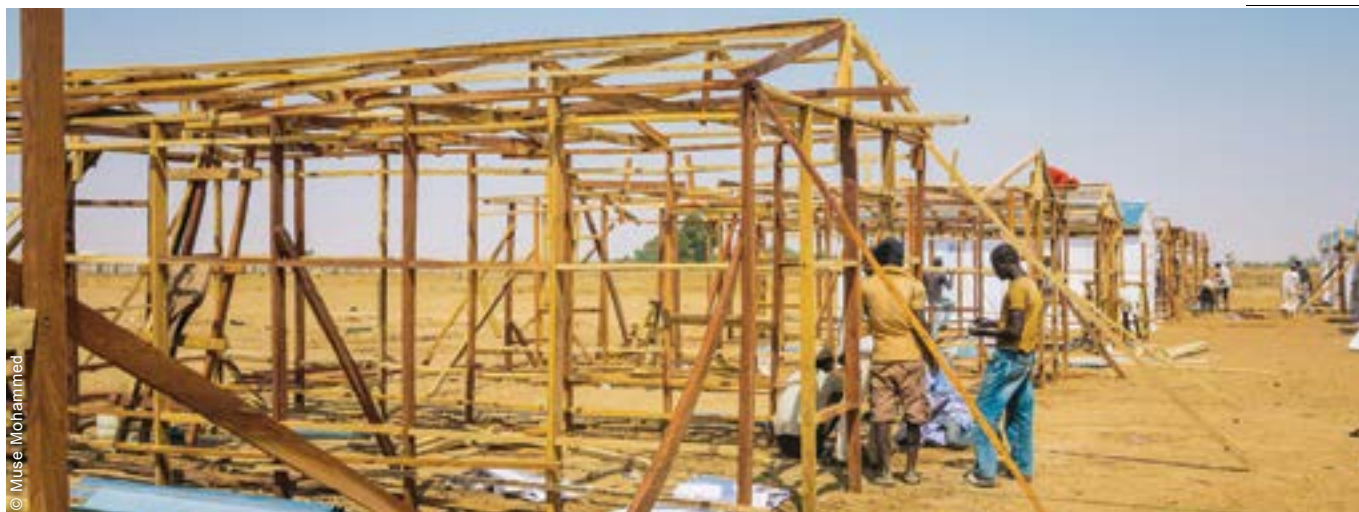
The shelters were built by contractors, with the condition that they hired workers locally including IDPs, who received on-the-job training.

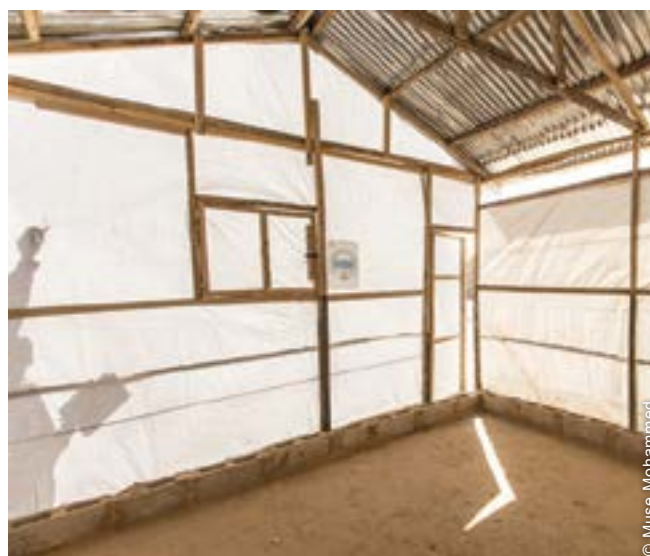
Two models of shelter were agreed upon by all agencies: one for emergency response and one with a longer lifetime (two years anticipated).

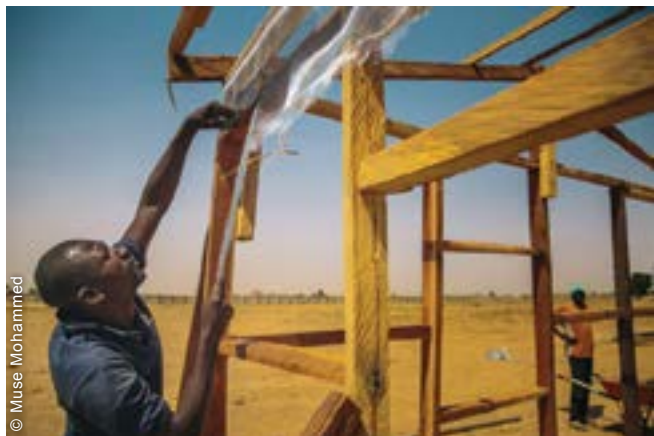
Shelters included specific details, such as mosquito nets in the open gap beneath the roof, which was intended for ventilation.

The original design presented by the Sector Working Group featured a **raised roof and an open space under the eaves** for ventilation. The design had to be quickly adjusted to include concrete foundations and metal strips to lock all trusses to the beam, to **prevent the entire structure from being lifted by strong winds**. Backfilling in all shelters was also undertaken, to raise the plinth to prevent water coming into the shelter.

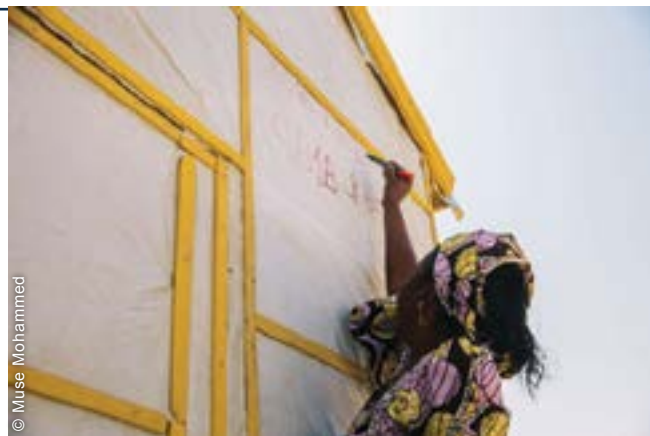
Shelters were numbered to facilitate the allocation process.

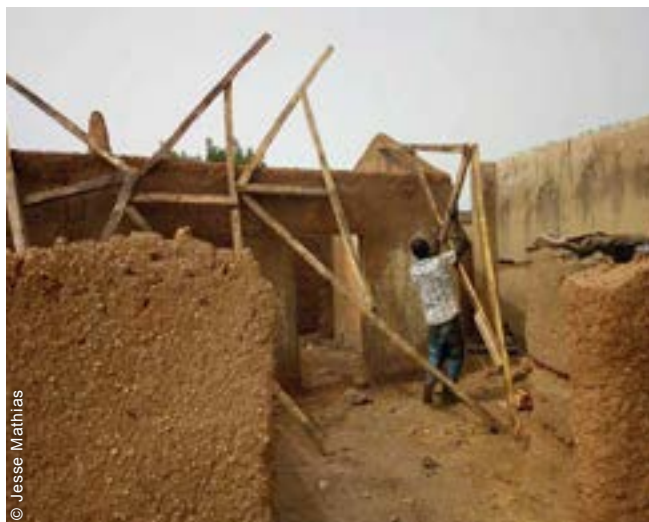
The project rehabilitated damaged houses in return areas by providing materials and technical assistance.

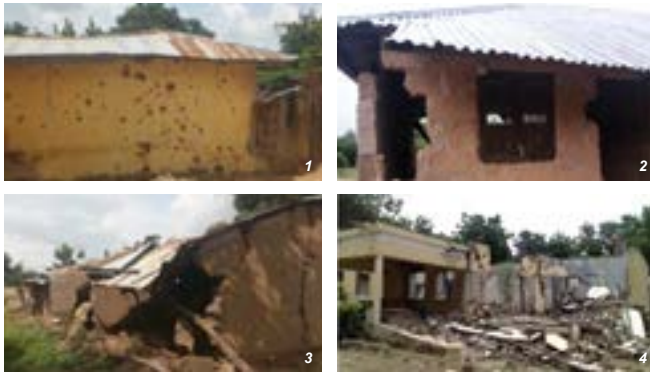
Damage was categorized in four groups. 1) Bullet holes on the external walls but not penetrated inside; hairline cracks in very few walls; fall of small pieces of plaster only. 2) Doors and/or windows need to be replaced, damage to brickwork 10%. 3) Failure of structural elements, damage to walls 25%. 4) Completely damaged with bullet holes, serious failure of walls; partial structure failure of roof and floor.

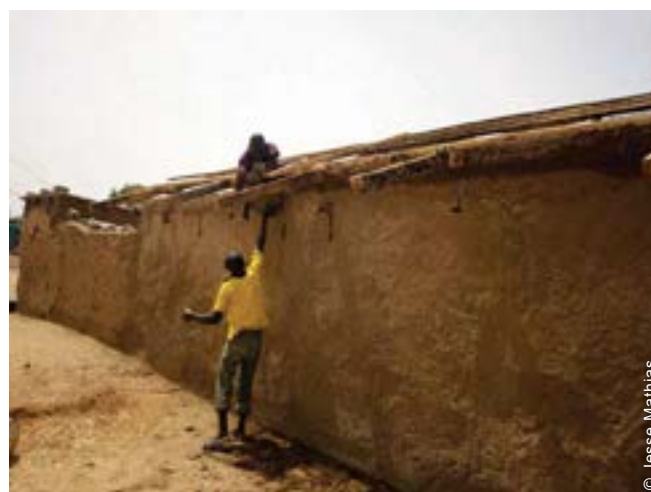
Families were able to repair their entire house, in some cases even expanding the original size. This also supported family reunification.

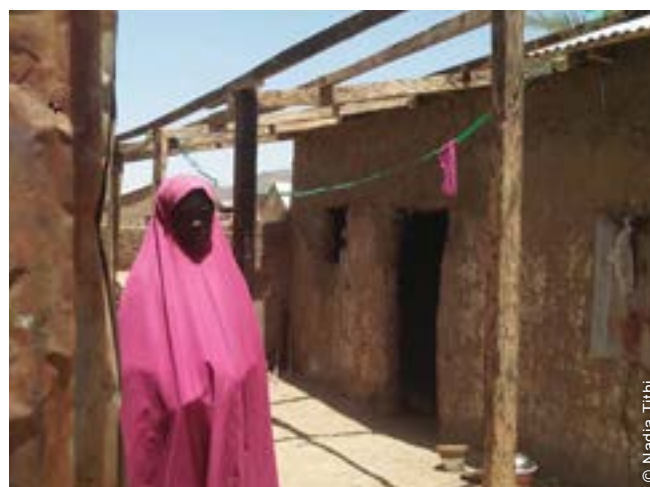
In some cases carpenters helped vulnerable members of their communities to rehabilitate their houses.
