A.5 Liberia- 2007- IDPs, refugees

Self-build shelters

- Community mobilisation
- Self-build shelters
- Materials distribution
- Cash payment for materials and labour
- Technical support for improved design

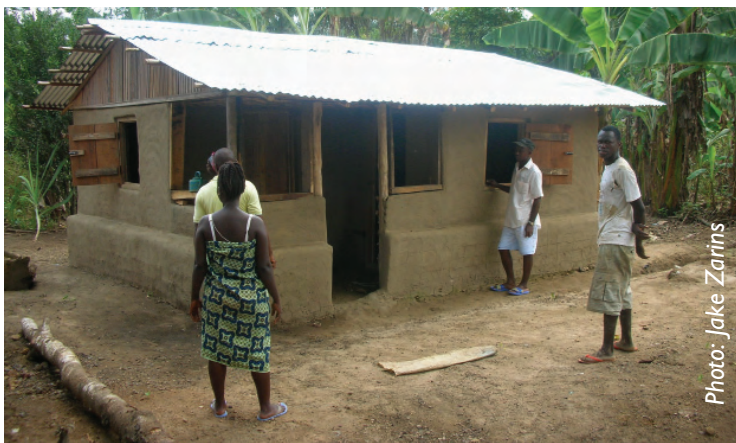
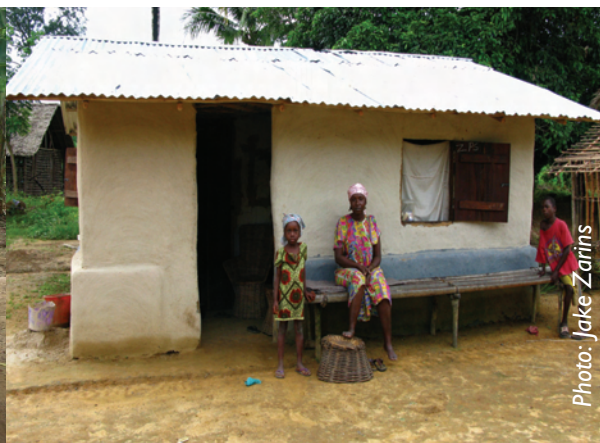
Completed houses for returnees

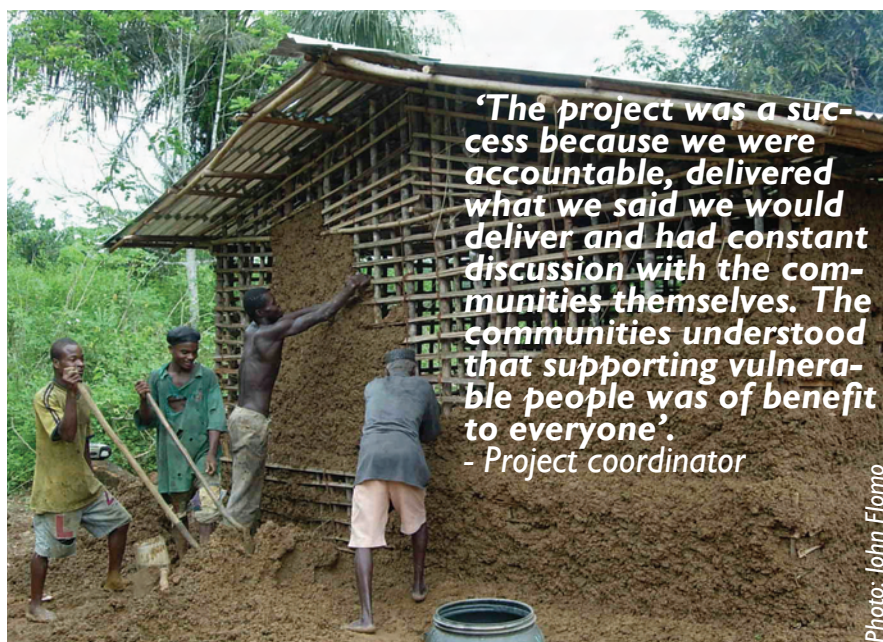
Traditional shelters under construction

The traditional house design is a bush pole-framed, mud-walled construction with a thatched roof of grass or palm leaves. The project improved the design to include a corrugated iron roof, which reduced the need to maintain a thatch roof, and a stronger central pole to improve structural stability.

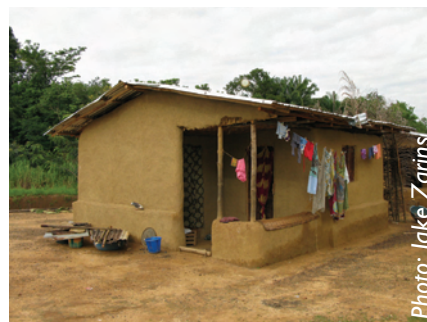
Completed house

Shelter supervisors marked out the agreed 25m². A standard design was proposed for a two-room construction with a veranda. However, beneficiaries were free to alter this design according to their needs. The NGO felt it necessary to make further stipulations about central support poles, to ensure that the building was safe once the project was underway.
