## B.9 Pakistan - 2005- Earthquake

## B.10 Pakistan - 2005 - Earthquake

### Case Study: Transitional shelter construction

## B.II Pakistan - 2005 - Earthquake

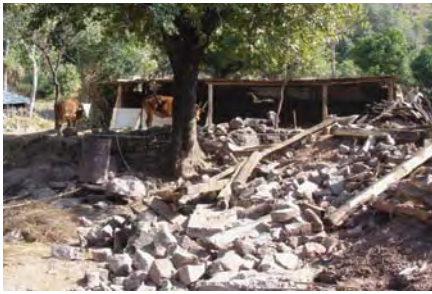
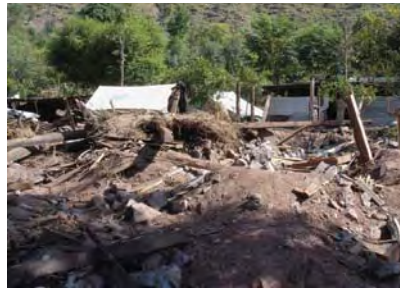
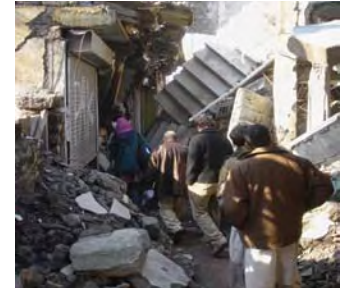
Destroyed rural houses (left, centre) and urban houses (right) in Kashmir

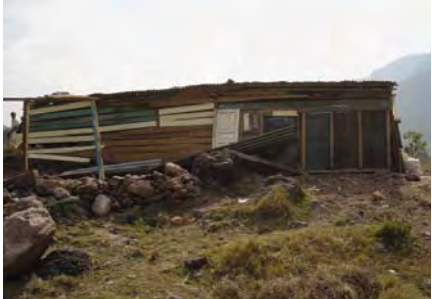
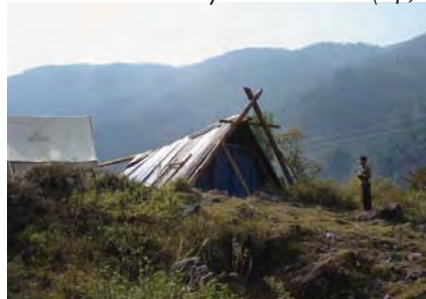
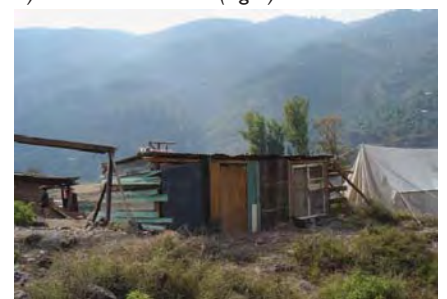
Self-built shelters in Kashmir built using reclaimed materials only ten days after the earthquake

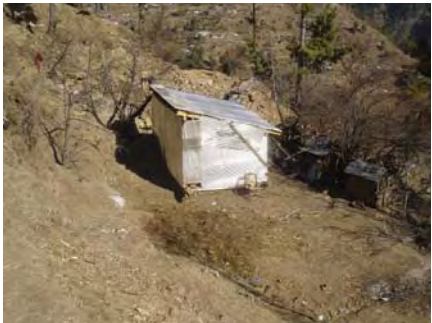
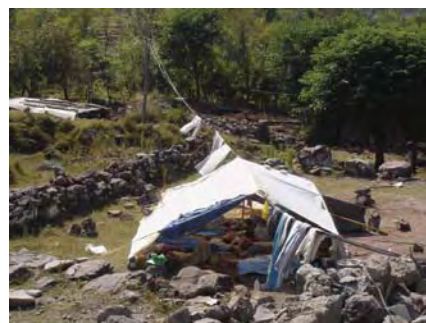
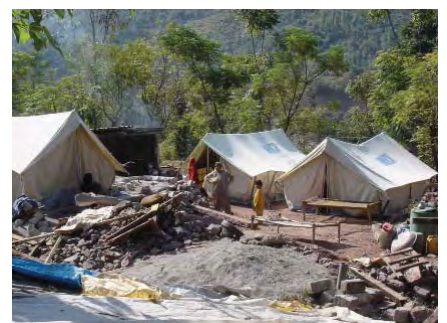
Left to right: Self-built shelters in Kashmir using donated iron and toolkits, an emergency shelter days after the earthquake, tents.

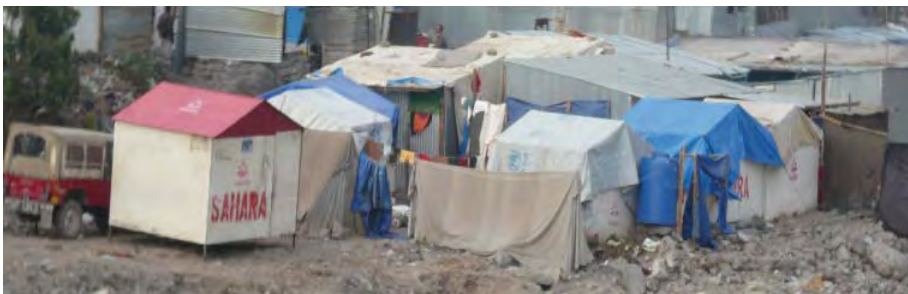
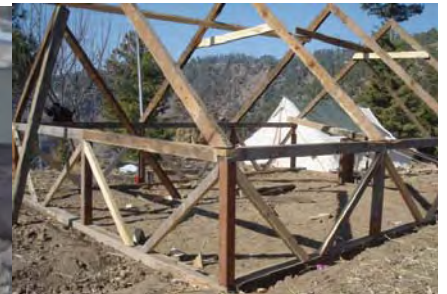
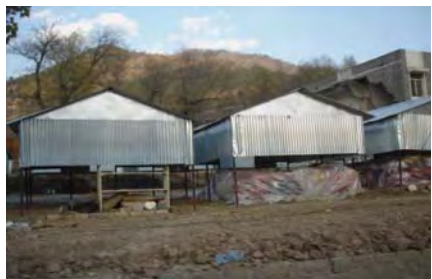
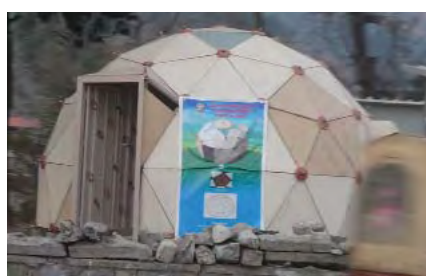
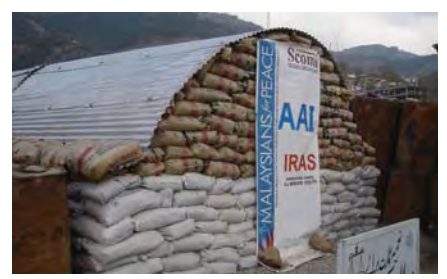
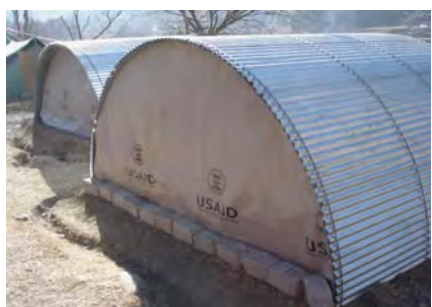
Above, assorted model shelters built in the North-West Frontier Province and Kashmir. Note that not all of these models (e.g. the domed shelter design in the centre) were culturally acceptable, sufficiently durable or spacious enough for people to live in.

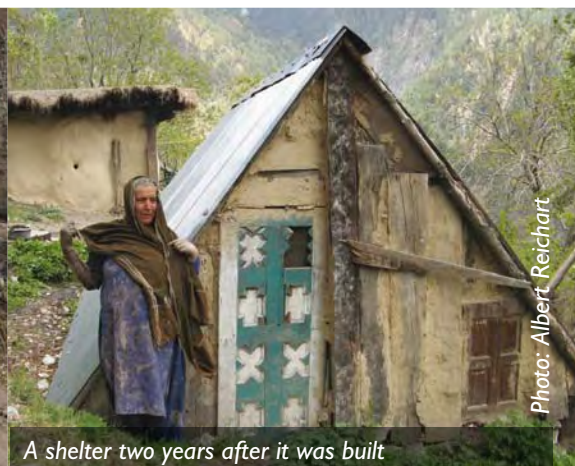
A shelter two years after it was built

After two years, nearly half of the shelters were still standing in their original position. Of those that had been removed, one was reassembled in the summer pastures. Shelters were commonly removed to make space for the 'permanent' house or to reuse the materials. The corrugated iron and the timber were the most commonly reused materials.

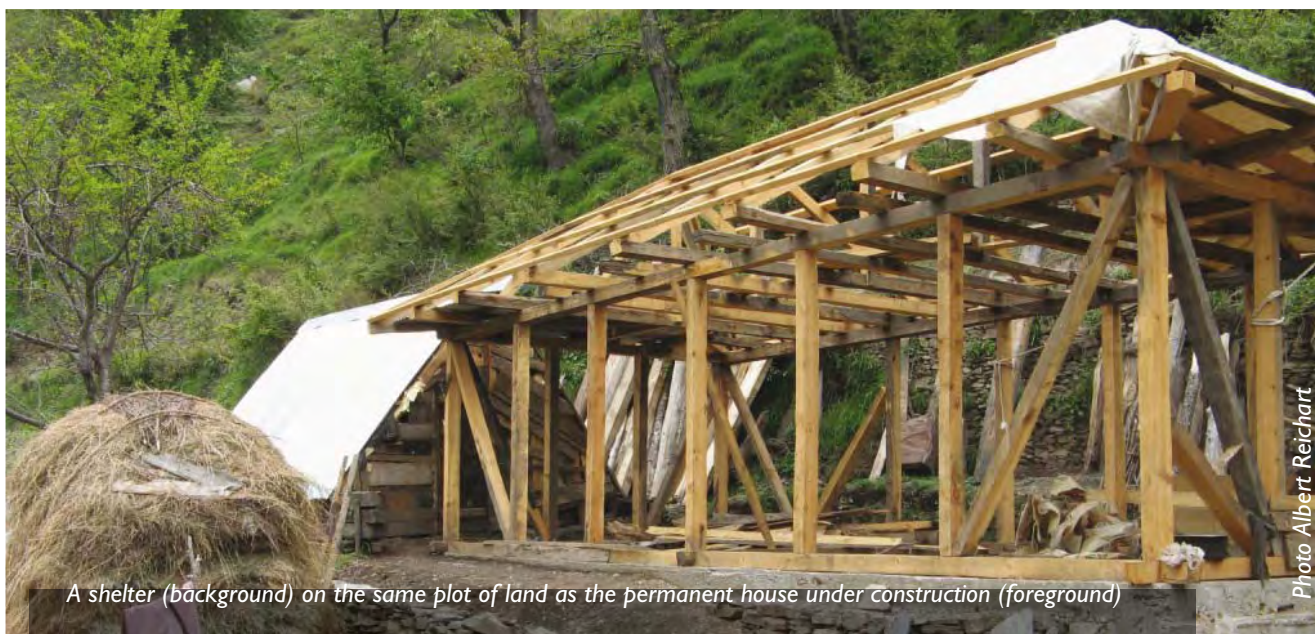
A shelter (background) on the same plot of land as the permanent house under construction (foreground)

W Because they were built on the same plots, many shelters had to be later demolished to build permanent houses.

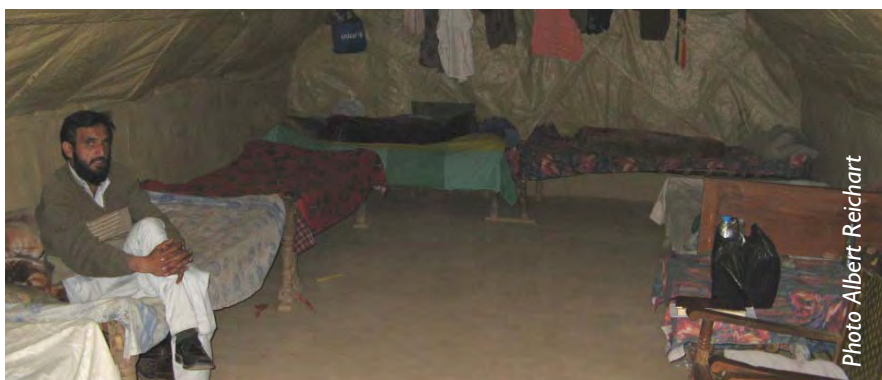
Inside one of the transitional shelters

The shelter design had low walls and a sloping corrugated iron roof. It provided covered space for people and for their livestock (at one end). Its base was made of soil. On this base, walls were built out of polypropylene sacks filled with soil. The higher parts of the wall were made from sacks filled with lighter materials, such as crop wastes, straw or pine needles. The roof was made from corrugated iron fixed to a reclaimed timber frame. Additional sandbags were provided with the intention that they would be filled with lightweight material and placed against the corrugated iron as insulation.

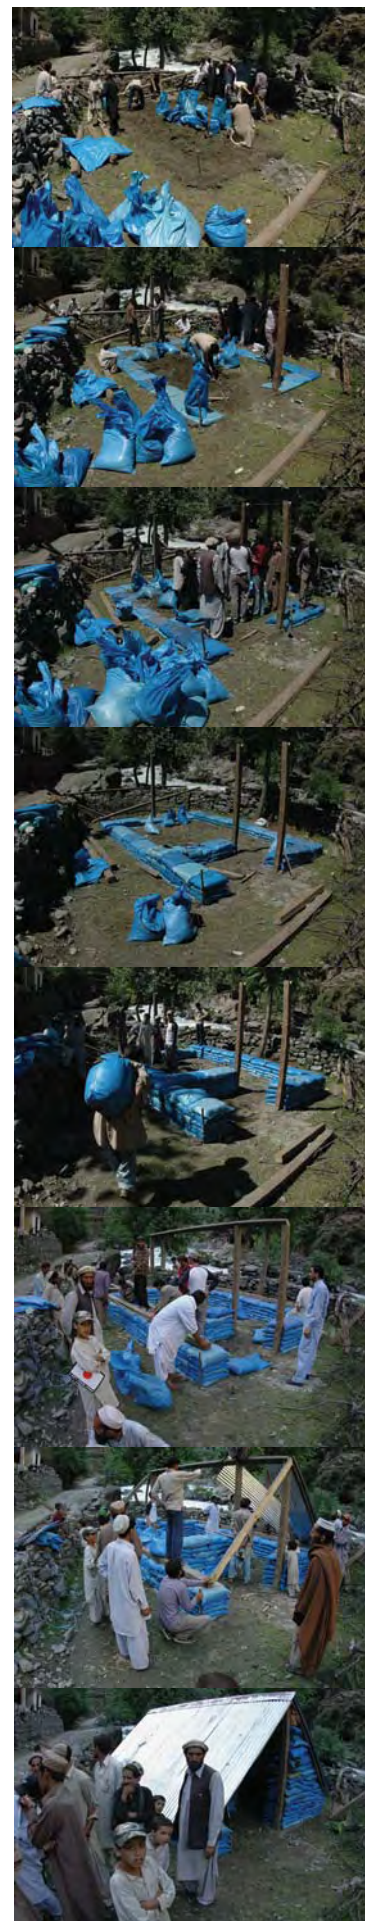
Building one of the transitional shelters

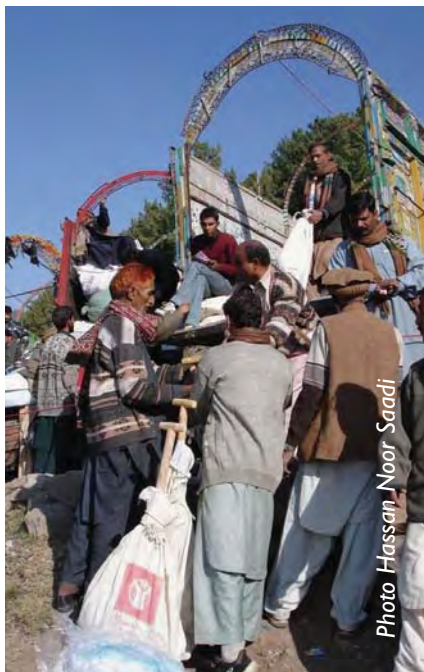
*The shelter programme distributed directly to affected families*

Corrugated iron and plastic sheeting were distributed for use as roofing materials. The advantage of corrugated iron and plastic is that they are relatively lightweight. Even a poorly built shelter is unlikely to kill people in the event of further aftershocks and building collapse.

Toolkits containing basic carpentry and earthmoving tools, as well as nails and metal strapping for use as fixings, were developed through a limited but rapid community consultation. The time pressure was such that orders for large numbers of kits could be rapidly placed, leading to cost and logistics savings. The idea of delivering
