## C.2 Peru - 2007- Earthquake

## C.3 Peru - 2007 - Earthquake

### Case study: Community mobilisation

### Case study: Self-build transitional shelters

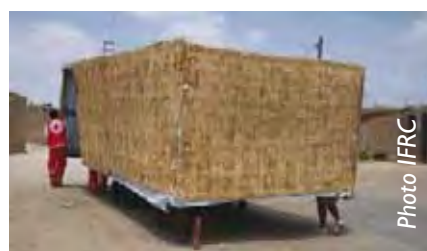
*Some programmes supported people to build lightweight shelters so that landless people could benefit from assistance programmes.*

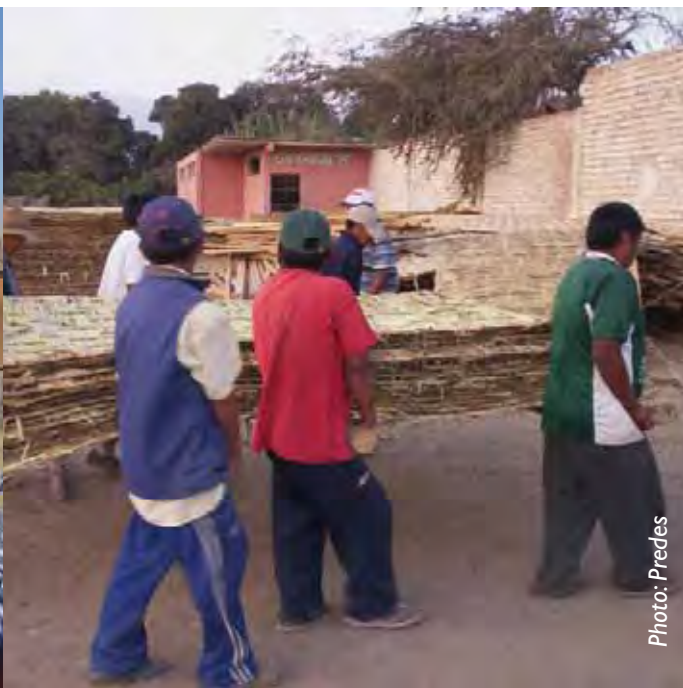
Transporting the mats for a shelter to site

Beneficiaries were first given wooden poles and received the mats only when the structure was properly assembled. Materials were distributed by the block coordinators. Most families ended up digging a new latrine on their property.

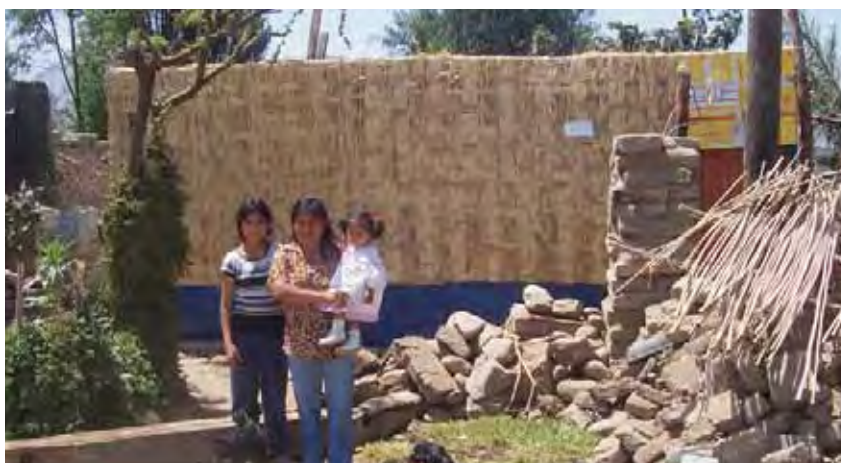
Family shelter built during the project

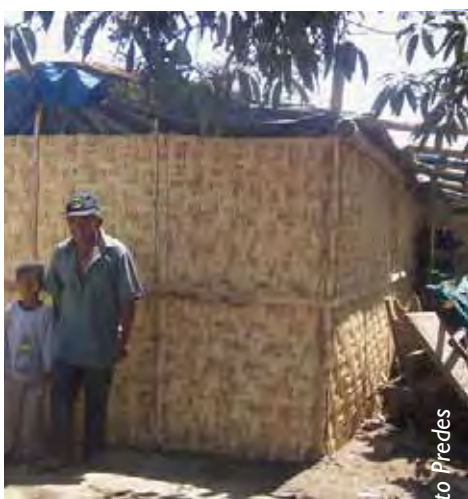
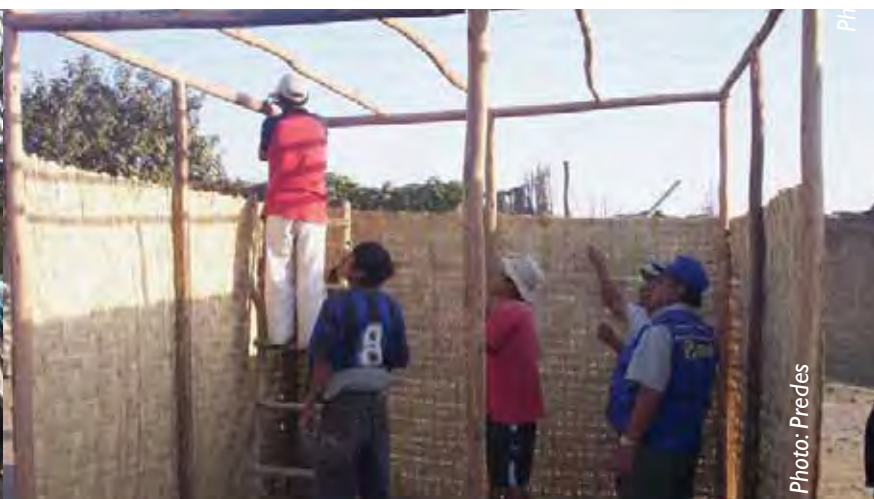
Making a basic shelter

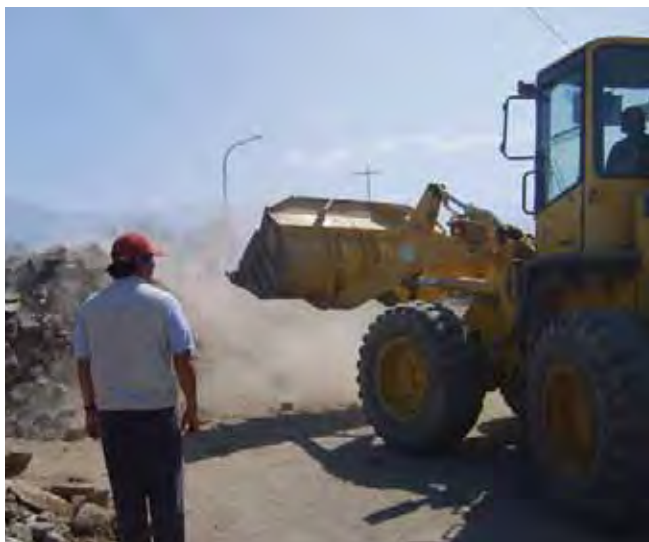
Rubble clearance

The project was conducted in close consultation with the local authorities. Before distribution of materials could take place, each family had to clear the debris from their damaged house into the street.

The mayor had the responsibility of removing the debris from the streets in trucks. The programmes supported the authorities through cash for work for debris clearance.

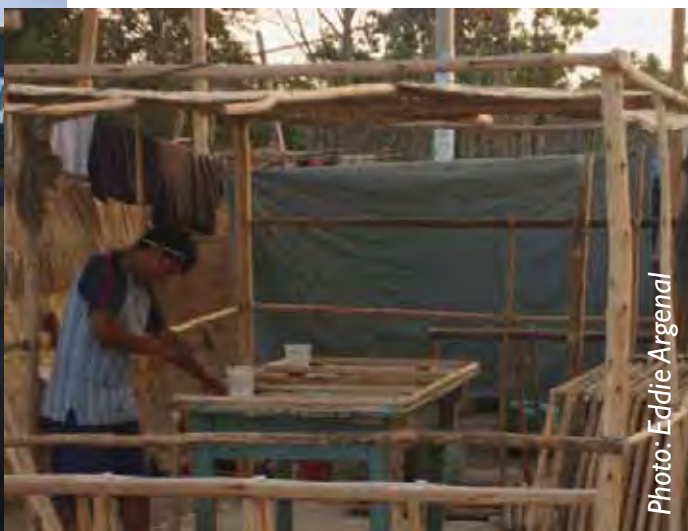
Fabricating doors

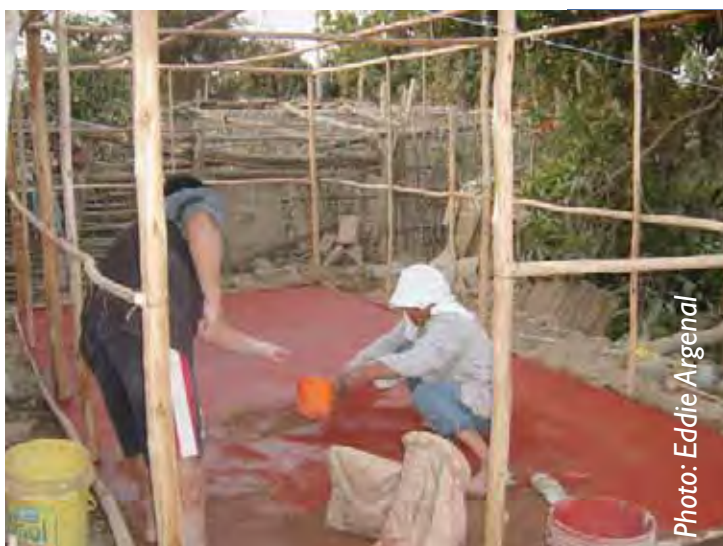
Making the concrete floor slab

The shelter provided had an area of 18 m<sup>2</sup>, enough to host a family of five. The shelter area was chosen based on Sphere indicators. The shelter itself consisted of a timber pole-framed structure with a soil-cement mix as flooring. Plastic sheeting covered the timber structure and woven reed mats were placed on top of the plastic sheeting to increase insulation and

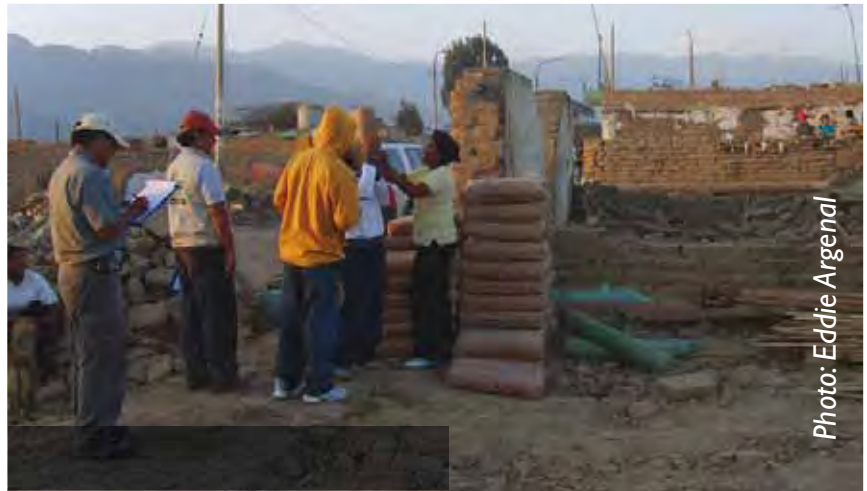
Distributing cement

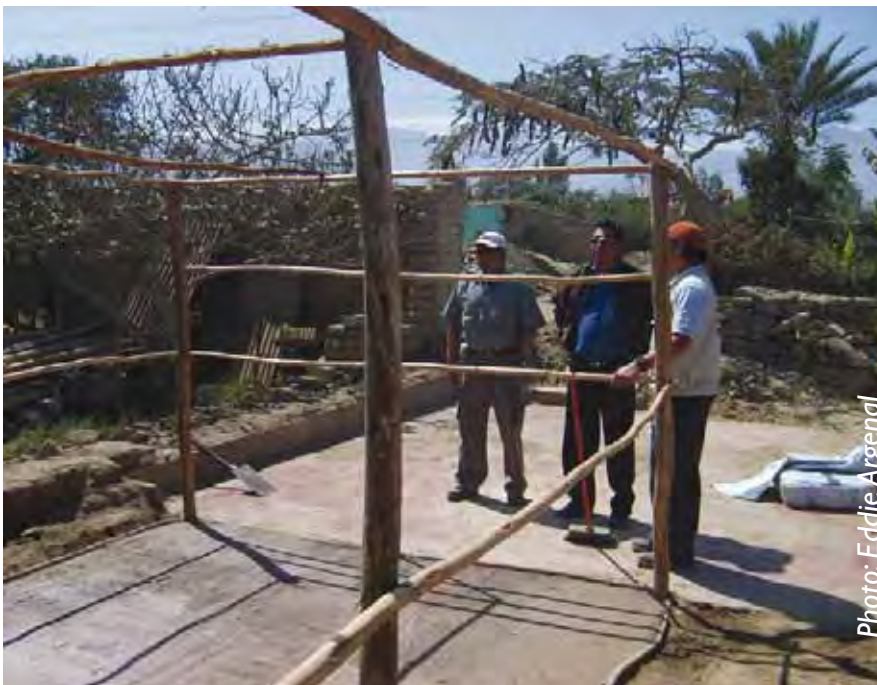
Round poles, not sawn timber, were used

Timber poles proved easier to procure than sawn timber and the local population was accustomed to building with them.

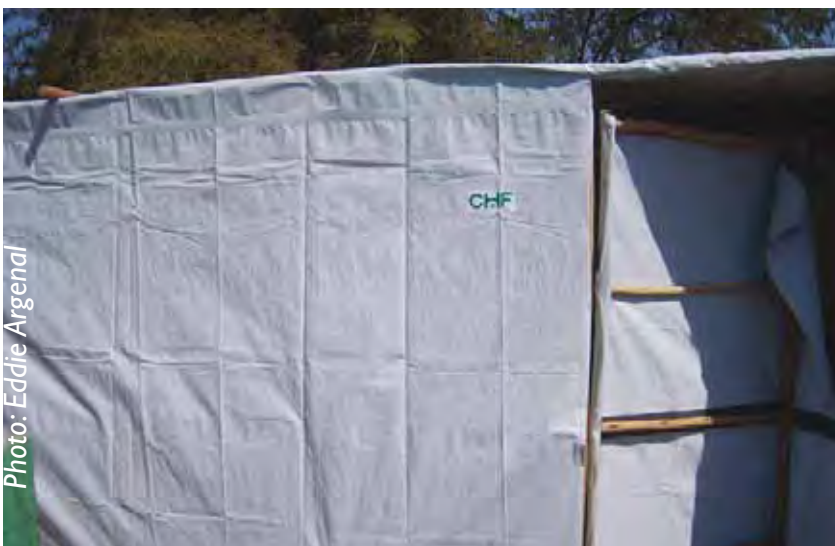
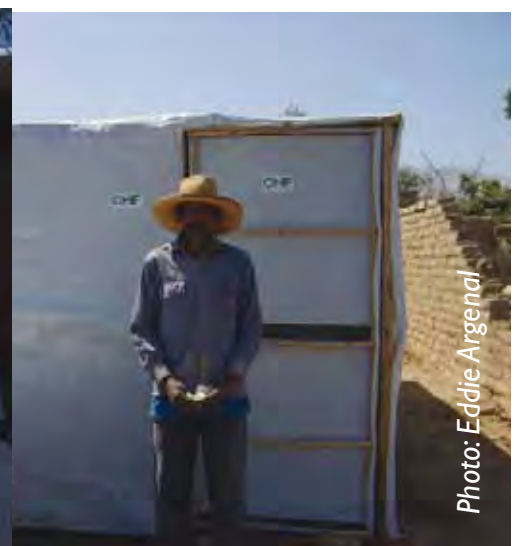
Shelters under construction

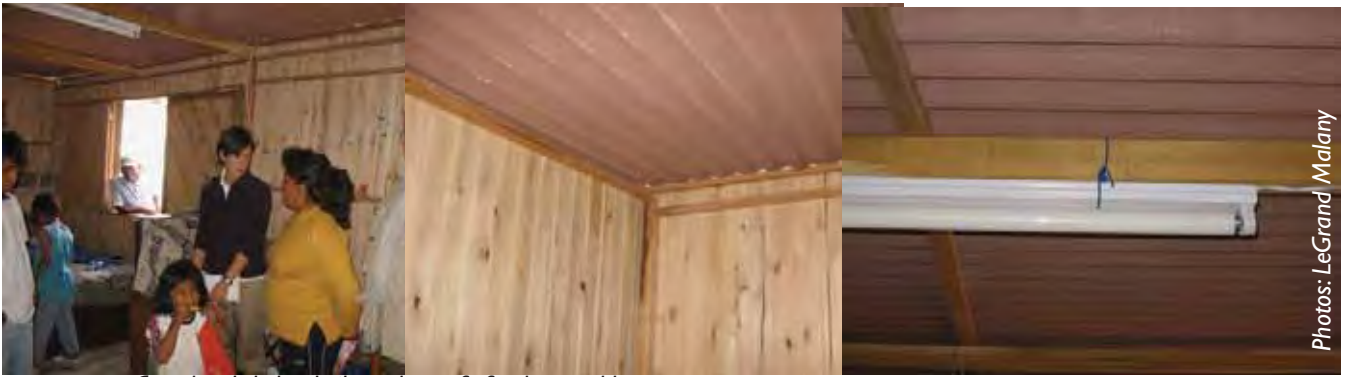
*Completed shelter built on the roof of a damaged house*

The shelter design was a rectangular, single-storey, 18m<sup>2</sup> (3m x 6m), wood-framed, shed-roofed building. The side covering was vertical, tongue-and-groove wood. Each panel was approximately 1cm thick and approximately 10cm wide. The shelter had one door and a large window on one long wall (at the front). The roof was a shed style made with lightweight, corrugated cement panels approximately 1m wide and about 2cm thick. The roof panels were long enough to run the full width of the roof. The flooring used pre-existing concrete slabs.

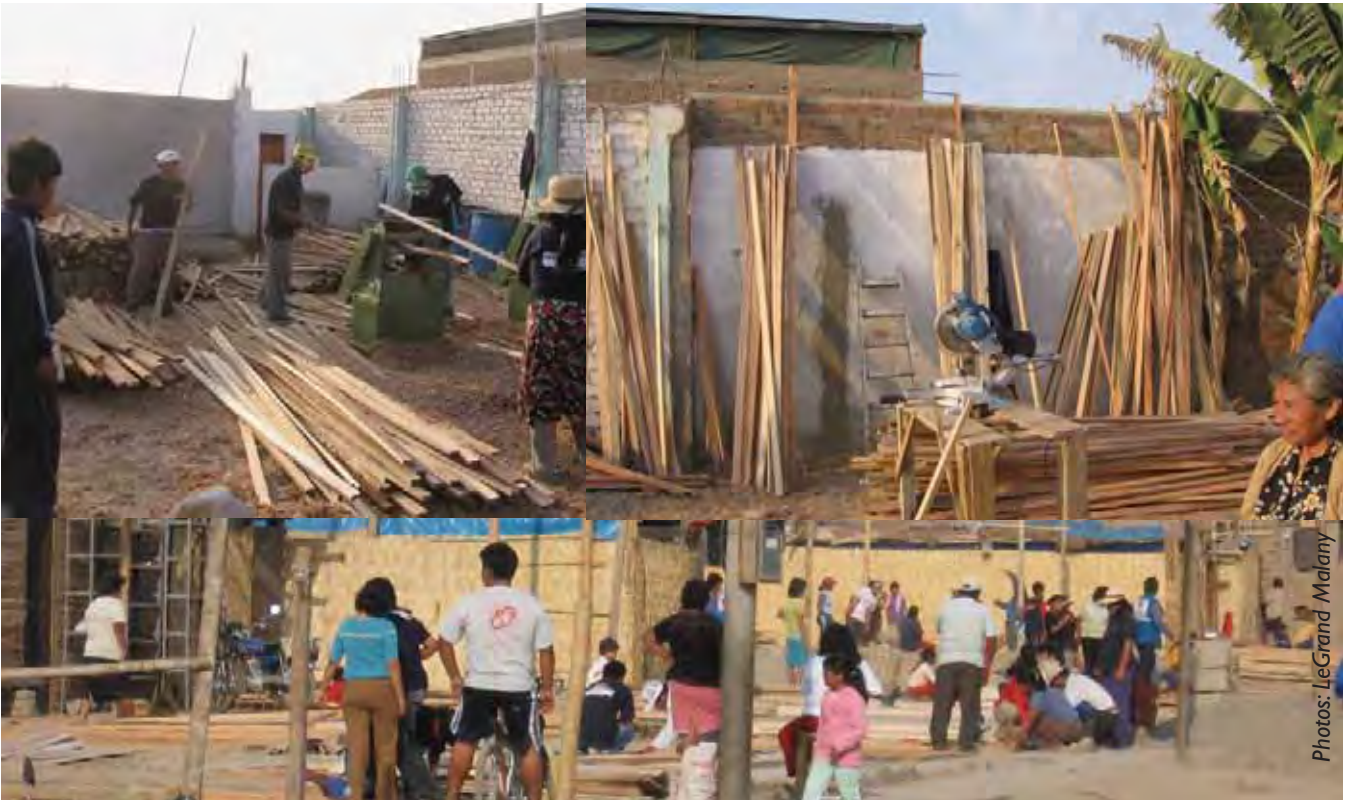
*The raw materials were prepared in workshops set up in the communities where shelters were to be built.*

The contractor set up a materials manufacturing 'factory' in each project area. At this site, the contractor's employees (using some local labour) cut, planed and finished the wall frame units. Only the contractor's employees used power tools.

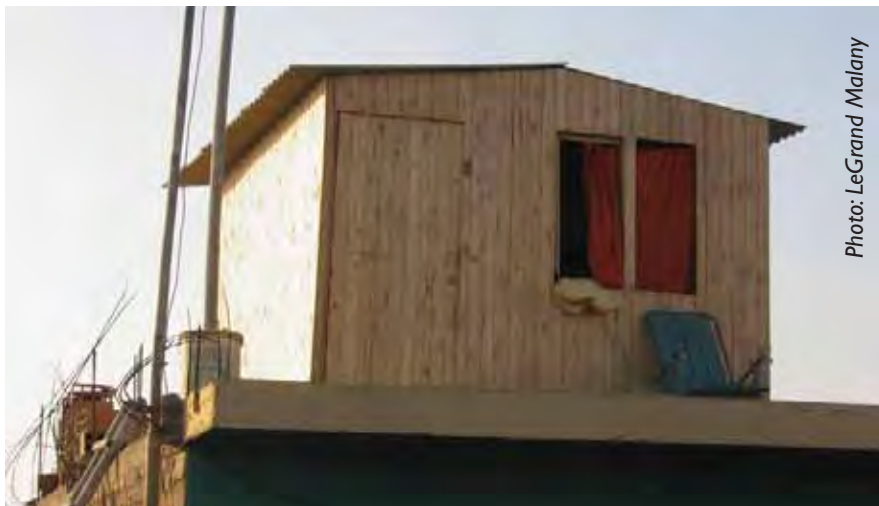
Completed shelter built on the roof of a damaged house

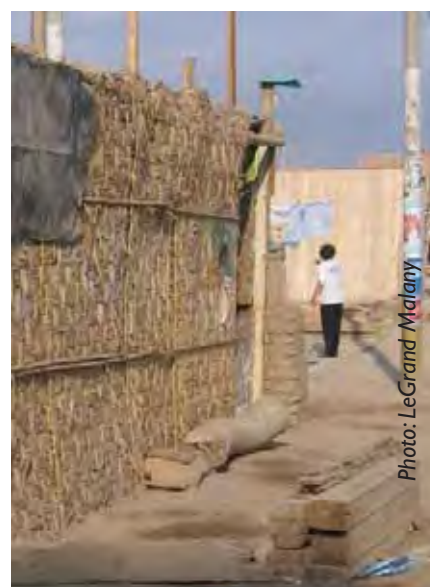
One of the project's shelters (background) and a shelter walled with reed mats (foreground)
