B.15 Myanmar - 2008 - Cyclone

Shelter construction

Myanmar

Cyclone Nargis

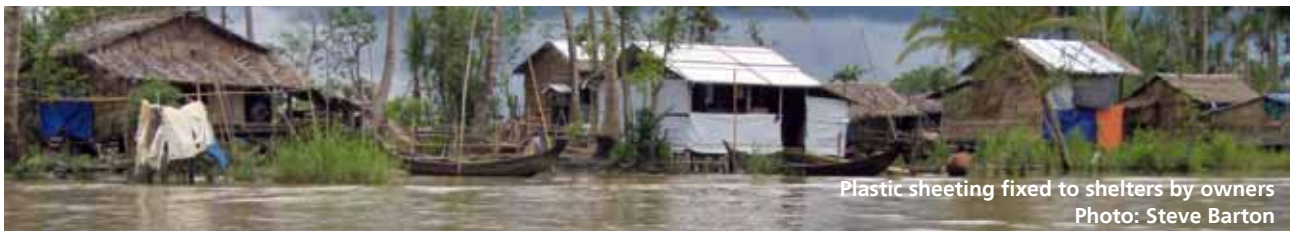
Plastic sheeting fixed to shelters by owners
Photo: Steve Barton

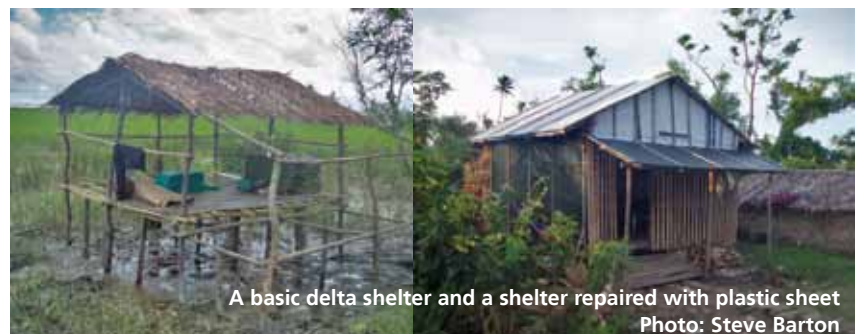
A basic delta shelter and a shelter repaired with plastic sheet
Photo: Steve Barton

Emergency shelter was made of recovered wood (45.3%) and locally available traditional sources of building materials such as bamboo (32%) and areca palm (22.7%). They also used the recovered bamboo (46.8%) and areca palm (53.2%) for the floor. Tarpaulin was mostly used for the roof (83.9%). In some cases, it was also used for the walls (25.8%).

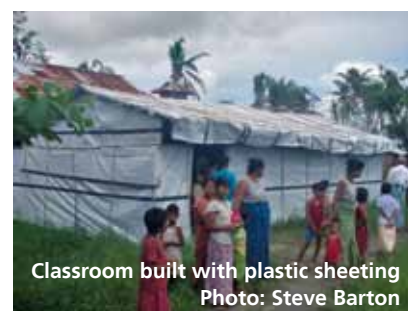
Classroom built with plastic sheeting
 Photo: Steve Barton

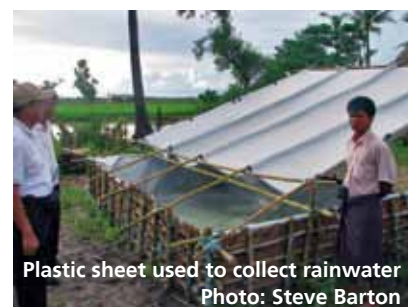
Plastic sheet used to collect rainwater
 Photo: Steve Barton

88.7% of the total amount of tarpaulin was used for shelter and 11.3% of the tarpaulins were used for rain water harvesting, covering the harvested paddy and other purposes.
