CASE STUDY

# BURUNDI 2017–2018 / CAMPS CLOSURE

**KEYWORDS:** Camp decommissioning, Semi-permanent shelter, Rental support

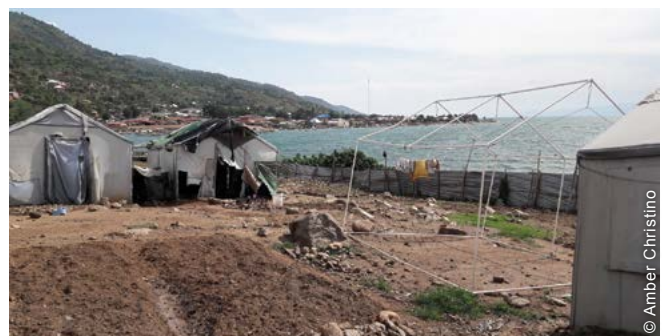
The tents provided in the camps were intended to last about six months, but families lived there for two years, in battered tents like these at Cashi camp.

The shelter kits initially provided were intended to last approximately six months, though families lived there for more than two years. Living conditions rapidly deteriorated; tents were in dire need of repair; rain poured in from holes in the roofs, creating a muddy sleeping area and leading to increased incidence of pneumonia and other illnesses. In January 2018, the camps of Mushasha I and II were partially destroyed by floods. Many inhabitants expressed their desire to leave and requested assistance for a more durable shelter solution.

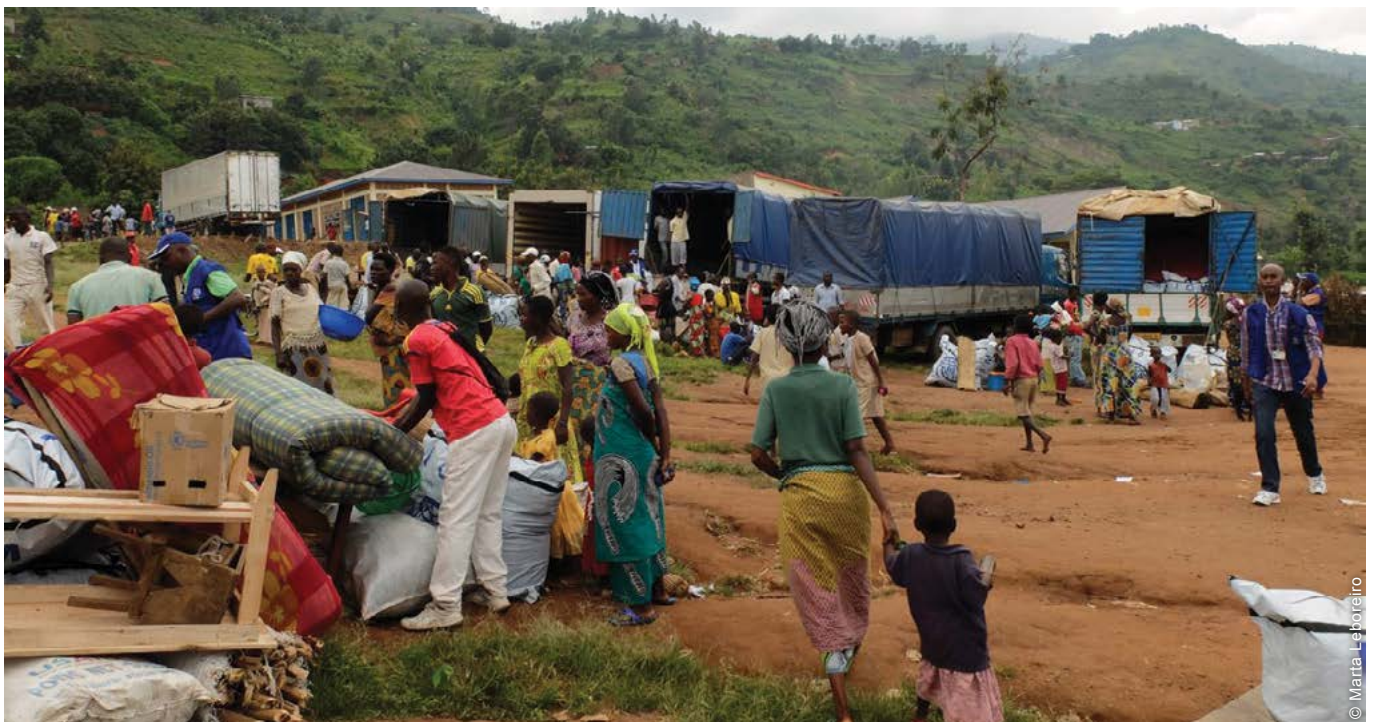
To facilitate the decommissioning process, the organization provided transport assistance and a cash-for-work grant for the dismantling and cleaning of tents and family plots in the camps.

**CASH-FOR-WORK ACTIVITIES.** To generate income and involve them throughout the decommissioning process, all families were provided with a cash-for-work grant for the dismantling and cleaning of their tent and plot in the camp.

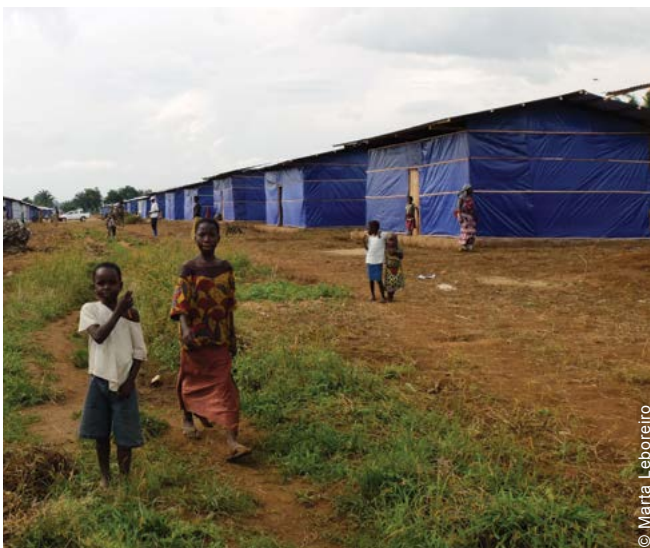
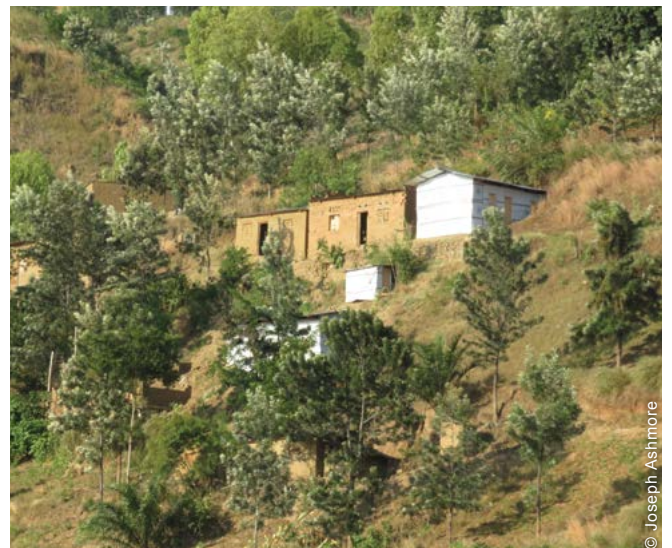
The project supported return by providing shelters on a resettlement site on government-issued land in Kigwena (above left). When land tenure and safety allowed it, shelters were built in the area of origin of the IDPs (above right, in the hills of Rumonge).

**A. SEMI-PERMANENT SHELTERS IN RESETTLEMENT SITE.** Those in Cashi and Gitaza who did not own land were relocated to the government-issued land of Kigwena, where 174 improved semi-permanent shelters were built. These included latrines and kitchens (including 40 for the most vulnerable among the host community). Due to budget restrictions, the shelters were built using corrugated iron sheets on the roof and temporary walls made of tarpaulins. The host community actively participated in the construction, supported through a cash-for-work programme.

**B. SEMI-PERMANENT SHELTER IN AREA OF ORIGIN.** 159 semi-permanent shelters were built in the areas of origin of the population living in Cashi and Gitaza camps, across seven different hilly locations. Due to timing and the complexity of transport to the isolated hills, some of which are located three hours away from a major road, the stone foundation was removed and households received cash to transport the materials (the equivalent of USD 2.50 per trip from the camp to the new land). Each household built its own latrine with materials provided and a cash grant for digging.
