CASE STUDY

NIGERIA 2017–2020 / CONFLICT

KEYWORDS: Coordination, Land advocacy, Site management, Site planning

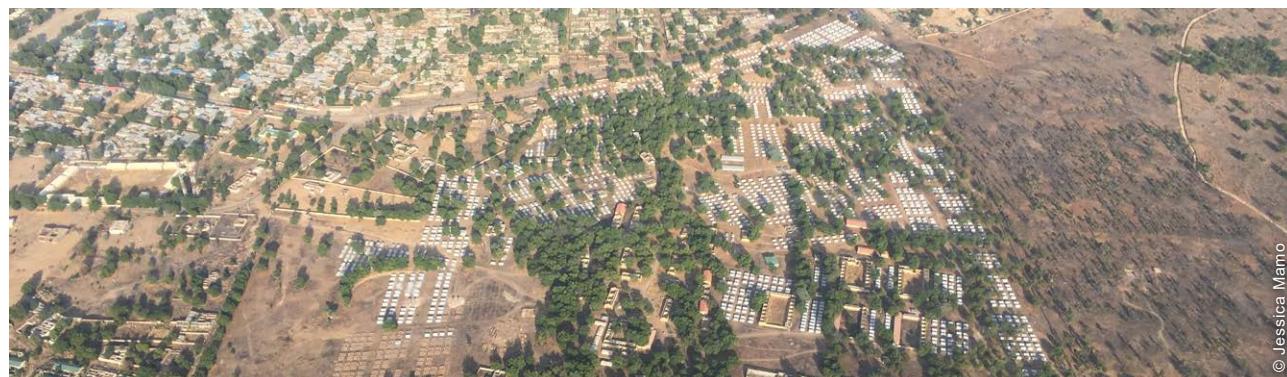
An aerial view of the GSSSS camp during camp set-up. The camp, located on the edge of Bama town was set up to enable the relocation of IDPs from the overcrowded General Hospital camp.

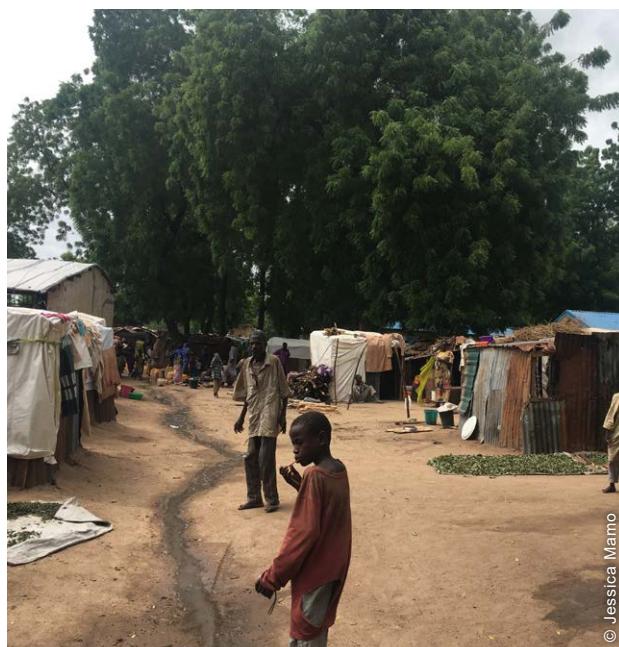
The General Hospital camp shown here was closed at the end of 2017, with camp residents relocated to the new GSSSS camp.

The conditions of the camp rapidly deteriorated, with the main concerns being poor sanitation (such as latrines being quickly filled up) and lack of shelter (up to 1,000 households sleeping outside). This was further compounded by lack of adequate drainage during the rainy season, with a rapid increase in cases of diarrhea and a small cholera outbreak.

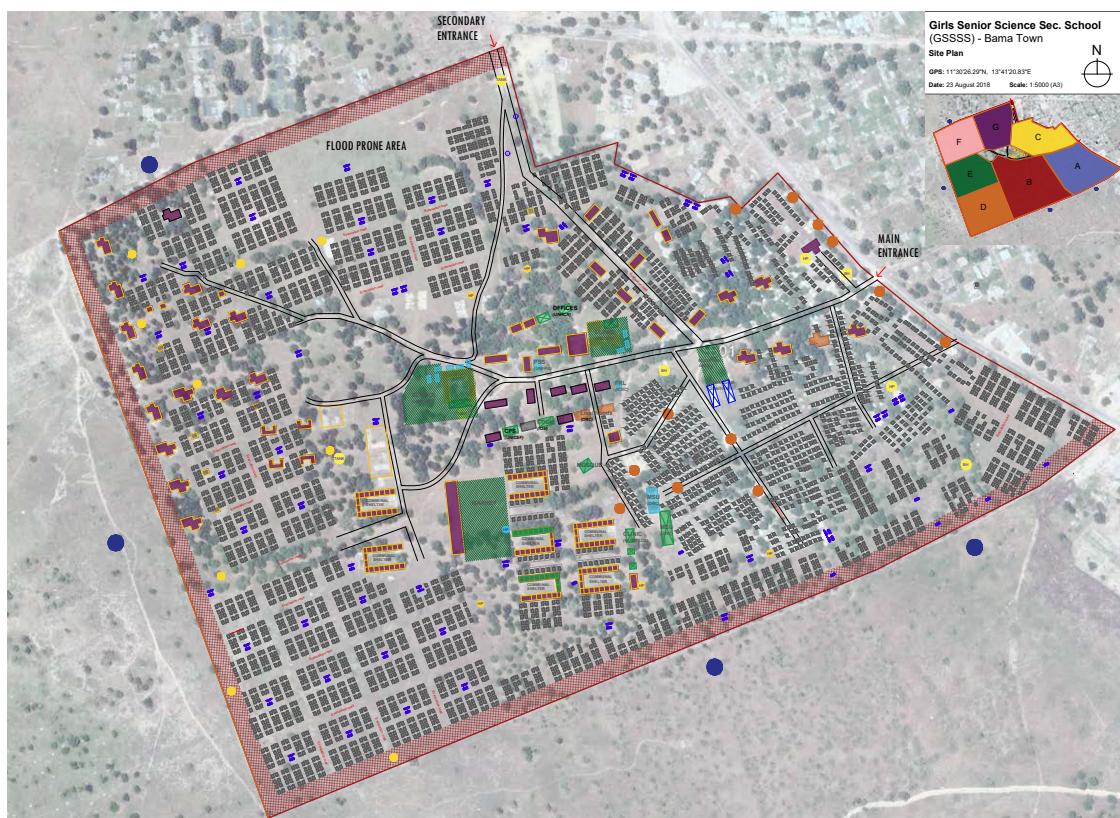
With the input of partners a single site plan was developed, which aimed to make the best use of the limited available space.

However, shelter partners then rapidly came together with other sectors under the Shelter/CCCM Sector and followed a multisectoral plan, agreed upon at the Humanitarian Country Team level, which included roles and responsibilities and a single site plan. The site plan comprised seven zones and was based on a mapping of existing infrastructure, mainly damaged school buildings, and the nearly 1,200 shelters that had previously been constructed in zones A, B and C. Priorities in site planning included making best use of space given the limited area, while considering GBV mitigation measures, flood risk, fire safety considerations, and planning around the many existing trees on the site.

By October 2017, setting out and shelter construction started with two main shelter partners implementing an additional 3,700 shelters in phases. One organization used multiple private contractors while the other implemented via a government agency. This was mainly due to the scale of the operation and the limited timeframe to complete construction. Works were always supervised by technical staff of the implementing organizations. Although some delays in materials supply were experienced, the initial capacity to accommodate the population in General Hospital was achieved in around two months. The implementation of water and sanitation facilities, as well as other services, had also been started by a range of humanitarian partners. Commitments and construction updates were being coordinated with dedicated meetings and captured with frequent updates of the site plan, led by one of the shelter partners.

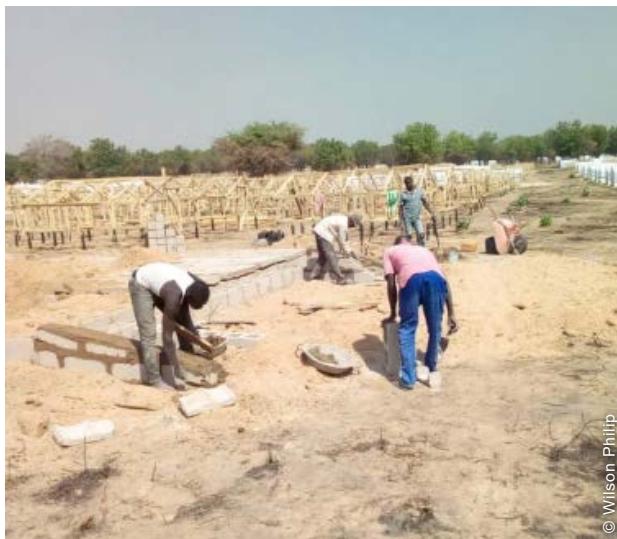
Shelter and latrine construction commenced in October 2017 in preparation for the anticipated relocation date of January 2018 (which was later brought forward to mid-December 2017).

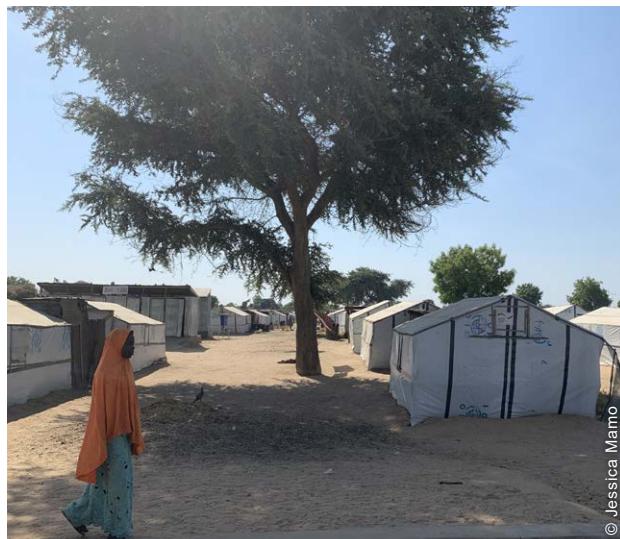
There were many existing trees on the site which were integrated into the site plan.

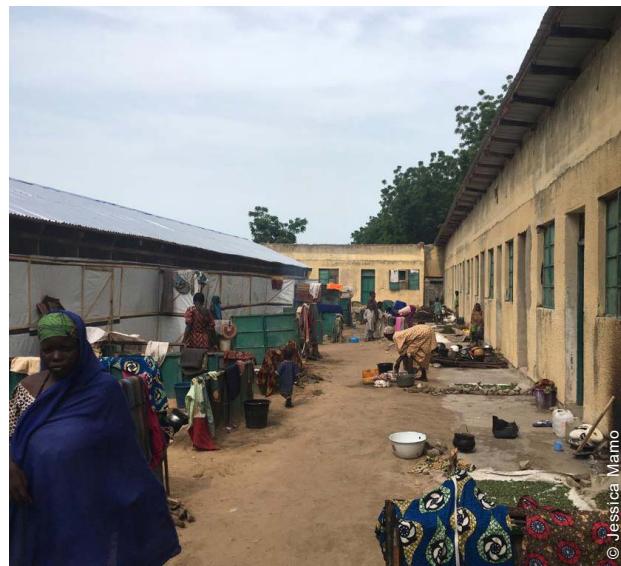
Existing buildings on the site were rehabilitated and partitioned (right) to provide additional shelter in the camp. Partitioned communal shelters (left) were also constructed due to the lack of space for individual family shelters.

There were many existing buildings within the GSSSS site; mostly classrooms and teachers' accommodation. Most did not have roofs, doors and windows due to fire or vandalism. A few had been destroyed, while only two were in good conditions. One organization conducted a comprehensive inventory of all the buildings in the camp, including an estimate of all the rehabilitation works required, which focused mainly on the reconstruction of roofs, rehabilitation of some damaged walls, provision of doors and windows and partitioning using plastic sheeting. Due to funding constraints, only some of the buildings could be rehabilitated in 2018, while more were rehabilitated the following year.

Initially, contractors were engaged to provide all materials and conduct the rehabilitations. In 2019, one organization used a different approach based on the availability of an existing stock of emergency shelter kits. These were used to construct the roofs and to clad openings and partitions for an additional 39 buildings. Throughout, community carpenters were engaged through a Cash-for-Work modality. In this case, plastic sheeting was used for the roofs instead of corrugated iron sheets, thus reducing the lifespan of the intervention. However, the involvement and on-the-job training of carpenters from the camp provided new skills and income opportunities to the IDPs.

Due to the lack of space for individual shelter construction, one organization piloted the construction of 14 communal shelters of 20 rooms of 3x3m each in available pockets of space within the camp. This was implemented via contractors and was then adopted as a model for reception facilities across the state. Initially intended to be a temporary solution, the continuous influx of new arrivals and the inability to acquire additional land meant that these shelters continued to be used as accommodation. This shelter solution was initially criticized by some based on claims of limited privacy and cultural appropriateness. This led to the sector deciding to discontinue this type of intervention as a shelter solution, while it continued to be used for reception facilities. However, through later discussions with the Protection Sector, it was accepted that partitioned communal shelters were still a better solution than exposing IDPs to the weather.

In 2019, following large-scale influxes across locations and advocacy by one organization, the sector approved the introduction of a more affordable model of communal shelter – with 16 rooms and plastic sheet roofing – which was implemented via community carpenters. In the case of Bama GSSSS camp, a total of 10 structures were built on available space in 2019 and an additional five in 2020. Despite the initial criticism, findings from a survey in 2019 showed that only very few households complained about the lack of privacy, while over 95 per cent of respondents were satisfied with this shelter type and reported that it had significantly improved their living conditions.

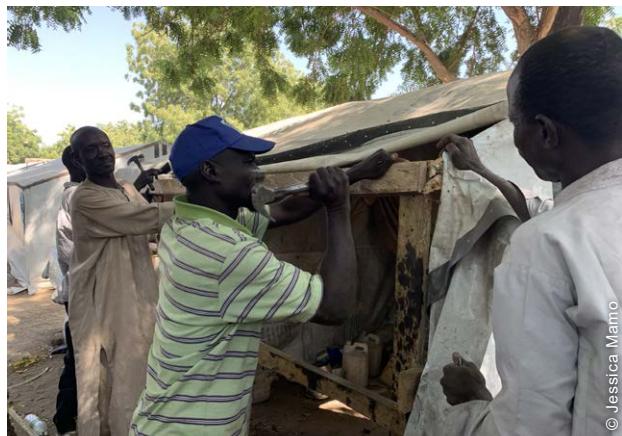
The engagement of community carpenters from within the camp population supported skills development and livelihood opportunities.

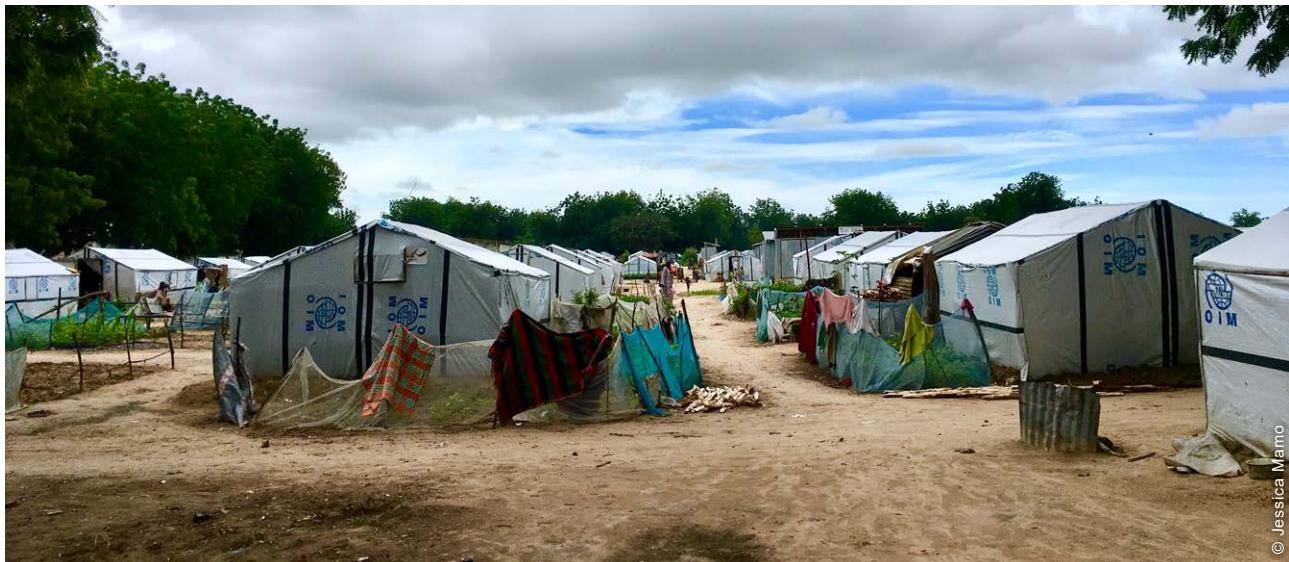
Given the continued population increase in the camp with limited options for site expansion, the levels of congestion within the camp continue to increase.
