B.3 Bangladesh - 2007 - Cyclone Sidr

Core shelter, repair and awareness

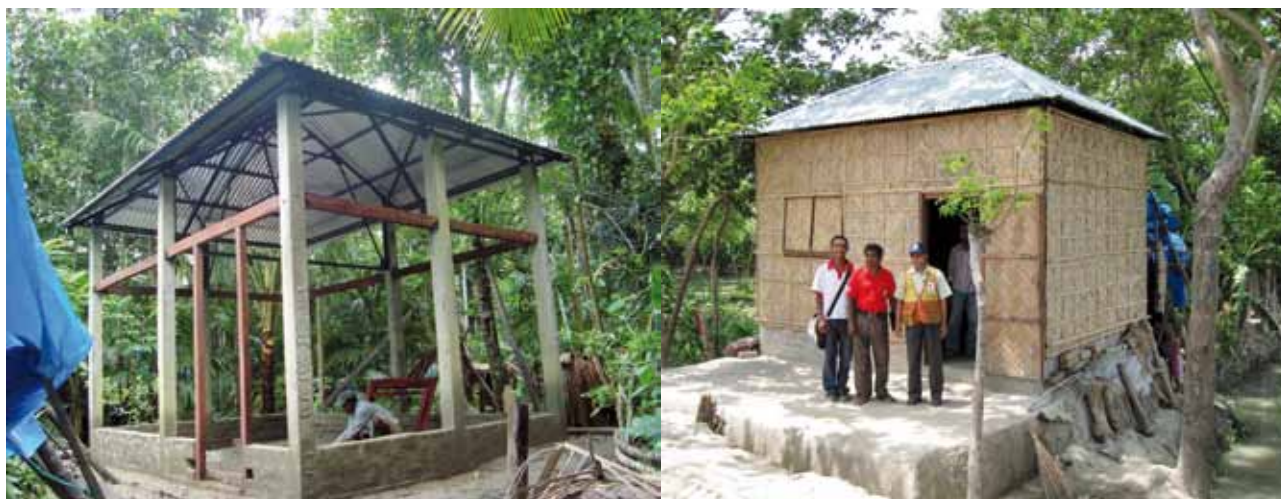
The core shelters were built by contractors and selection of families was through a lengthy transparent process
Left shows the frame of the structure
Photos: Xavier Génot, IFRC

The core shelter was built on a mud plinth to protect from flooding. It was anchored to the soil by the 8 reinforced concrete columns with 5 feet deep foundations. The structure was braced, had a six-

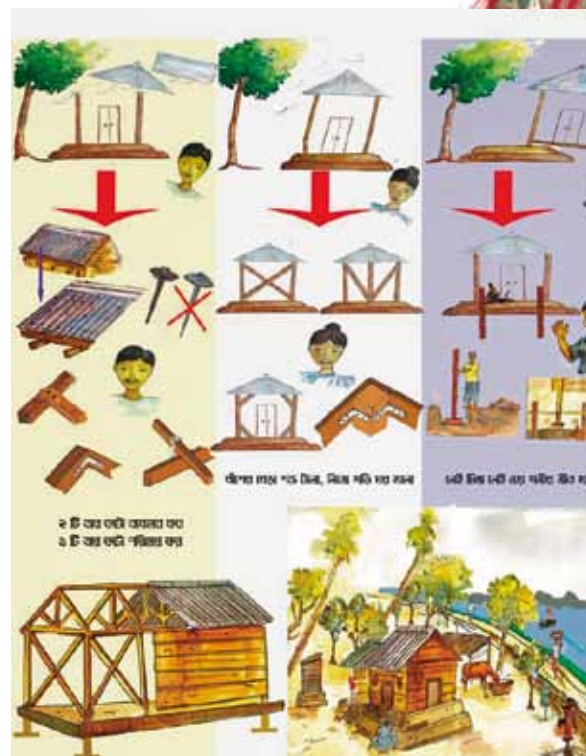
Below: training poster developed for the Sidr Programmes

Training events in safe shelter awareness were interactive and took about three hours. They were conducted in sessions attended by between 20 and 25 people, led by two people and monitored by one observer. Trainings were to help families to assess their shelter vulnerability, help families to strengthen their shelters (with focus on bracing, foundations and roofing), and to present toolkit components.

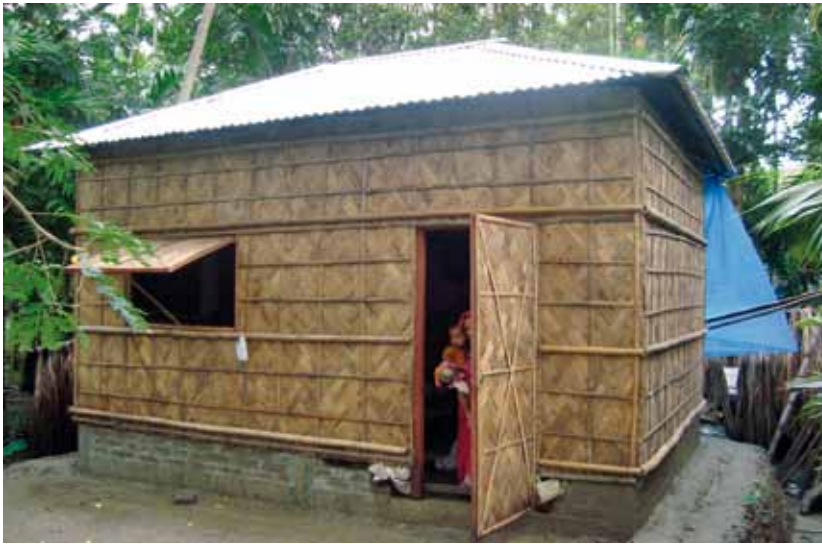
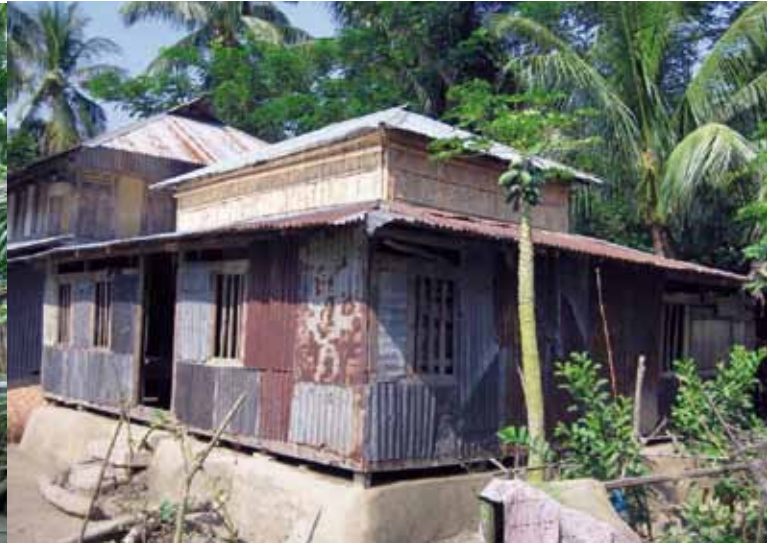
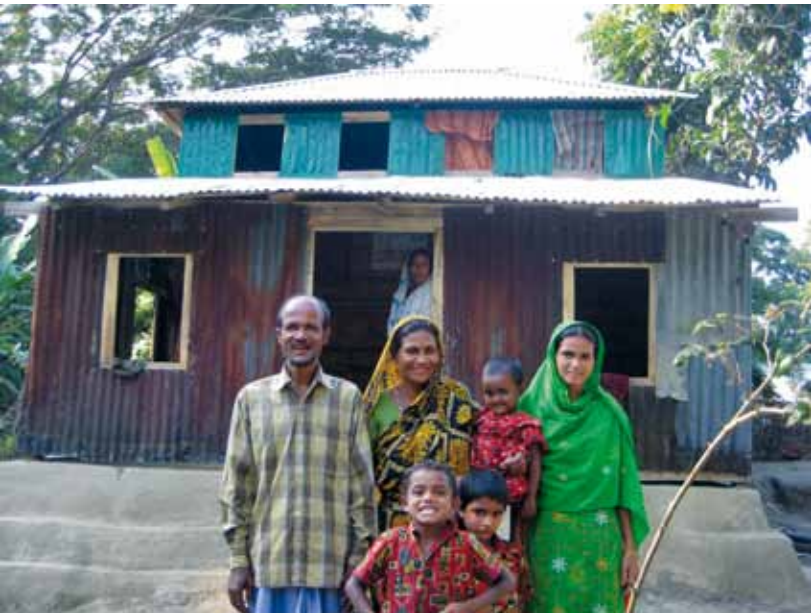
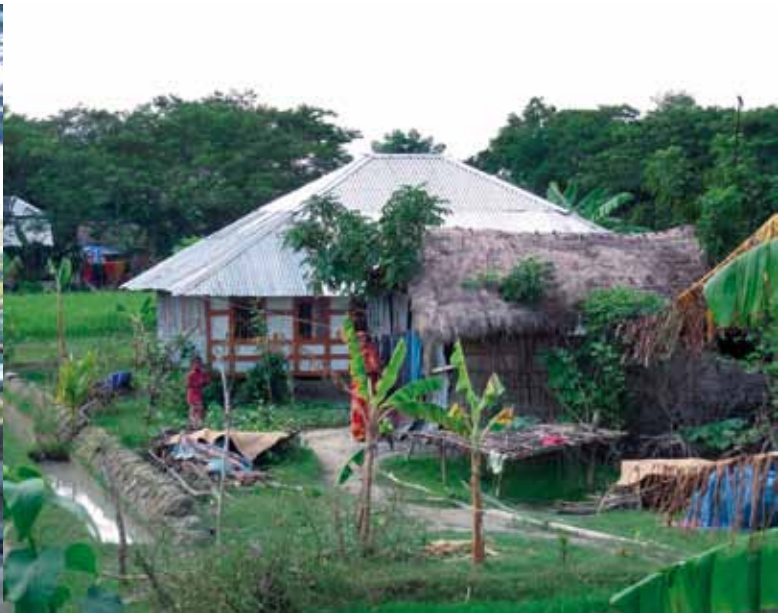
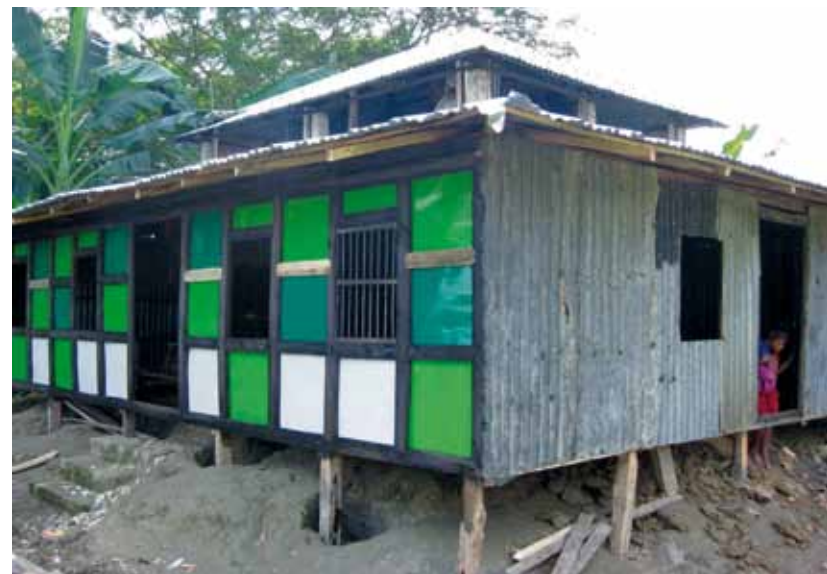
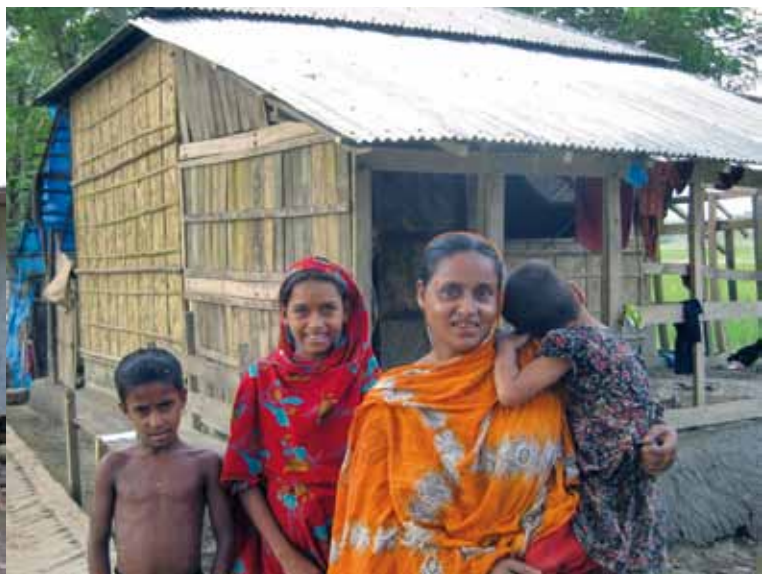
The programme provided support for families to upgrade their shelters. Many families were able to make improvements and extensions from the core house (top left) to the various extended structures (above)
Photos: Xavier Génot, IFRC

and brackets could be found in the repairs and extensions that families had built.
