A.18 Madagascar – 2012 – Tropical Storm

Case Study: **Keywords:** Construction materials, Core housing construction, Training, Guidelines and training materials.

Madagascar

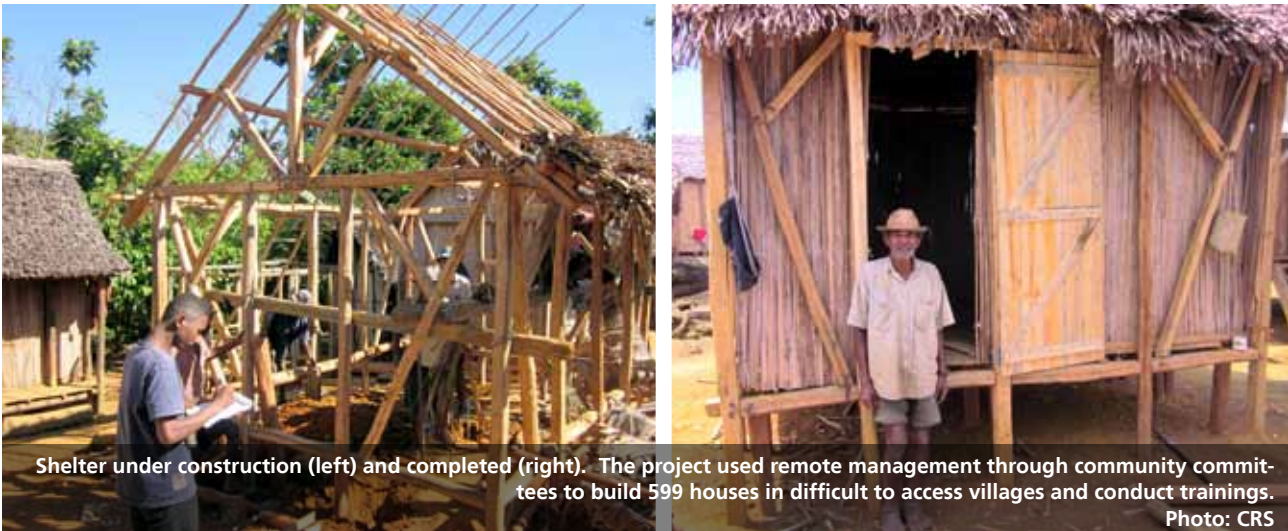
Shelter under construction (left) and completed (right). The project used remote management through community committees to build 599 houses in difficult to access villages and conduct trainings. Photo: CRS
