CASE STUDY **DOMINICA 2017–2018 / HURRICANE MARIA**

KEYWORDS: Roof repairs, Core housing, Training, Migrant labour

PROJECT SUMMARY

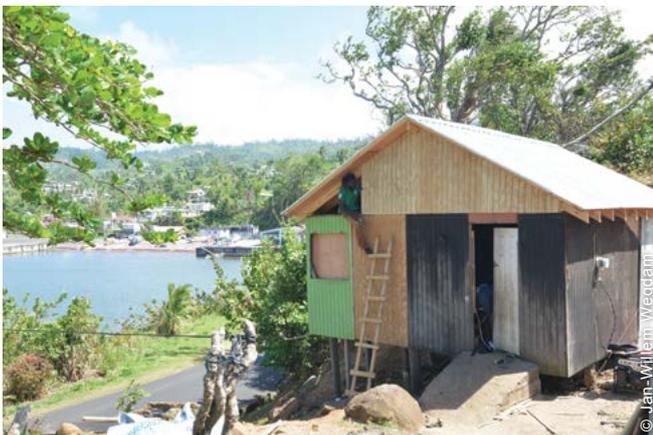
The project repaired 670 roofs in compliance with an improved building code after the hurricane.

ROOF REPAIRS. Roof repairs were provided to 670 households. **An underestimation of the structural damage** in initial assessments, combined with the emphasis on the building code and a shortage of building materials in the region, led to a high increase in the cost of repairs, forcing a reduction in the number of beneficiaries. **For 25 per cent of the targets, “interim solutions” were provided** following a widely adopted approach by the Sector, which highlighted different options for assistance depending on the structural conditions (code compliant or non-compliant) and the safety of the location. For non-compliant (but repairable) houses, the organization implemented the repairs instructing households to further strengthen their structure according to the building code.

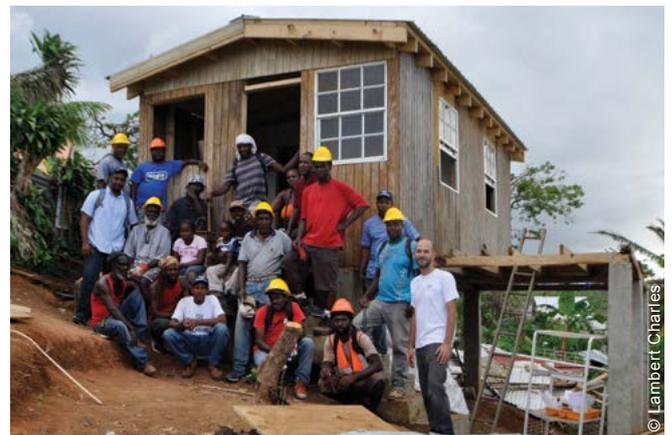
For vulnerable households with a completely destroyed house, core houses were built according to a locally approved studio design. Due to its cost, targets had to be adjusted.

CORE HOUSES. Given the small average family size in Dominica, the organization initially proposed to build 225 12m² timber transitional shelters. However, these did not meet the Dominica building code, which prescribed a minimum floor space of 18.5m² including a kitchen, bathroom and connection to sewage or septic tank. **The design had to be adapted into a larger core house** with an already approved studio layout and optimized materials. The donors agreed to a reduction to 80 beneficiaries.

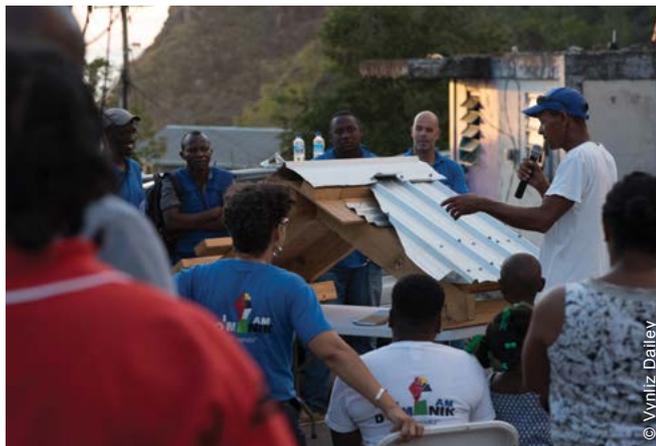
A model was used to explain safe roof repair interventions.

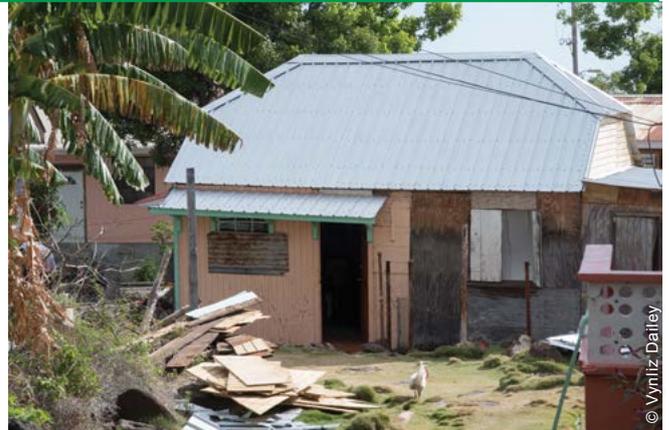
Even though roofs were repaired to code, structural improvements were not considered, nor were water, sanitation and livelihood components.

- **The project scope and budget did not include structural reinforcements** needed by many of the damaged houses to support a code-compliant roof.
