## C.7 Honduras - 1998 - Hurricane Mitch

### Case study: Transitional shelter

Transitional shelter  
construction

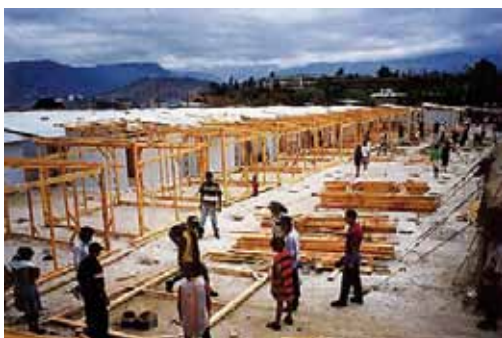
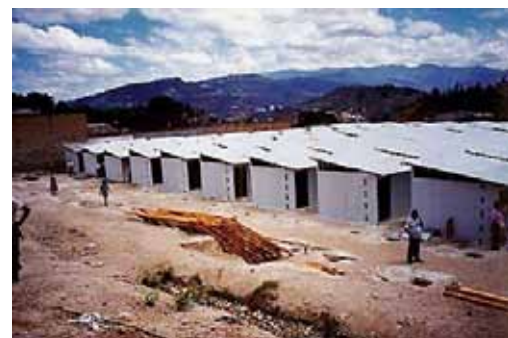
Although the preferred option was to build shelters on people's own land, in some cases it was necessary to build shelters on a temporary relocation site.

The program provided materials and technical assistance for construction of a 3.05m x 3.65m wooden framed shelter in central and southern Honduras for victims of hurricane Mitch. The roof was made of galvanized roof sheets that were reused when the families re-built their houses with more durable materials. Sides were made of reinforced good quality woven plastic sheeting. The shelter included a door and two windows with nets to provide both privacy and ventilation.
