A.2 Burkina Faso – 2012 – Conflict

Case Study: **Keywords:** Planned and managed camps, Construction materials, Emergency shelter, Transitional shelter / T-shelter, vouchers, Site planning.

Férério Refugee Camp, Oudalan Province

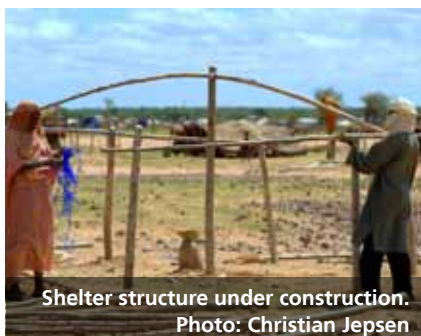
Shelter structure under construction.
Photo: Christian Jepsen

The refugees paid a lot of attention to detail in construction. The two plastic sheets provided were hand sewn together while the 8mm rope connecting the plastic sheets to the roof was skilfully secured in place by tying it to the corner poles of the shelters.

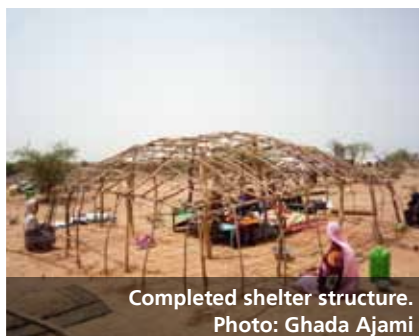
Completed shelter structure.
Photo: Ghada Ajami

The shelter model chosen was similar to a traditional Tuareg tent. It had a wooden-pole structure but instead of the traditional tanned skins for the roof and walls plastic sheeting was used. In some cases families used the emergency tents that had been provided earlier as roofing material.

Tuareg tents are suited to the environmental conditions: high wind loads, high temperatures and sand storms. The shelter contained no concrete so did not worsen water scarcity. The sides of the shelter were made from mats which could be re-positioned in order to change the location of the doors depending on the direction of the wind.

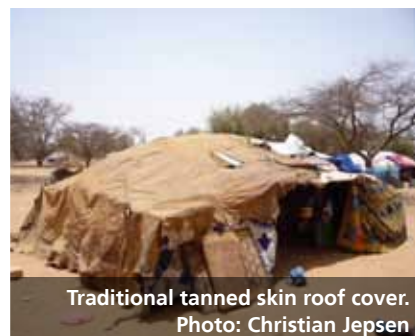
Traditional tanned skin roof cover.
Photo: Christian Jepsen

The Tuareg population in northern Mali is made up of nomadic and semi-nomadic groups moving across sparsely populated desert areas. Traditional Tuareg tent shelters are made from wooden supports covered with tanned animal-skin roofs, and are designed to be easily dismantled.

Tanned animal skins took too long to produce, and were not an option as a roofing material. To replicate the thermal insulation qualities of the skins, a set of nine woven straw mats were placed under the two plastic sheets.

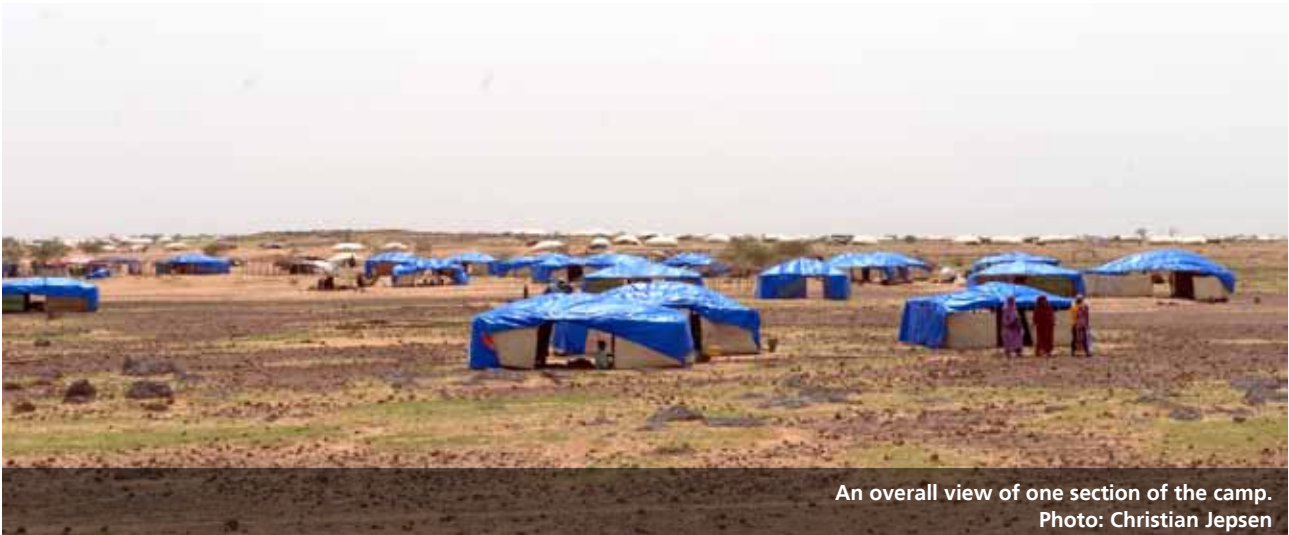
An overall view of one section of the camp.
Photo: Christian Jepsen

The camp held more than 25 tribal groups. The camp population re-organised itself according to these groups. A standard camp grid plan could not be applied to this more "organic" spread of families and if the refugees did not like where they were sited they simply dismantled their shelter and moved it somewhere else.
